The New York Landmarks Conservancy
Lucy G. Moses Preservation Awards
Submittal

The MacIntyre Building
874 Broadway
New York, New York

Facade Restoration and Roof Replacement

The MacIntyre Building is Readied for Its Next 100 Years

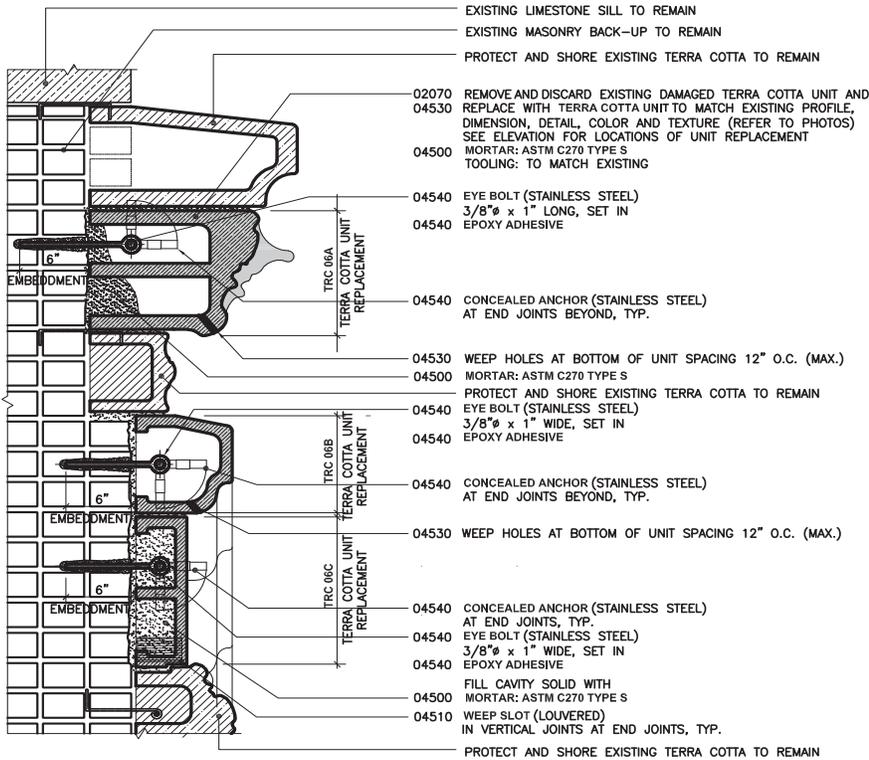
TRC 06A, 06B & 06C

TERRA COTTA UNIT REPLACEMENT : E. 18TH STREET 10TH FLOOR LEVEL

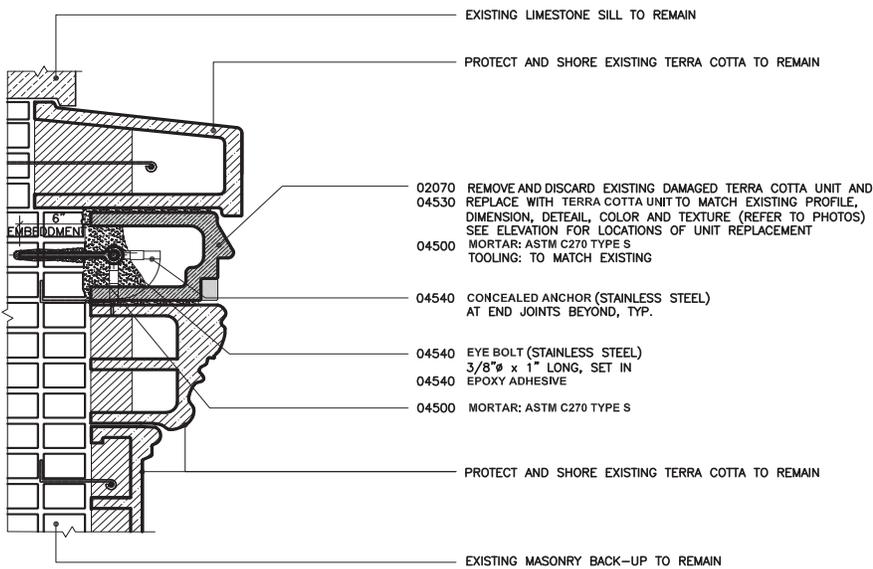
TRC 07

TERRA COTTA UNIT REPLACEMENT - DENTIL, E. 18TH STREET 9TH FLOOR LEVEL

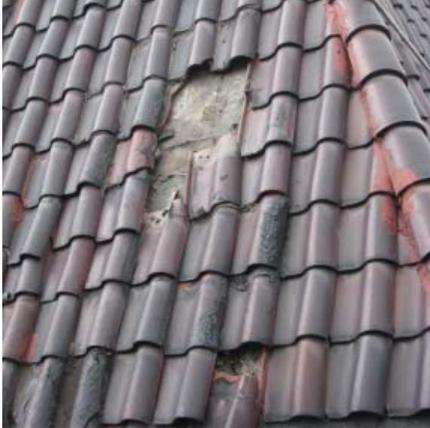
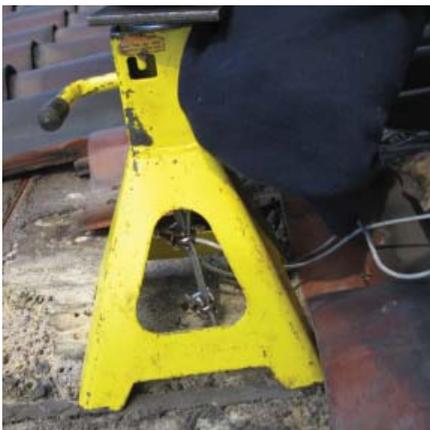
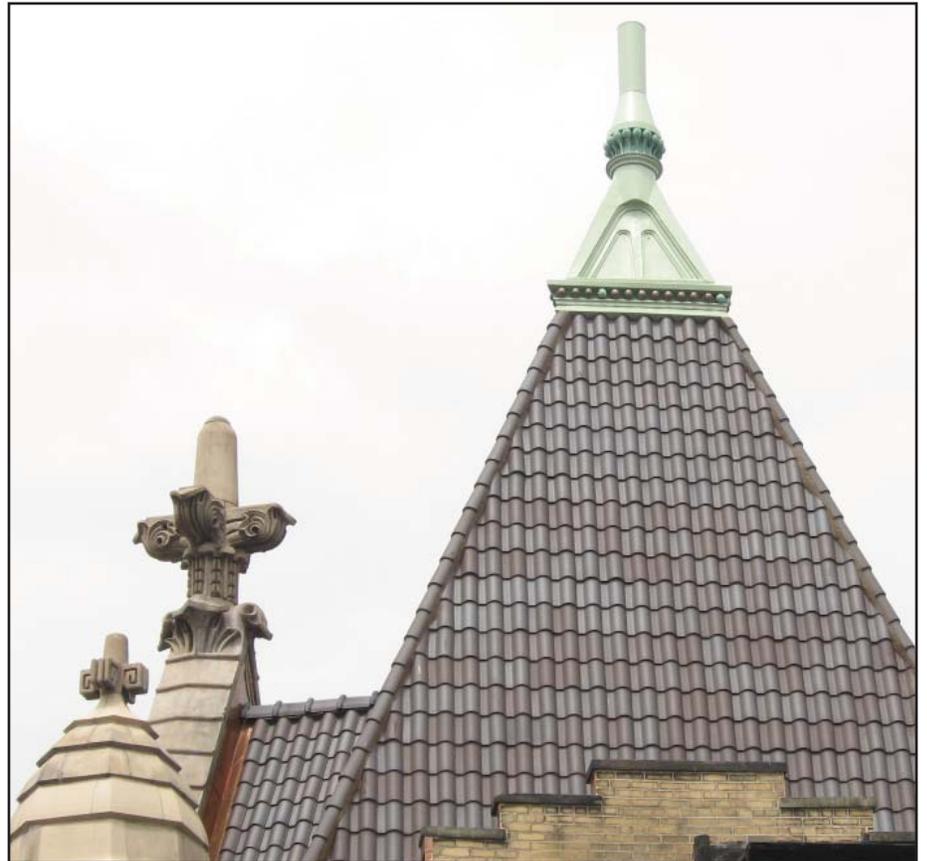
The tower is one of the most distinctive elements of the building's architecture. The Spanish-style clay tile roof was severely deteriorated and had clearly reached the end of its life span. In keeping with the Owner's budget, a facsimile tile of formed metal was originally considered. The Landmark's Preservation Commission staff took an interest in the roof and suggested the roof design might be approved, and the delay and expense of a full Commission hearing avoided, if the clay terra cotta roof was replaced in kind.

Below, top: Roof tile, before. Below, bottom: Pull test in progress. At right: Roof tile, after.

Custom-manufactured tile was deemed impractical for the project given the small size of the roof and the short construction schedule. Therefore all 15 domestic manufacturers of this type of tile were contacted in order to find the closest matching tile. The tile manufacturer Ludowici supplied a tile with the closest profile, only millimeters larger than the original, with the size difference not perceptible from the street. The new tiles' glaze closely replicated the mottled, almost smoky, finish of the aged tiles being replaced.

The roof tiles sit on the original gypsum concrete roof deck. This substrate is softer than materials used today, so pull tests were conducted for five different types of fasteners to determine which would work most effectively for this particular application.

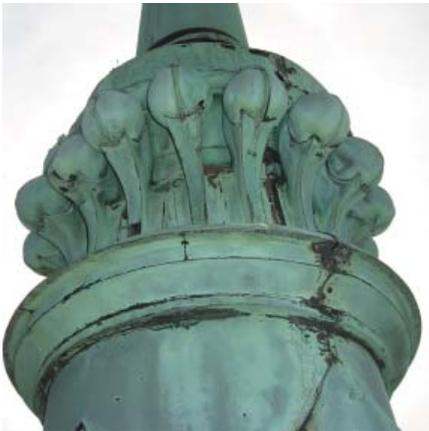
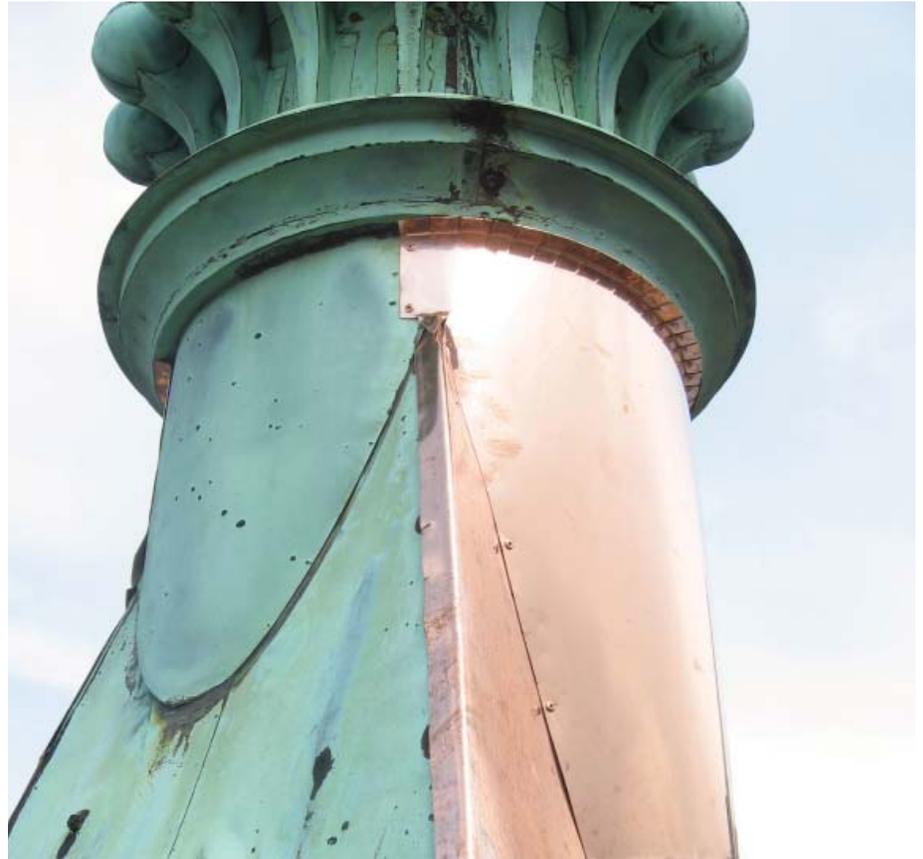
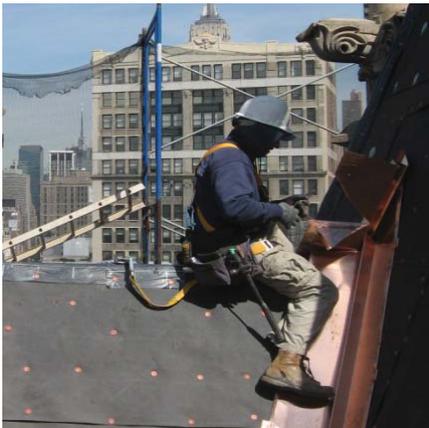
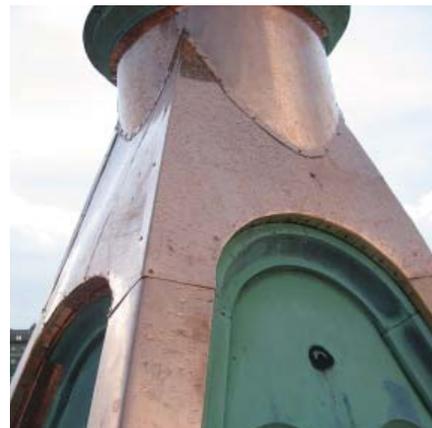
The copper spire, like many components of the building, was showing its age. The original fabric was retained where possible; elsewhere, new copper was “stitched” in. Due to the difficulty of accessing the spire, a copper patina-colored waterproofing coating was applied to minimize the possibility of future leakage. Copper was also used as roof flashing, gutter and downspouts.

Below, top: Copper spire, before. Below, bottom: Copper flashing being applied. Right, top and bottom: New copper installation in progress.

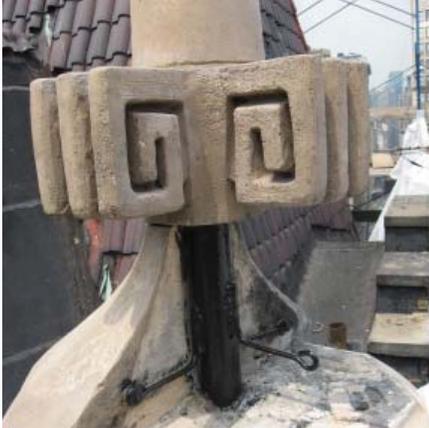
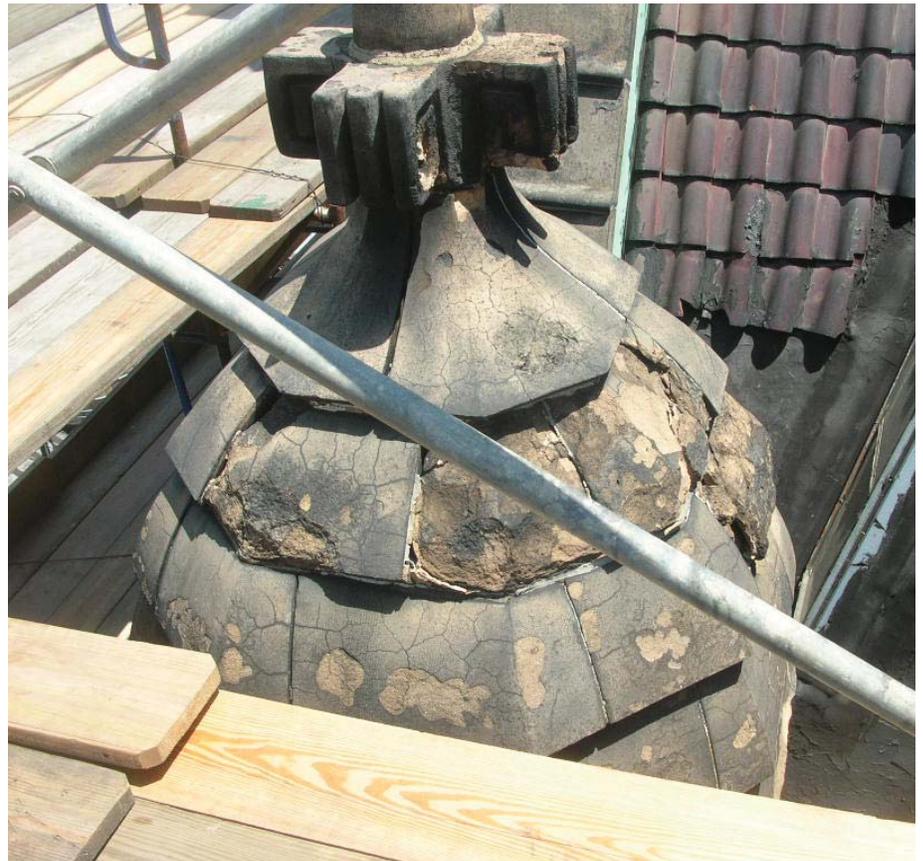
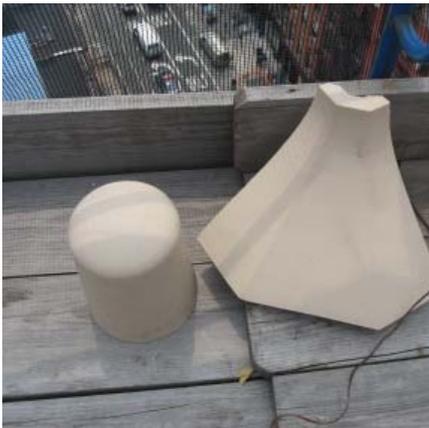
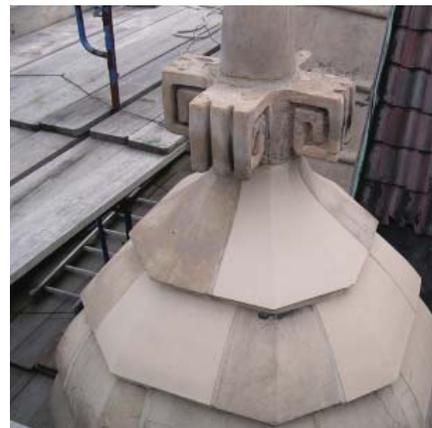
At right: Finial, before. Below, top: finial restoration in progress. Below, bottom: new cast elements. Right, bottom: Finial after.

The MacIntyre's Building exterior masonry work includes blocks, panels, polished columns and carved ornament in terra cotta, limestone, bluestone, granite and marble. Each material presented a variety of conditions. During conditions assessment, each defect was specified individually. Repair methods included pinning, patching, crack injections and replacement in kind. Whenever possible the original building materials were conserved in situ.

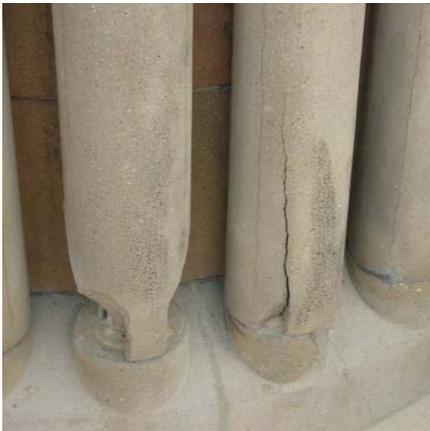
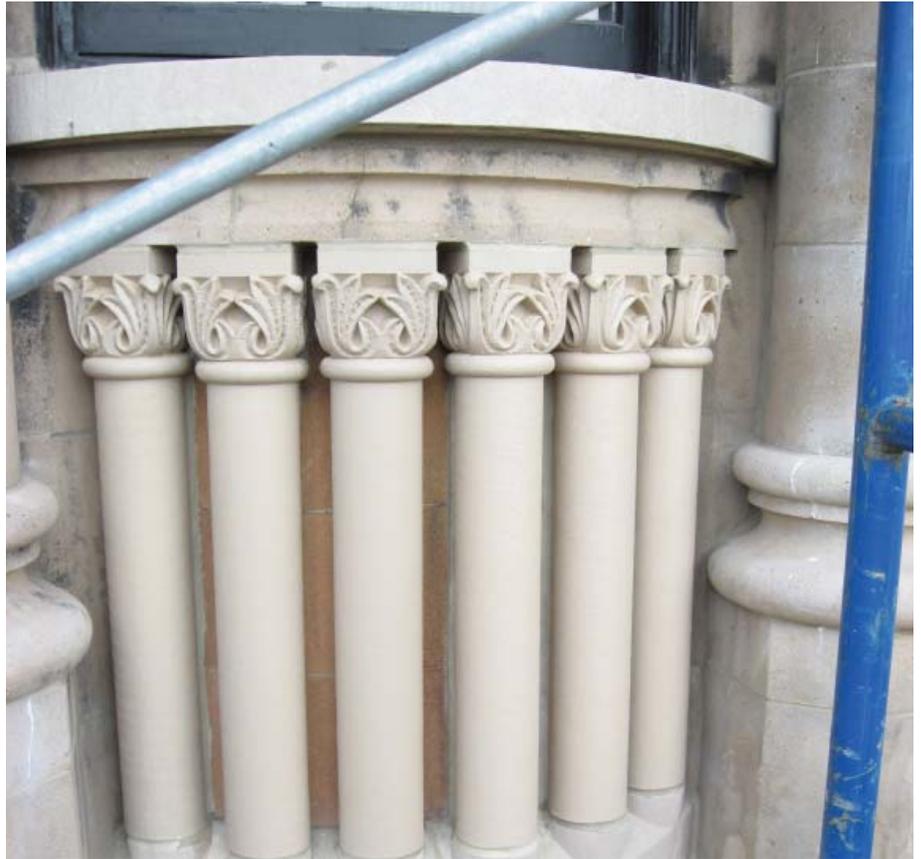
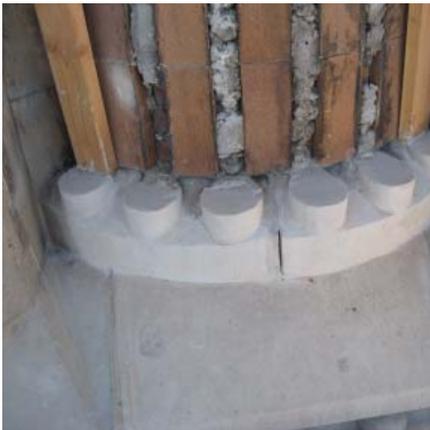
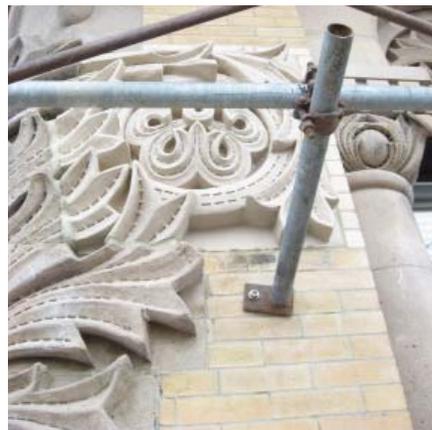
Below, top: Stone balustrade, before. Below, bottom: Balustrade restoration in progress. Right top: Balustrade, after. Bottom: Ornamental cast stone installation in progress.

In instances where stonework had deteriorated beyond repair, molds were made and new cast stone was put in place.

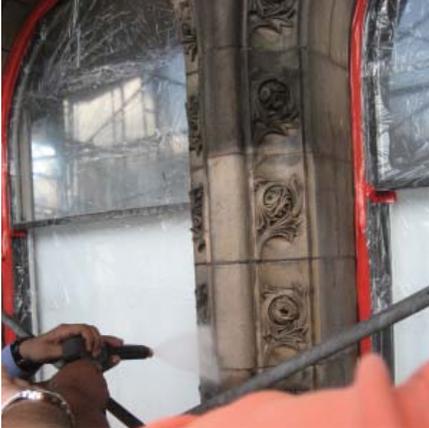
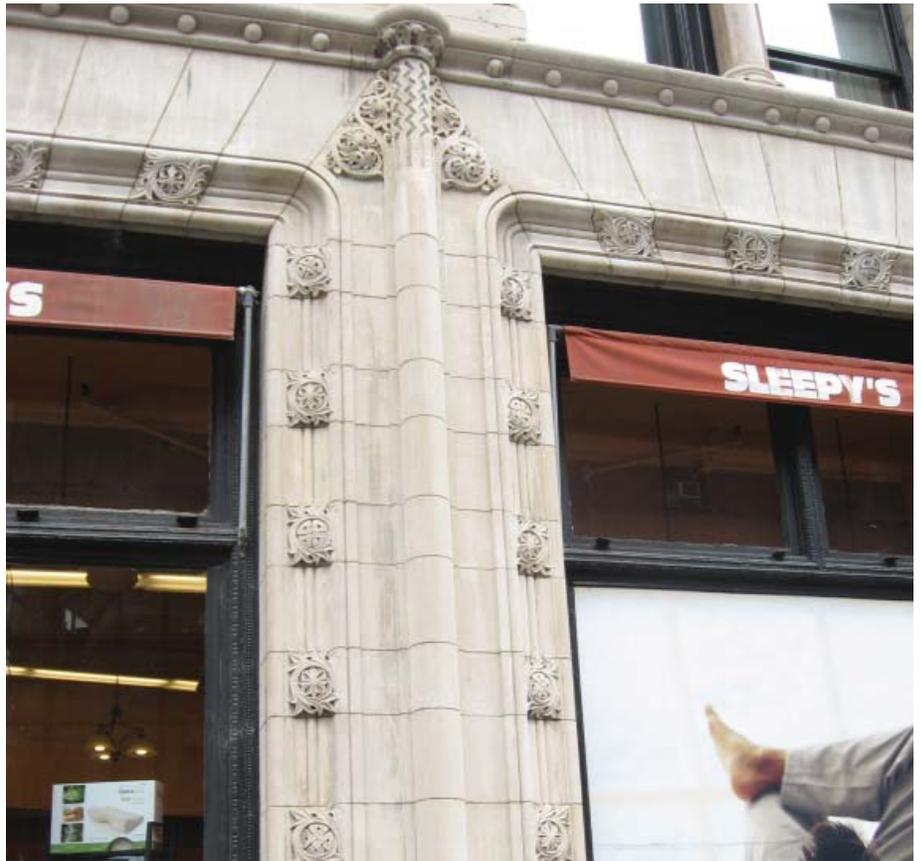
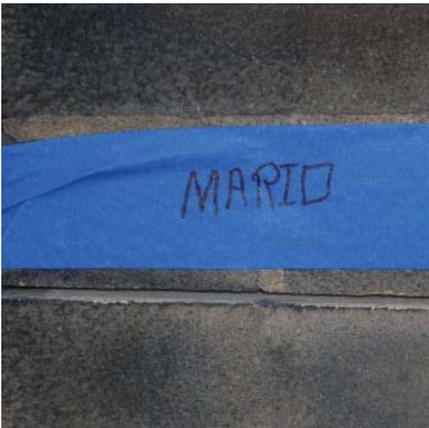
The building was completely cleaned. Under the direction of Joan Berkowitz, SUPERSTRUCTURES' Director of Conservation, conservators conducted tests on each type of material and monitored the execution. In one instance it was determined through absorption testing that some terra cotta had been partially de-glazed, so a special coating was specified that will preserve and protect the porous material from the elements.

Below, top: Limestone, being cleaned. At right: Limestone, after cleaning. Below, bottom: sample brick masonry labeled with applicant mason's tag.

The MacIntyre Building's bricks were laid with a butter joint, the re-pointing of which can test the skills of today's masons. SUPERSTRUCTURES' specifications required that each mason, prior to working on the building, submit a mock-up of a sample panel for review and approval. Only four individual masons met the quality test and were permitted to perform the re-pointing work on the building.

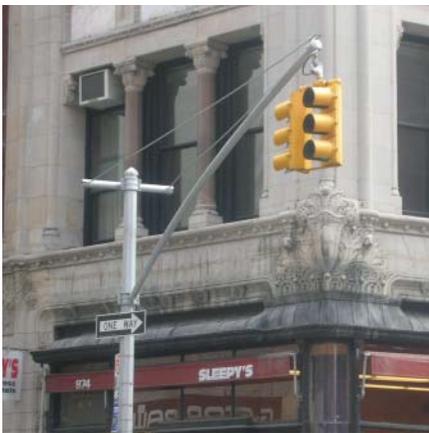
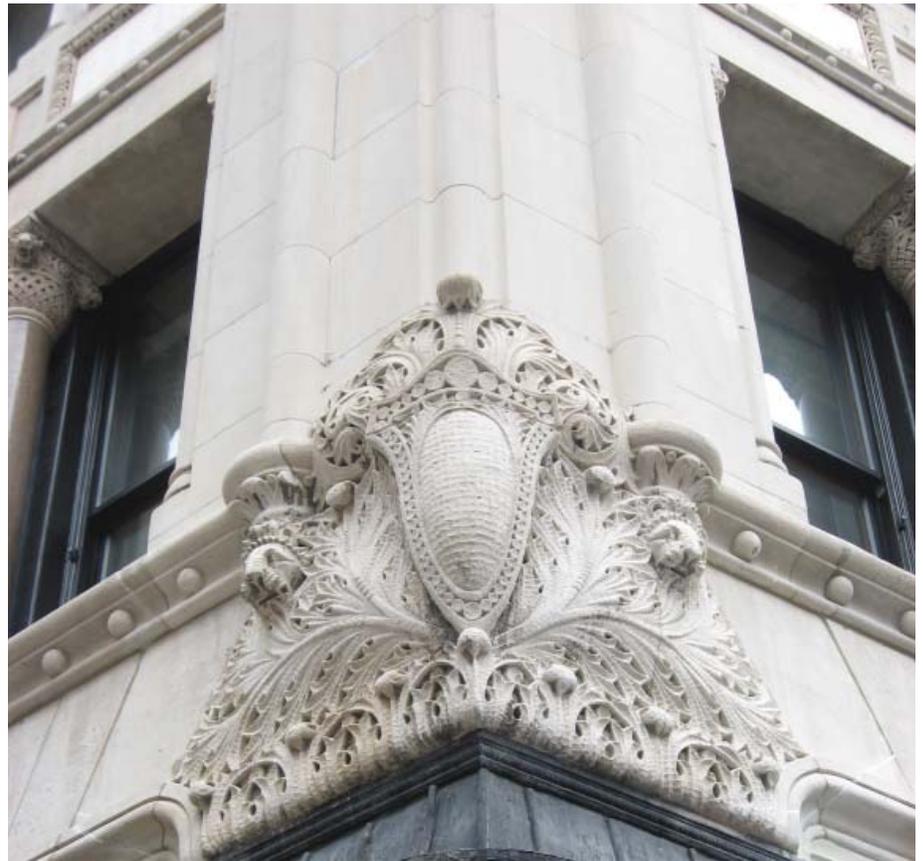
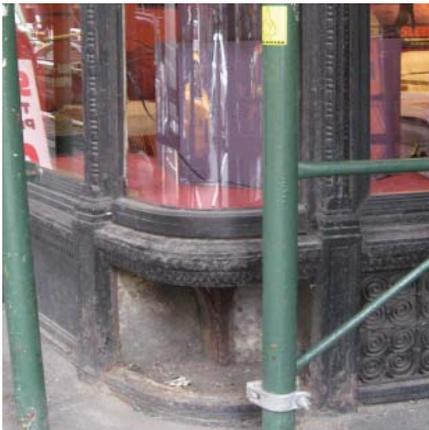
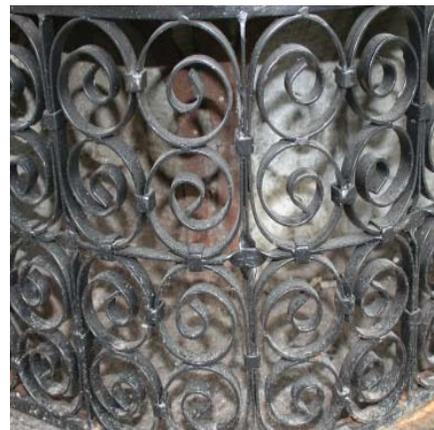
Below, top: Ornamental stone, before cleaning. At right: Stone, after cleaning. Below, bottom: ornamental grate missing. Right, below: Ornamental grate replacement.

At projects' end, the sidewalk bridge was removed and finishing touches were completed. For example, ornamental grates were fabricated to replace those that were missing.
