The New York Landmarks Conservancy  
Lucy G. Moses Preservation Awards  
Submittal

Clemente Soto Velez Cultural & Educational Center  
107 Suffolk Street  
New York, New York

Exterior Renovation

**SUPERSTRUCTURES**  
+ **ENGINEERS**  
**ARCHITECTS**

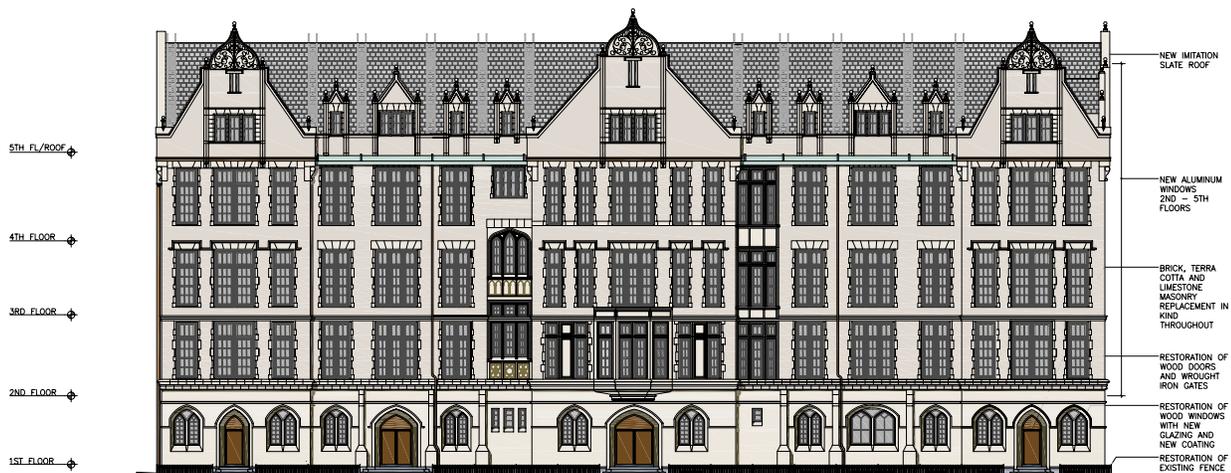
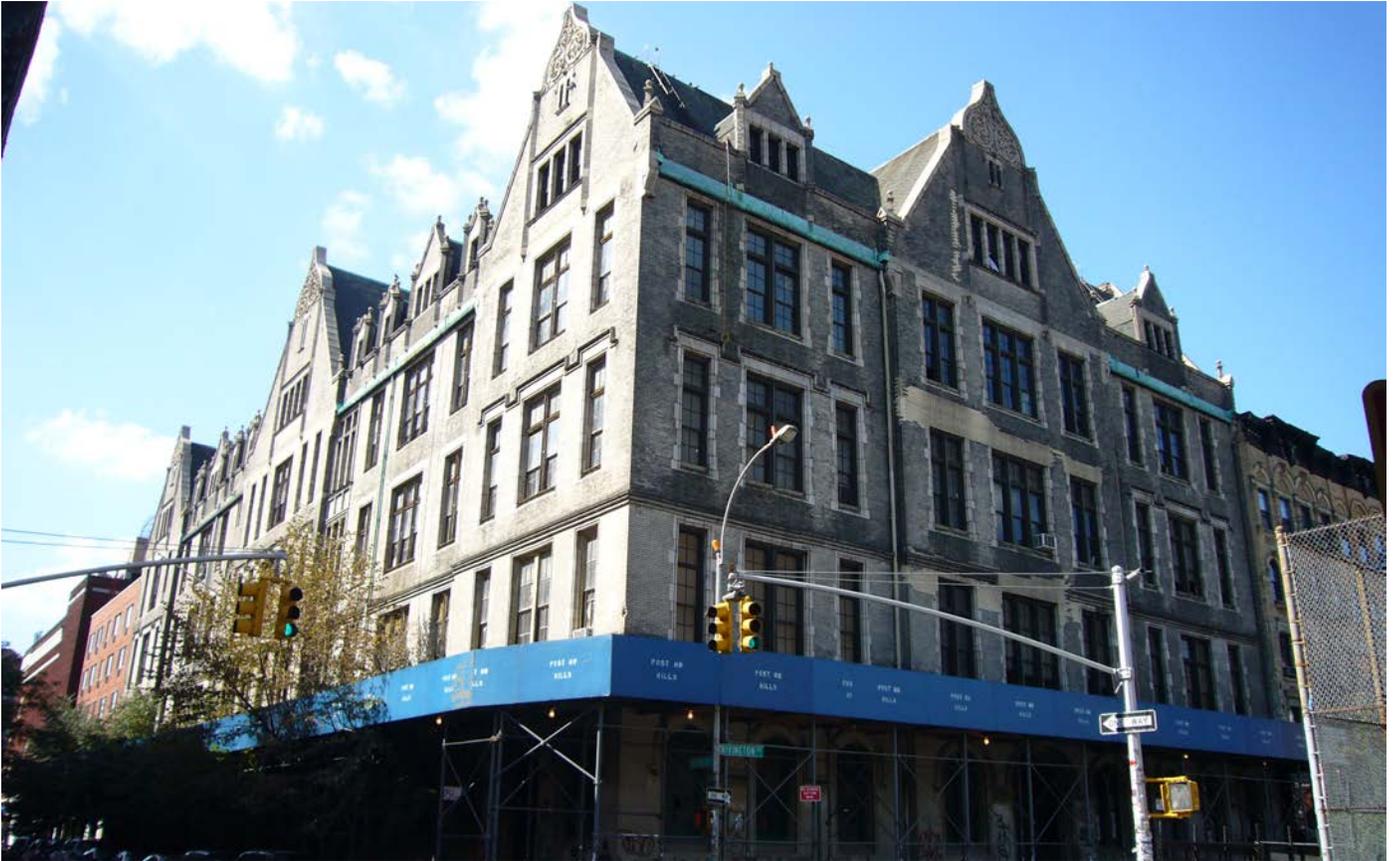
*107 Suffolk Street prior to restoration*

After over a century of service without substantial rehabilitation, the building was in very poor condition when SUPERSTRUCTURES began an investigation of the exterior in 2006. By that point there had been a sidewalk shed in place for eight years due to the deteriorated condition of the façade. Interviews done as part of a master planning study conducted by CSV during this period confirmed a deep respect and admiration for the architecture of the building's exterior. However, there was a vital interest in improving the safety of the building and in providing a more welcoming entrance.

The complete exterior restoration completed in 2012 included roof replacement and repair, replacement of bulkheads and copper gutters, replacement and/or repair of brick masonry, restoration or replacement of terra cotta, replacement and/or restoration of windows, cleaning of limestone and terrazzo. The Department of NYC Cultural Affairs and NYC Department of Citywide Administrative Services funded the project, which was managed by the NYC Department of Design and Construction. Text accompanying the photos on subsequent pages details some of the highlights of the renovation project.

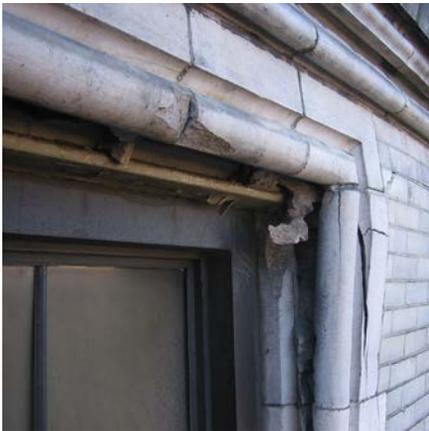
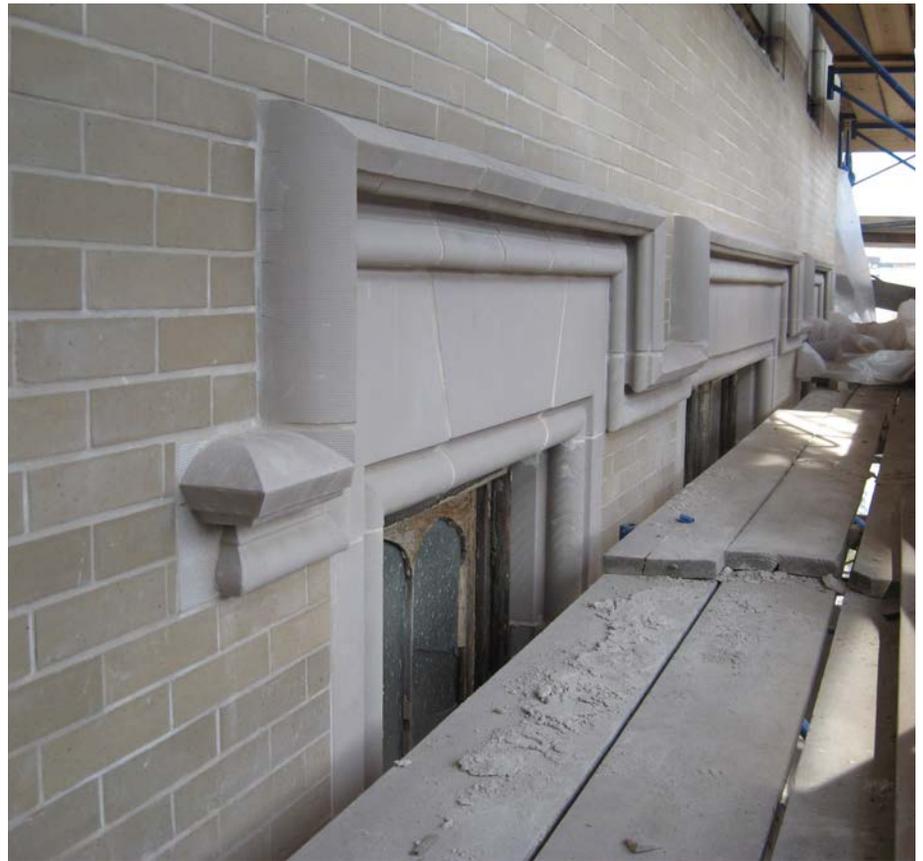
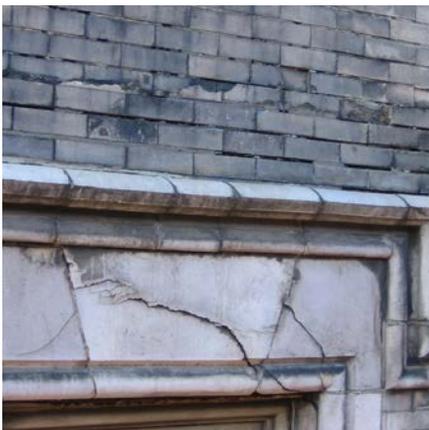
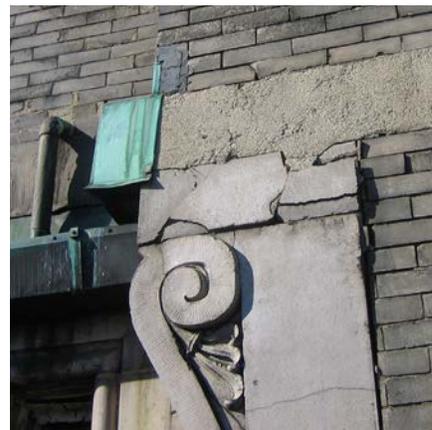
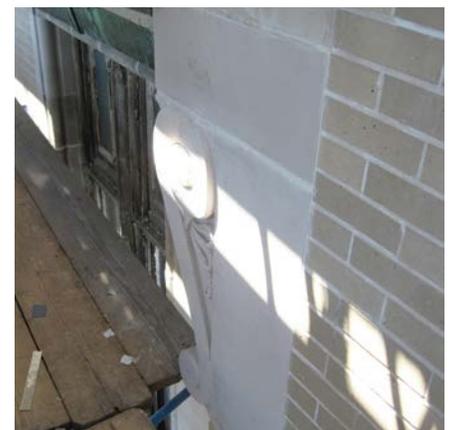
The terra cotta at the window heads and spandrels was severely deteriorated with cracks and spalls observed due to water penetration and expansion of corroding steel and could not be saved. On occasion terra cotta was found to be bulging from the wall. Replacement terra cotta was provided to match the original.

*Top, left; bottom, left: Terra cotta before.  
Bottom, center: Spalling and displaced terra  
cotta bracket. Bottom, left: Terra cotta  
bracket after. Top, right: Terra cotta after.*

Original terra cotta gables, window surrounds, and copings that were in fair condition were carefully cleaned and repaired. Mortar joints were repointed throughout.

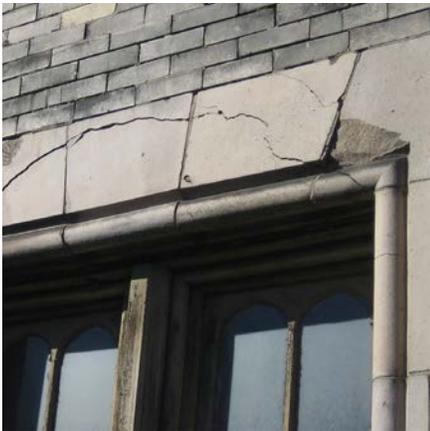
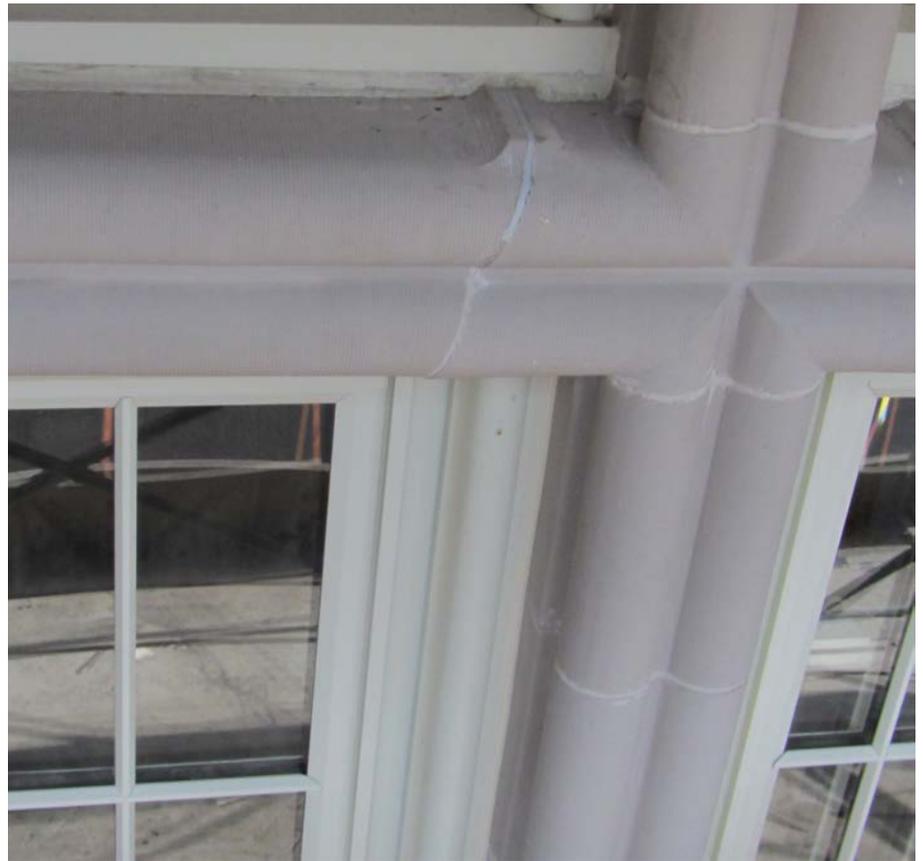
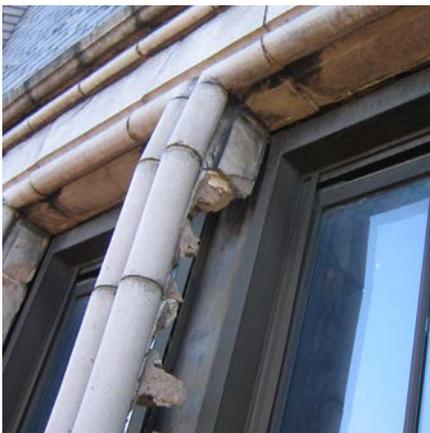
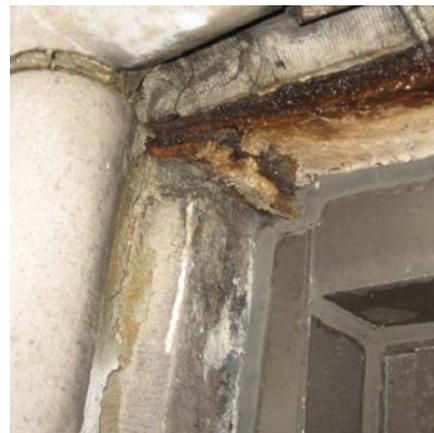
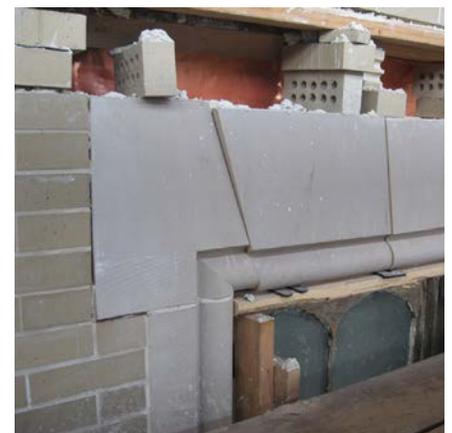
*Top, left; bottom, left; bottom, center: Deteriorated terra cotta. Bottom, left: New terra cotta installed. Top, right: New terra cotta after.*

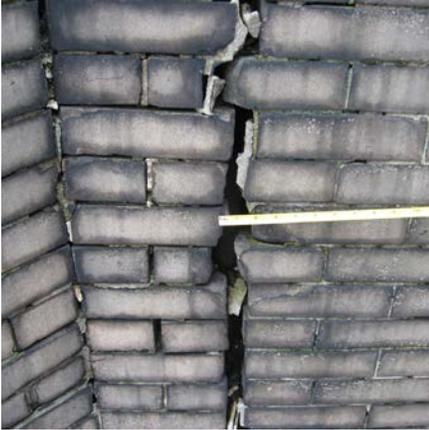
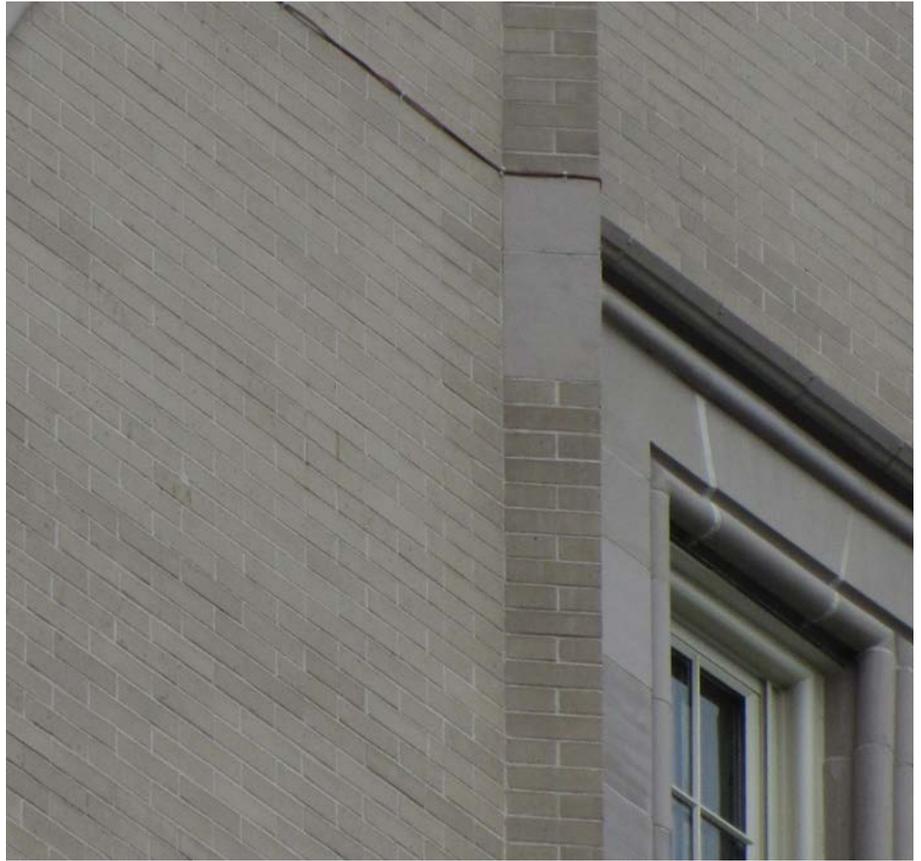
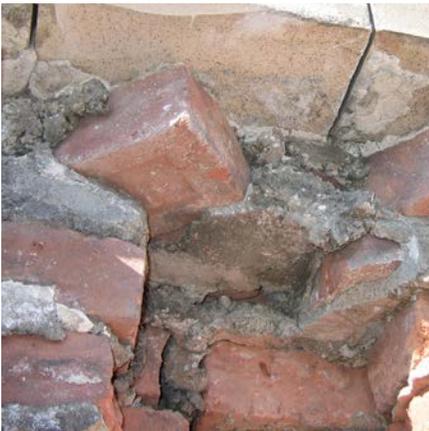
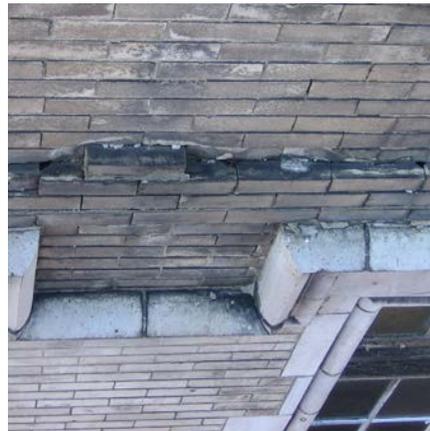
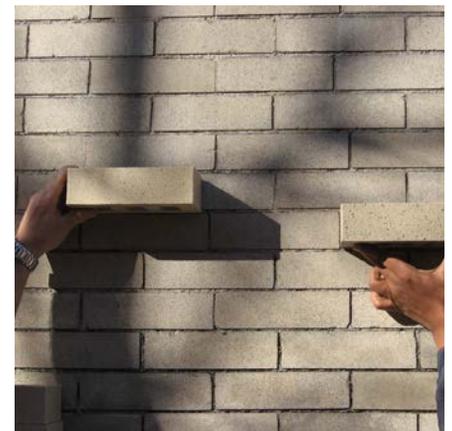
The outer wythe of brick was laid on a running course, i.e. there was no brick perpendicular to tie the courses together and back-up masonry was placed at an angle to tie the courses together. With the deterioration of the steel frame, particularly at the spandrels, exterior brick was pushed away from the plane of the wall. To stabilize the masonry, the angled bricks were replaced with stainless steel veneer anchors at every five courses.

*Top, left: Brick deterioration before restoration. Top, right: Brick after restoration. Bottom, left: angled brick used before to tie courses together. Bottom center: Brick displacement at spandrel level. Bottom right: matching new brick to original.*

Brick masonry was replaced on all five floors of the street facades. The replacement of iron-spot brick involved an extensive match process – approximately 20 samples were reviewed.

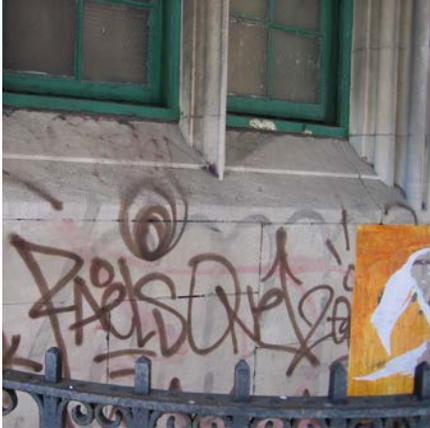
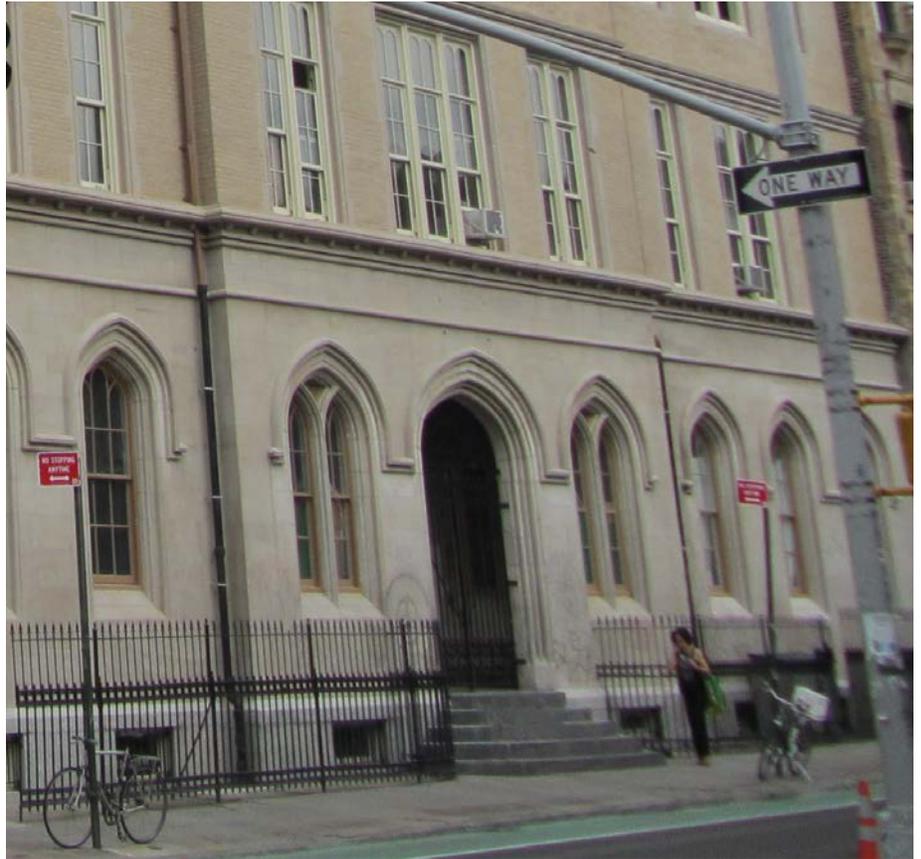
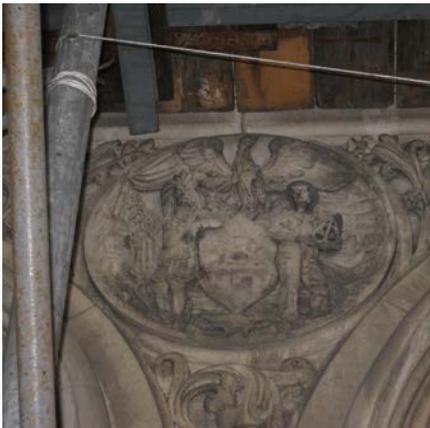
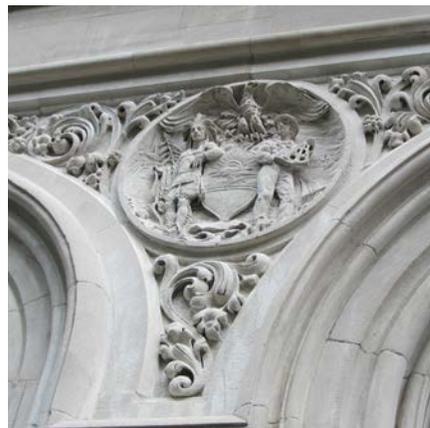
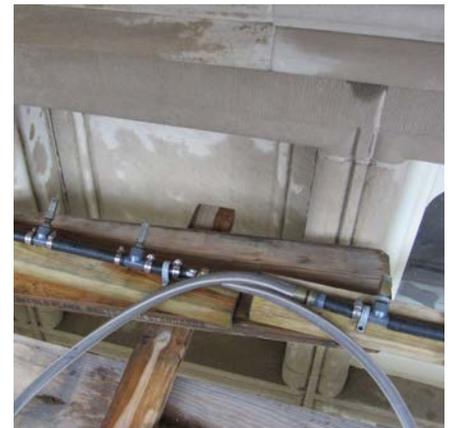
The sidewalk shed having been in place for many years encouraged vandalism of the limestone, bluestone steps, and windows. Limestone at the base of the building and extending up to the second floor at the center bay was cleaned, which due to the level of grime, graffiti, and biological growth was an arduous process requiring several different cleaning methods. Once cleaned, the limestone and granite base of the building was in fair condition.

Top, left: Graffiti covered limestone. Top, right: Limestone cleaned. Bottom, left: Ornamental limestone before. Bottom, center: Ornamental limestone after. Bottom, right: Limestone cleaning in progress.

Some areas required restoration or replacement of limestone in kind. One bluestone tread of the entrance steps was replaced. The limestone and granite base, as well as the bluestone entrance steps were repointed.

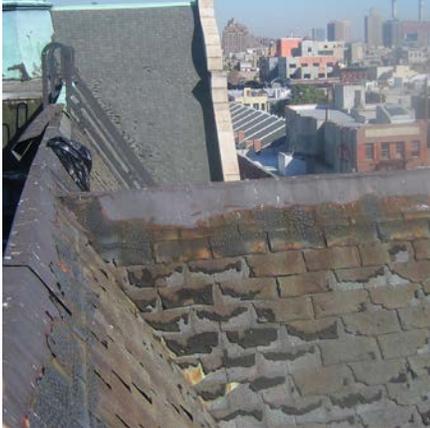
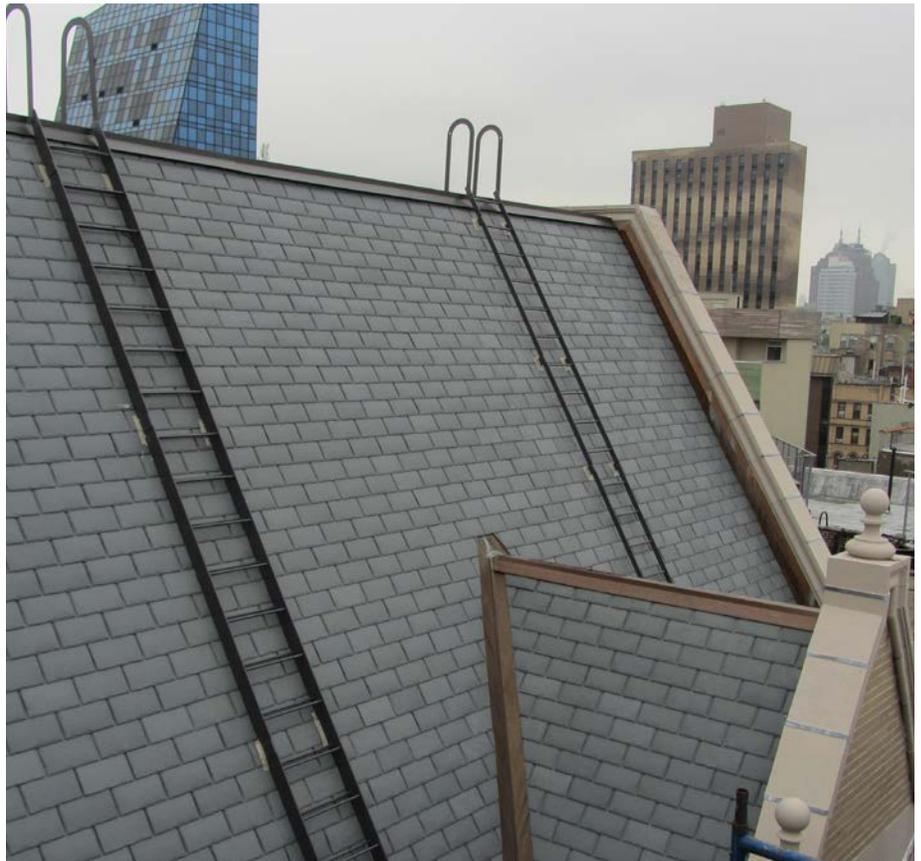
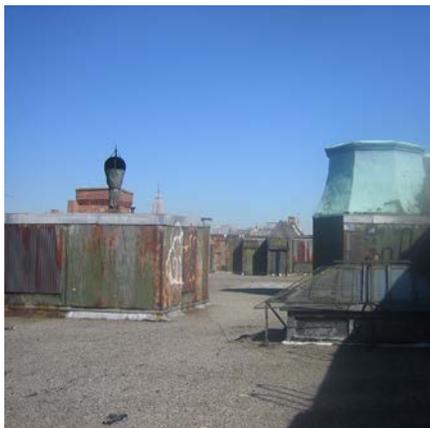
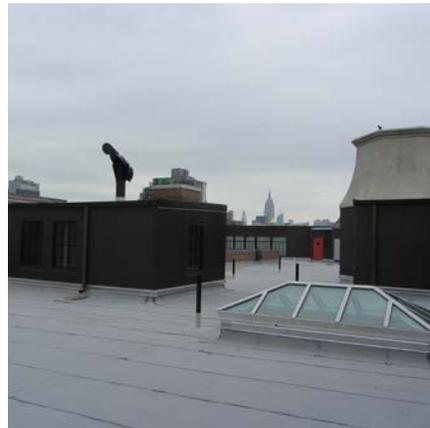
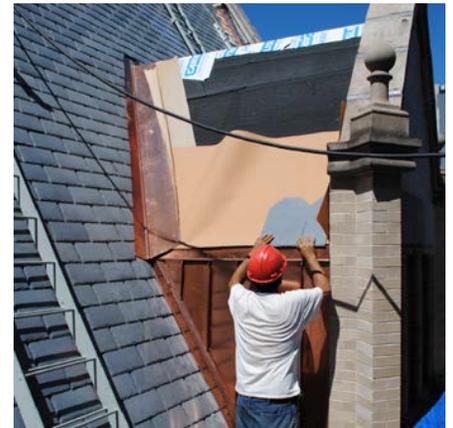
The existing pitched roofs were in very poor condition. The existing asphalt shingles were disintegrating, clogging the drains of the built-in copper gutters below. In many locations water was able to penetrate the interior causing damage to interior finishes and artist's studios.

*Top, left: Slate roof before. Top, right: Slate roof after. Bottom, left: Flat roof before. Bottom, center: Flat roof after. Bottom right: Roofing installation in progress.*

The asphalt shingles were replaced with imitation slate tiles made from recycled rubber and plastic. Copper flashings, ridge caps, and built-in gutters were replaced with new copper including the standing seam cladding at the dormer walls. The flat roof behind the sloped roofs was also replaced as were the bulkhead roofs and cladding and a skylight.

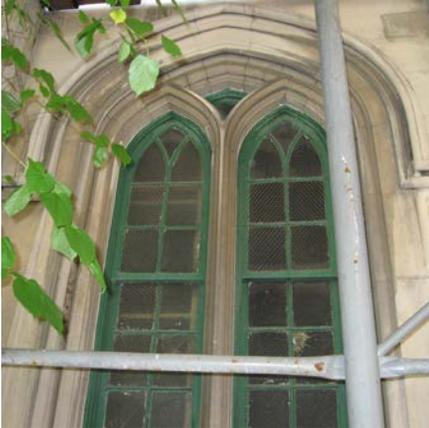
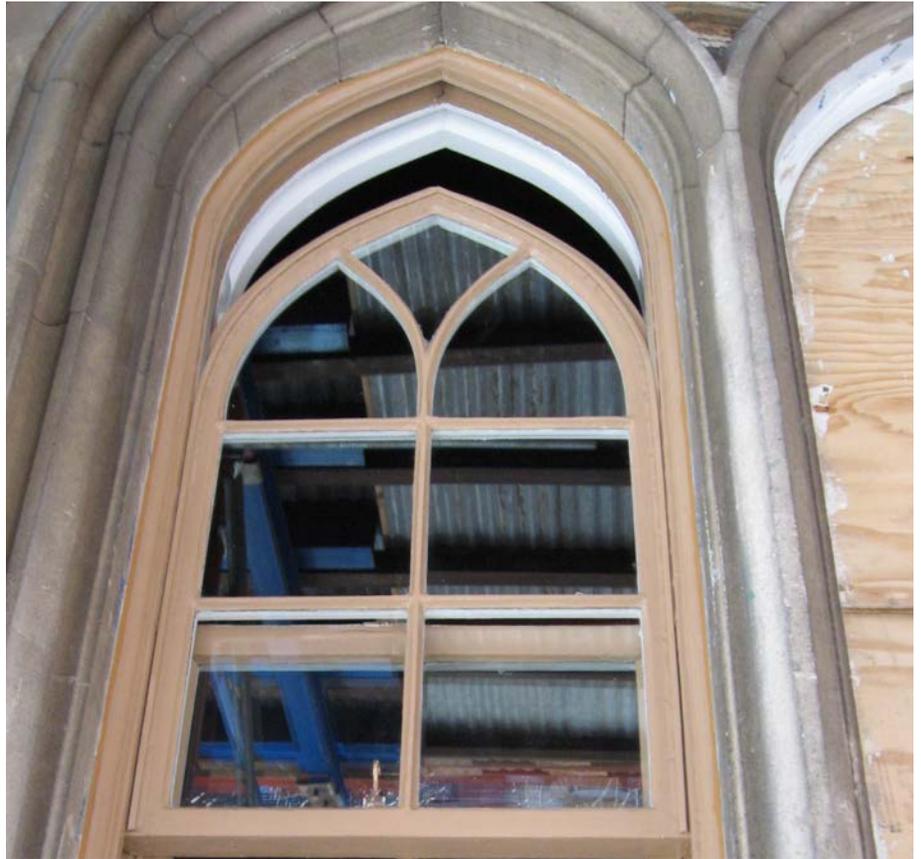
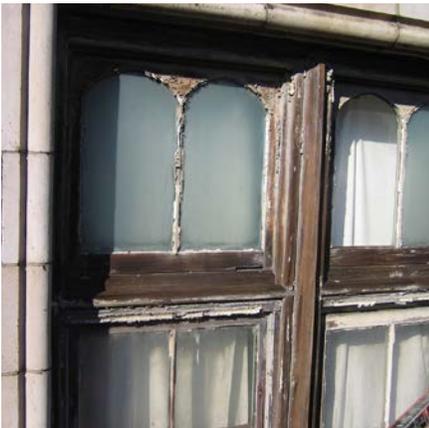
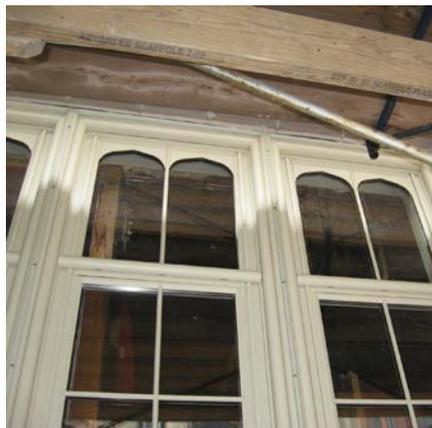
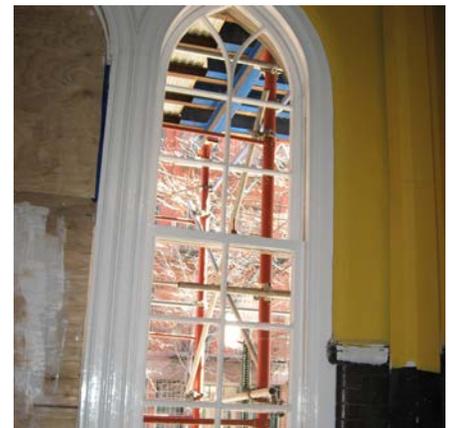
The first-floor wood windows were restored and fitted with new hardware to match the originals. Many of the windows had been vandalized and had to be fitted with new glazing. The windows were painted with color determined to be original based on paint analysis. The wood windows on the upper floors were found to be in advanced state of deterioration and were replaced with aluminum windows. The original wood windows had very detailed profiles which were replicated as closely as possible in aluminum. This was achieved by using custom extrusions of profile and width that closely replicate the original detailing, including the pointed arches of the fixed transoms above the double-hung windows.

*Top, left: Wood windows before . Top, right: Wood window after. Bottom, left: Window before. Bottom, center: Window after. Bottom, right: New wood window from interior.*

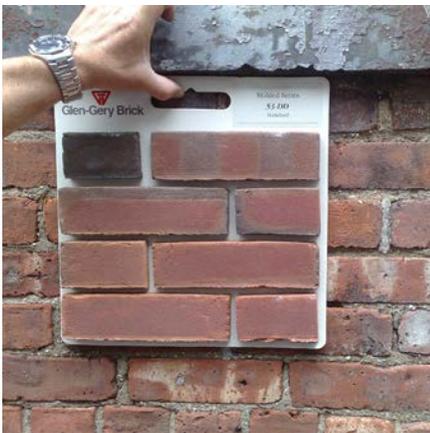
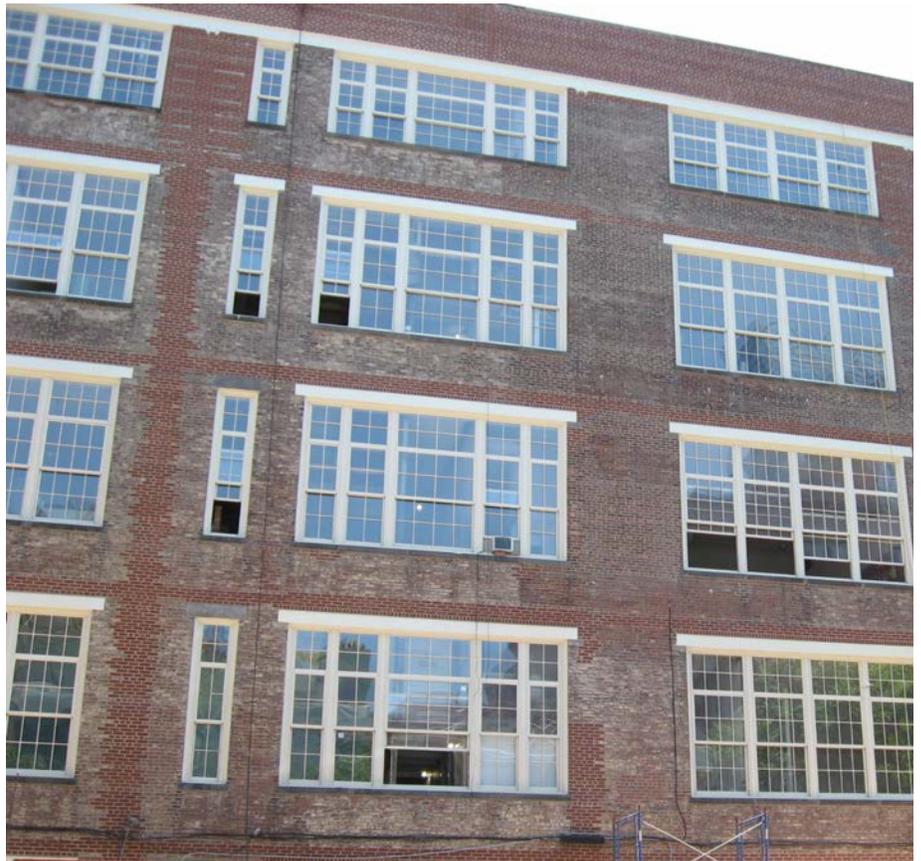
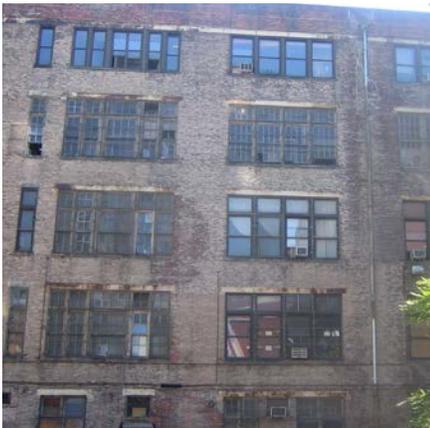
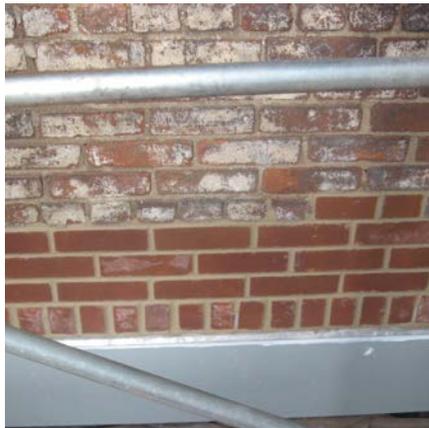
Top, left: Brick matching. Top, right: Rear facade after. Bottom, left: Rear facade before. Bottom, right: Brick replacement.

At the back of the building the brick masonry was restored including replacement of deteriorated brick, lintel repair and flashing, rebuilding of the parapets, and repointing. The windows were replaced with aluminum to replicate the original configuration of the wood windows.
