The New York Landmarks Conservancy
Lucy G. Moses Preservation Awards
Submittal

Jefferson Market Library
425 Avenue of the Americas
New York New York

Exterior Renovation

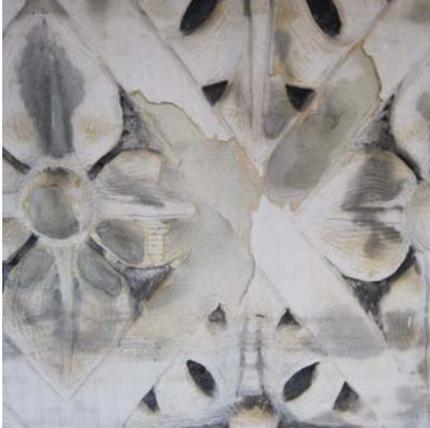
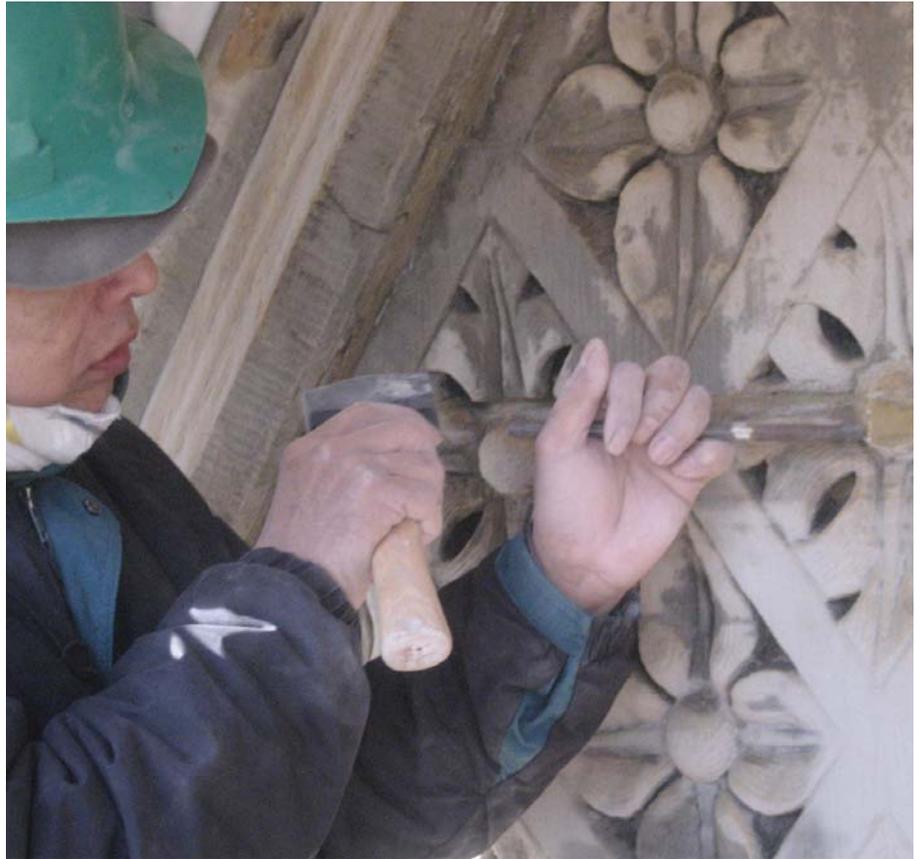
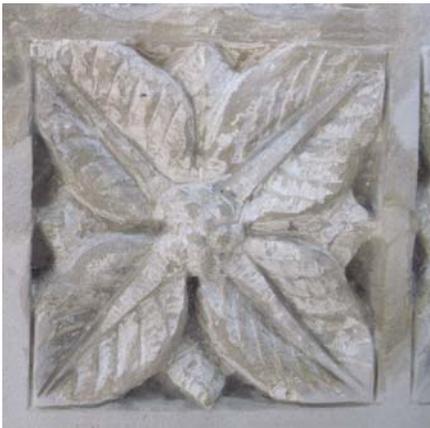
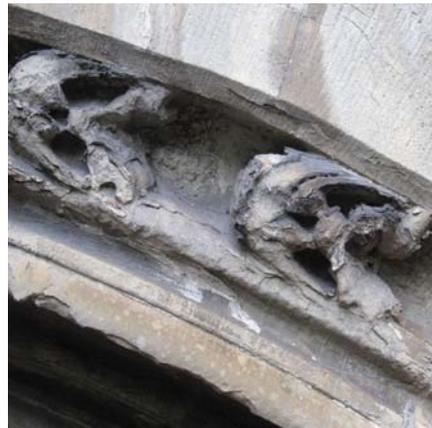
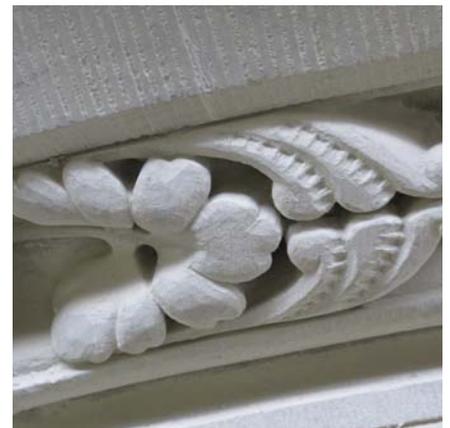
One of the glories of the Library's façade is the extensive Ohio sandstone ornamentation. The sandstone was found to be crumbling in many places due to age, weathering, and pollution. Though the condition of the stone varied widely, with some in perfect condition after 140 years, even some of the sandstone that did not appear deteriorated crumbled away when tapped. The goal was to keep the original material wherever possible, so extensive re-carving was done in place by skilled artisans to match the original as much as possible and preserve the sense of definition. Where stone replacement was deemed necessary, for instance the City seal, replacement pieces were carved out of the same Ohio sandstone used originally.

Top left: Deteriorated stone before restoration. Bottom left: Stone ornament after re-carving. Top right: Re-carving stone in place. Bottom center: Deteriorated stone before. Bottom right: Newly carved stone ornament replaces highly eroded original carving.

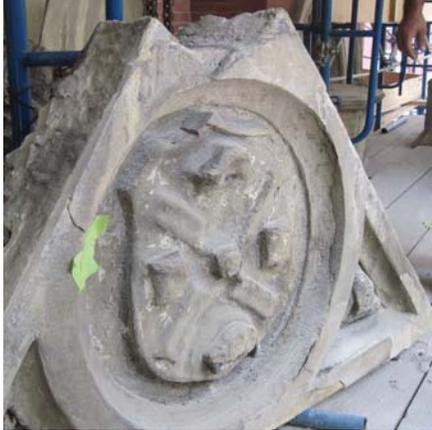
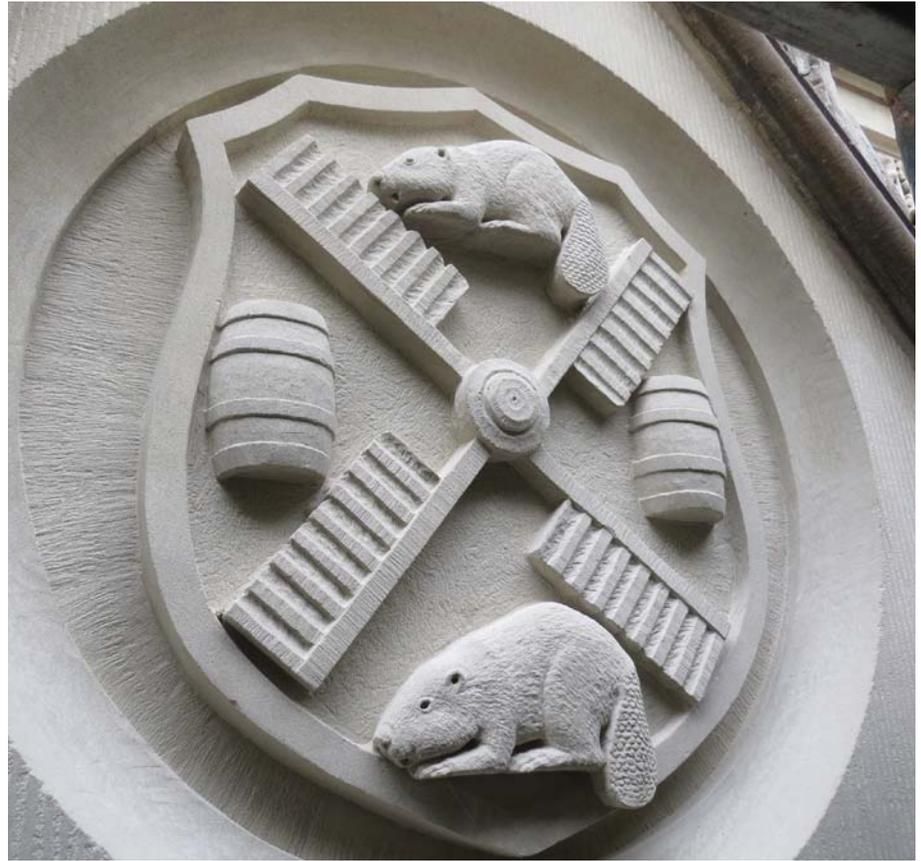
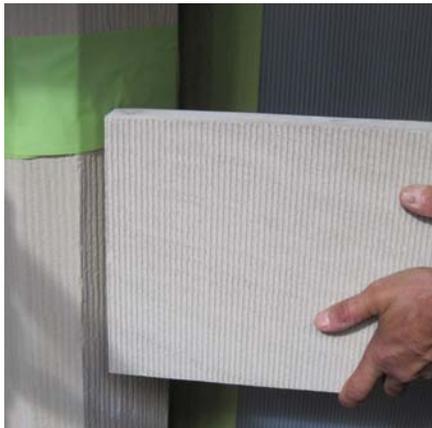
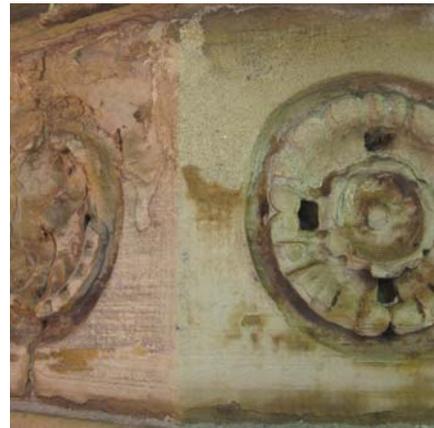
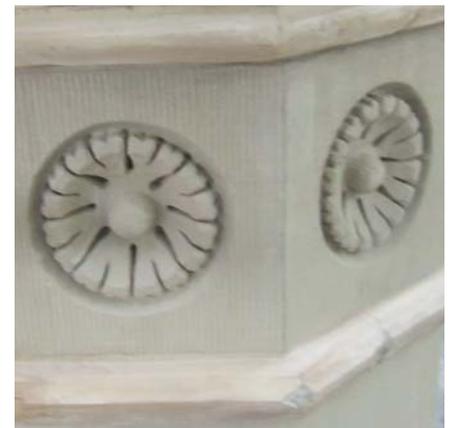
Retooling and honing addressed the prevalent flaking of ashlar stone. Dutchmen were used where spalling was more substantial. Dozens of cleaning techniques were tested for removing the existing staining on the building's stonework. On analysis the staining was determined to be a combination of ferrous oxide leaching (rusting) from the interior of the stone, staining from pollutants and possibly previous conservation treatments. Much of the staining was removed but it was not possible to remove all of it.

Top left: Worn sandstone gable ornament before. Top right: Replacement sandstone gable ornament. Bottom left: Matching tooled sandstone. Bottom center: Sandstone ornament before. Bottom left: Sandstone ornament after.

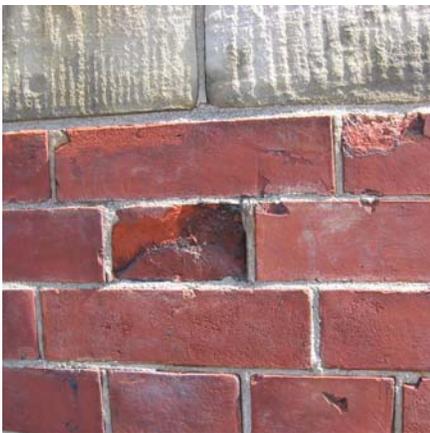
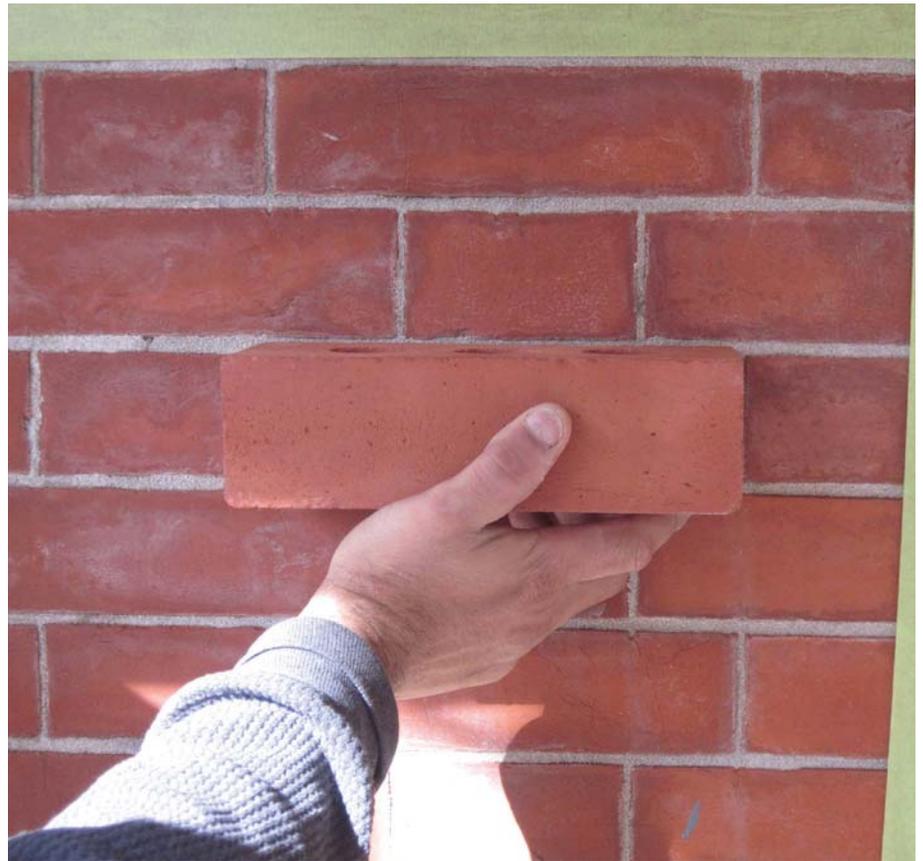
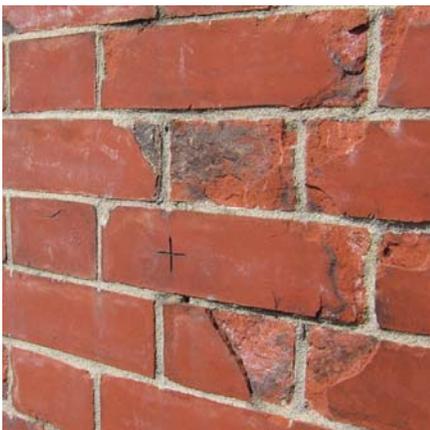
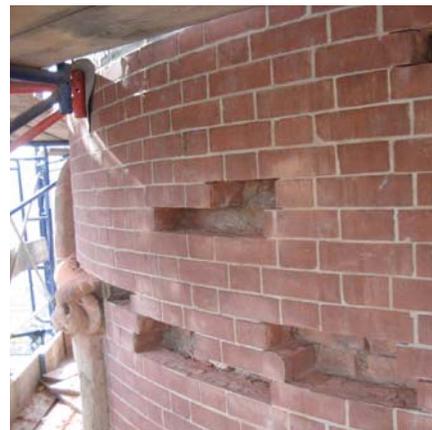
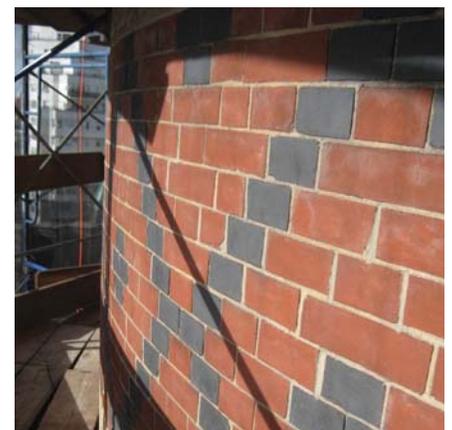
One of the signature design elements on the façade of the Library is the deep-red Philadelphia brick which provides appealing contrast with the light-colored sandstone ornamentation. Brick masonry restoration included spot repointing and cleaning of the brick. Badly deteriorated bricks were replaced in kind.

Top left: Deteriorated brick before. Top right: Matching brick in kind. Bottom left: Brick spalling. Bottom center: Brick on tower during replacement. Bottom right: Brick after.

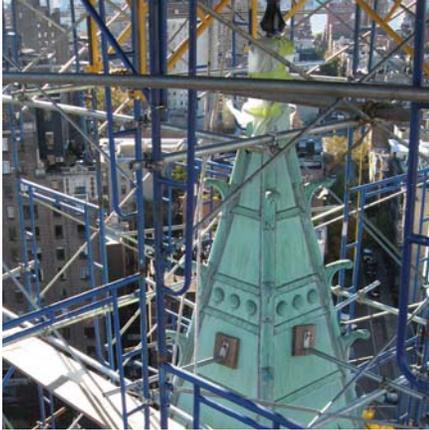
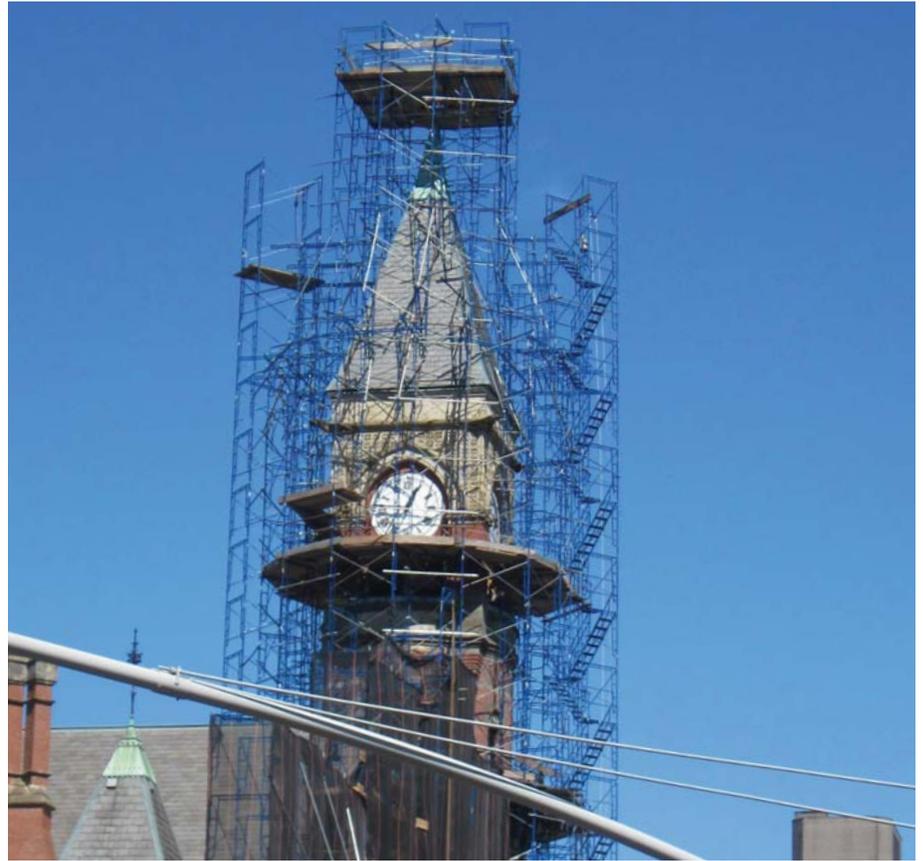
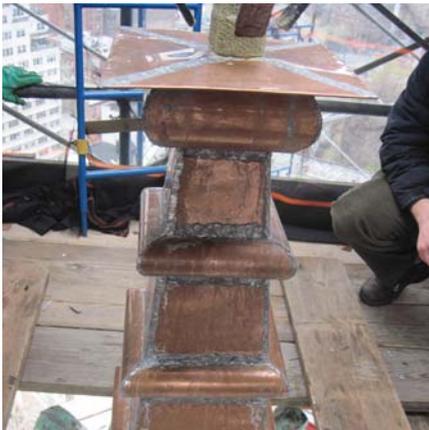
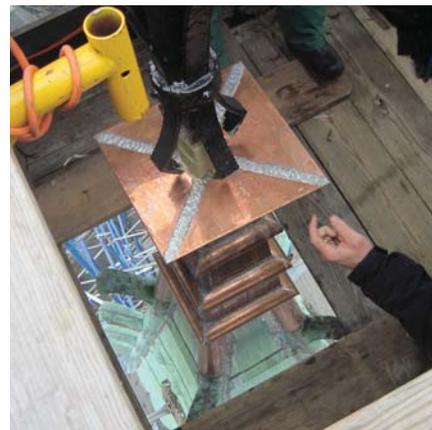
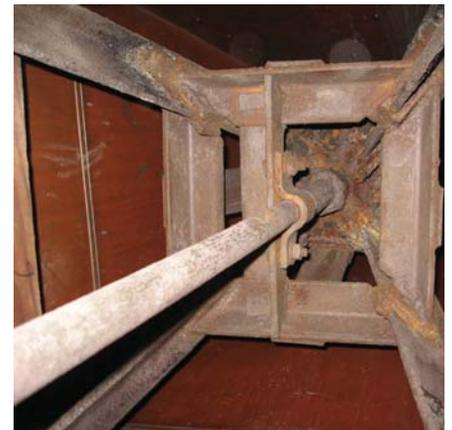
The project addressed several structural issues. Among them was the main tower's finial which, due to structural deterioration, was not properly supported to resist wind loads. In order to secure it, copper cladding at the top of the slate roof had to be opened up so that the finial could be tied back to the tower substructure. Accessing the work was its own design challenge: an elaborate pipe scaffolding was erected around the top of the tower, supported by the tower itself.

Top left: Tower cap during restoration. Top right: Scaffolding allowing work to be done on tower cap and finial. Bottom left and center: Newly fabricated copper finial on tower cap during restoration. Bottom left: Interior of tower cap.

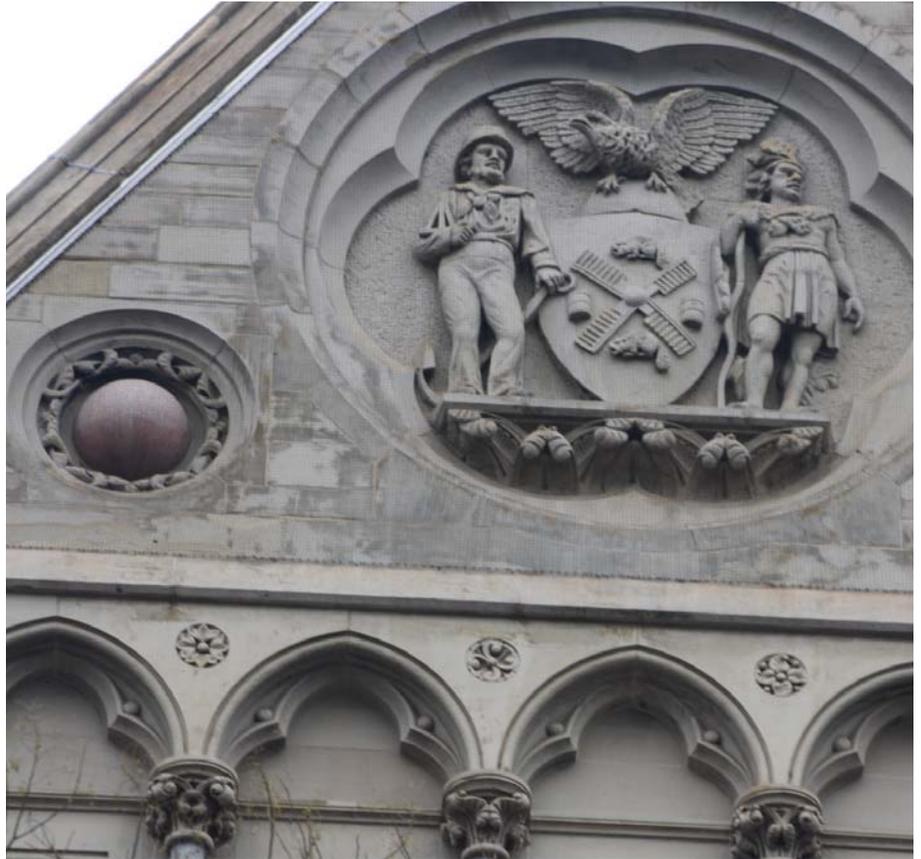
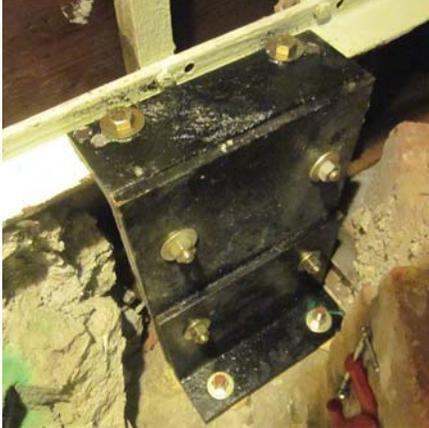
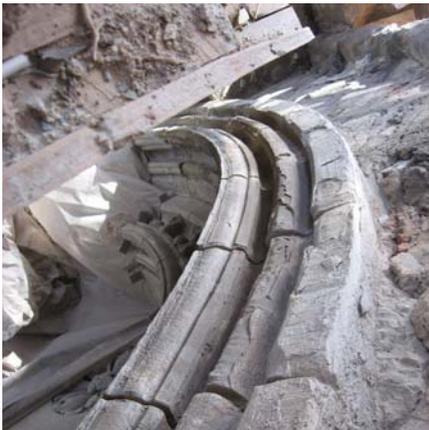
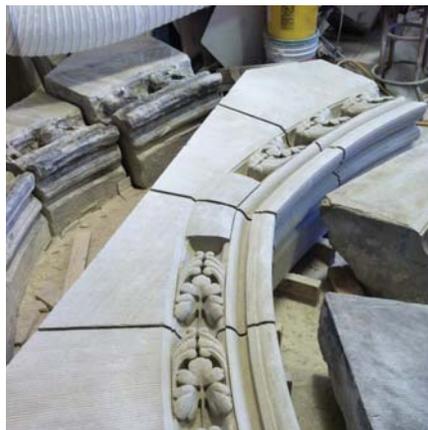
The main gable at the east elevation had displaced over time. Stone anchors and tension rods were installed to ensure the gable's and roof diaphragm's structural stability. The entryway gable had also displaced over time due to lack of proper ties to the building substructure. The scope included rebuilding the displaced stonework and installing structural ties.

Top left: Main gable being strapped to substructure. Top right: Main gable after stabilization. Bottom left and bottom center: Entry gable during reconstruction.

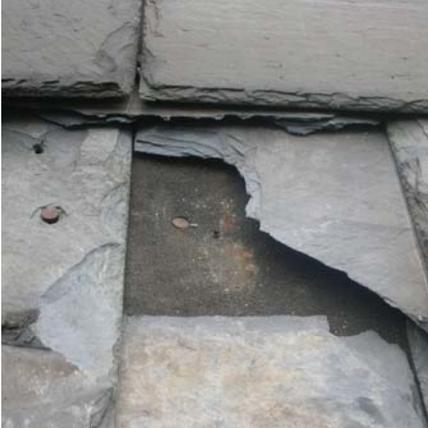
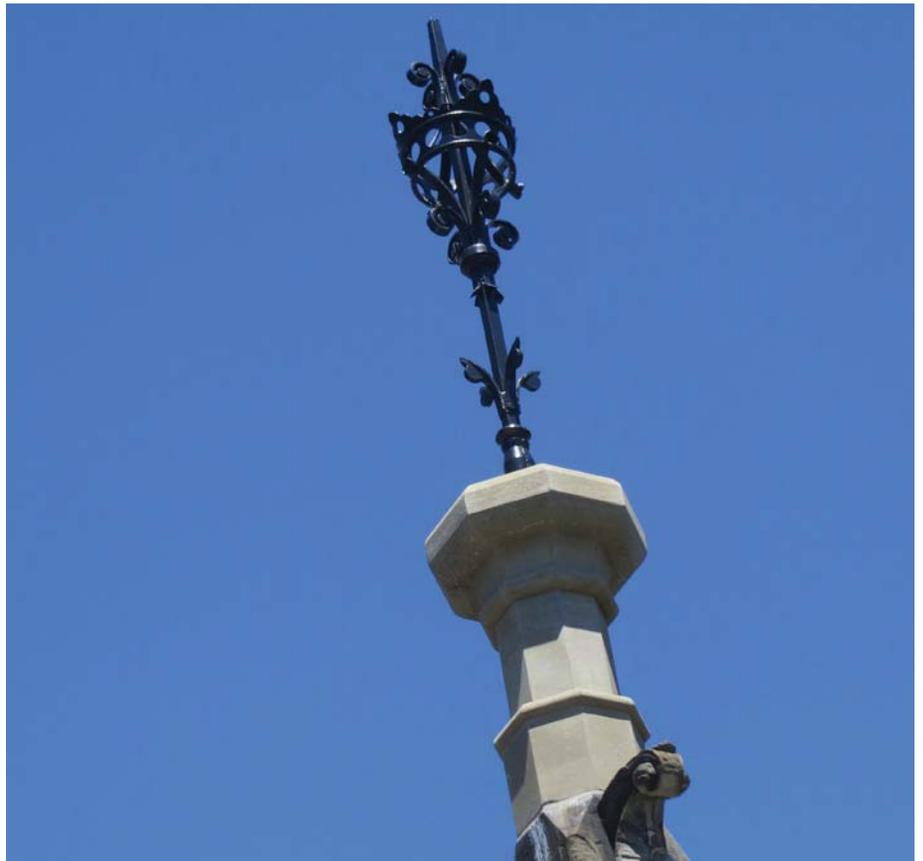
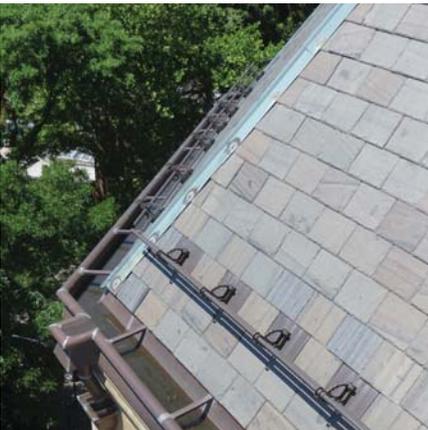
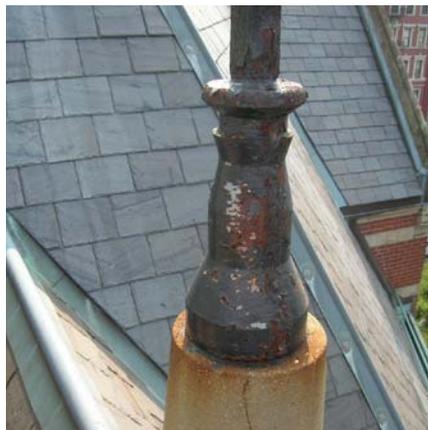
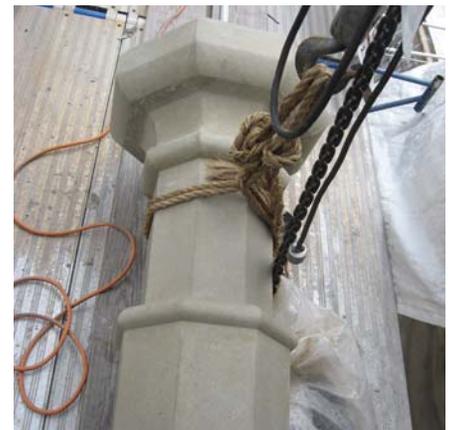
Spot repairs to the slate roof were performed, including replacing missing and broken slates throughout. The existing flat sheet metal roof was replaced with a new flat-seam copper roof.

The finial bases were spalling and breaking up because of the corrosion of the finial ironwork. New stone blocks were installed and the finials were re-set. Finials were restored as necessary off site. The drawing on the following page details additional repairs to sandstone and iron elements of various of the many finials on the building.

Top left: Slate roof before. Bottom left: Slate roof after. Bottom center: Finial before restoration. Bottom right: Restored finial base. Top right: Finial after.

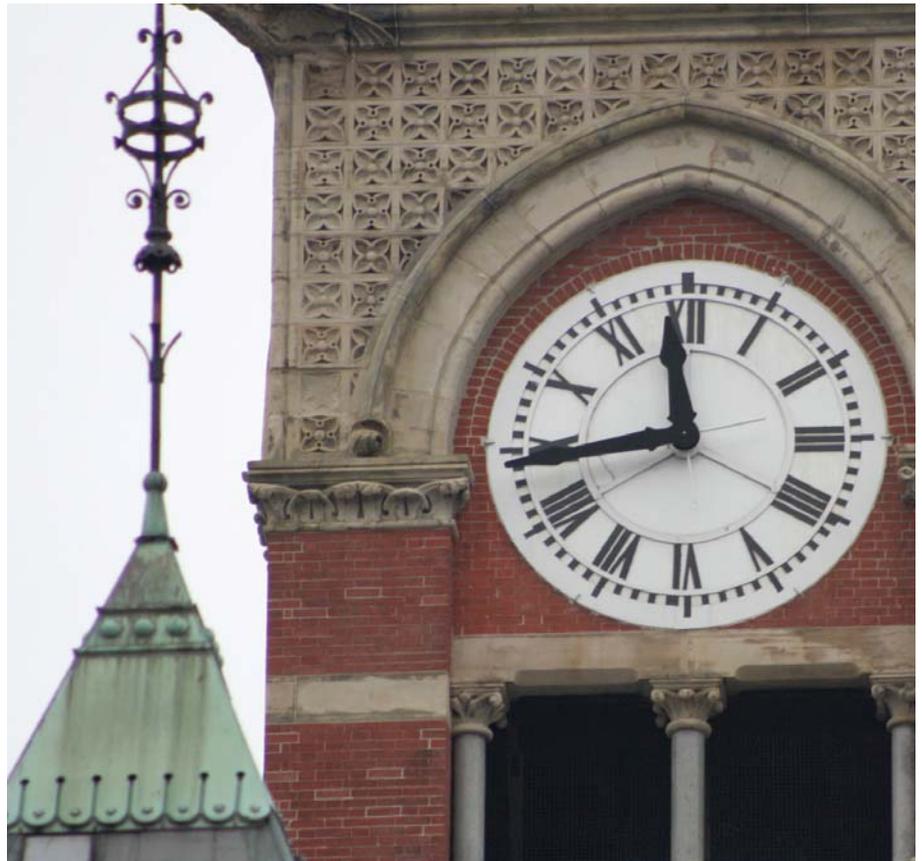
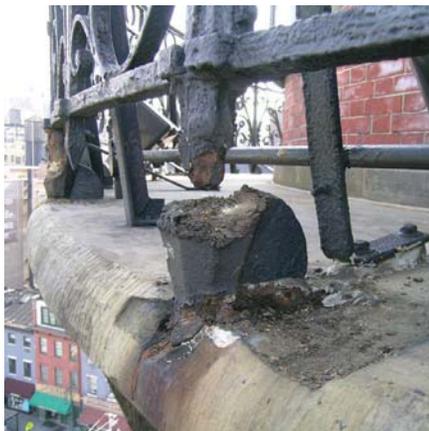
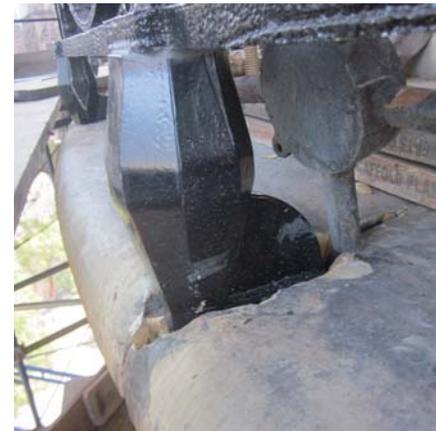
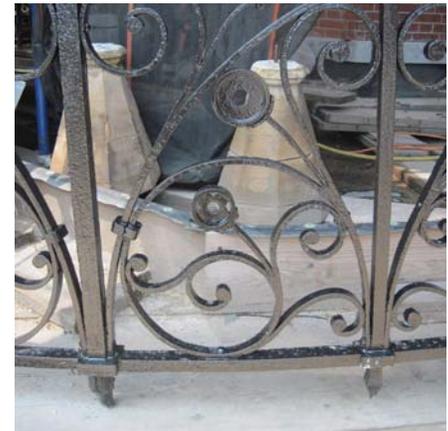
The wrought iron balcony railing on the tower was removed and repaired offsite by an ironworker and then remounted.

Restoration and repair of the clock faces was carried out by a specialist in clock restoration. In the 1960s it was a campaign to get the clock running again which initiated the eventually successful movement to save the building itself.

Top left: Detail of clock face interior before restoration. Top right: Clock face after restoration. Bottom left: Deteriorated wrought iron railing. Bottom center: New supports in restored railing. Bottom right: Railing after.

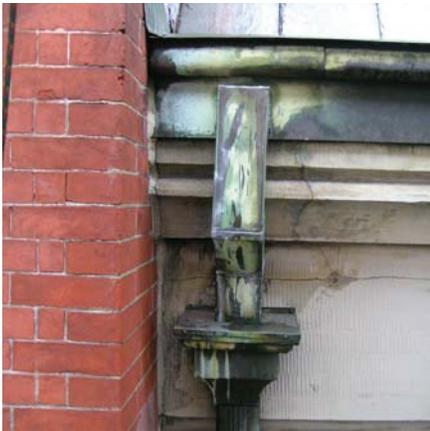
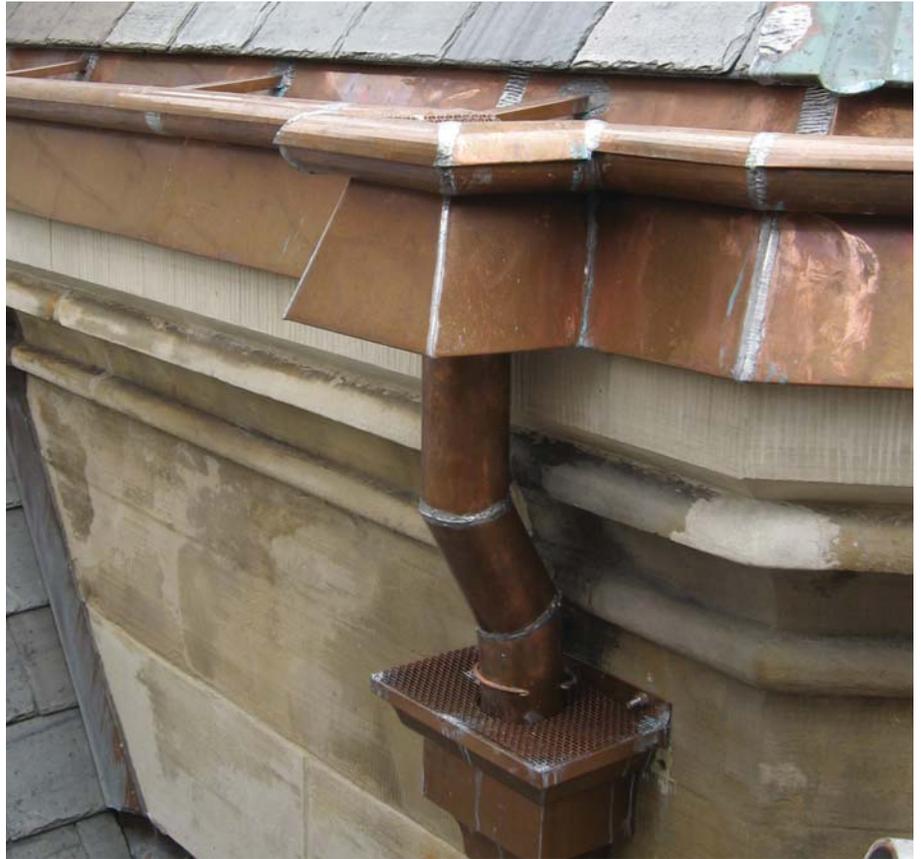
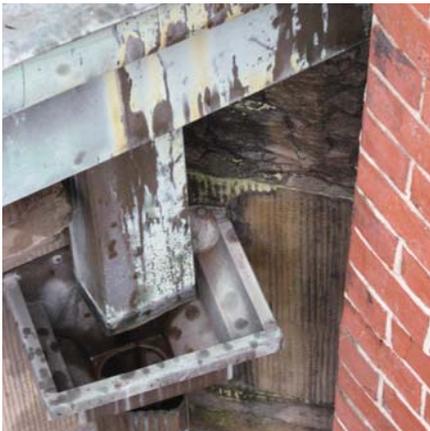
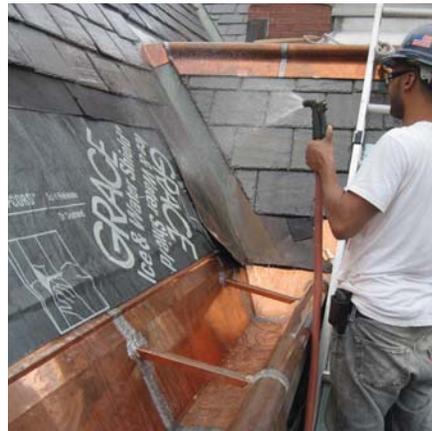
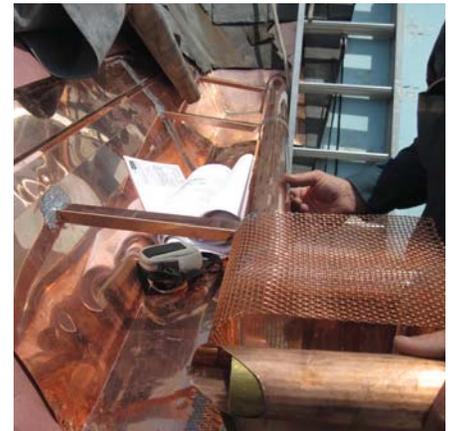
The existing gutters and leaders (downspouts) were highly deteriorated. They were replaced in kind with new copper. In some cases the interior leaders were experiencing ongoing leaking and were deteriorating the building's interior stonework, so leaking leaders were removed to the outside of the building.

Top left and bottom left: Gutters and leaders before. Bottom center and right: New copper gutters during installation. Top right: Gutter and leader after.

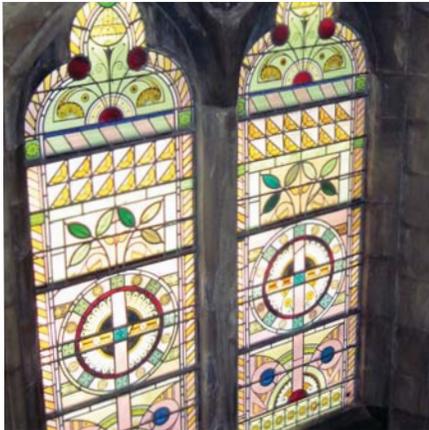
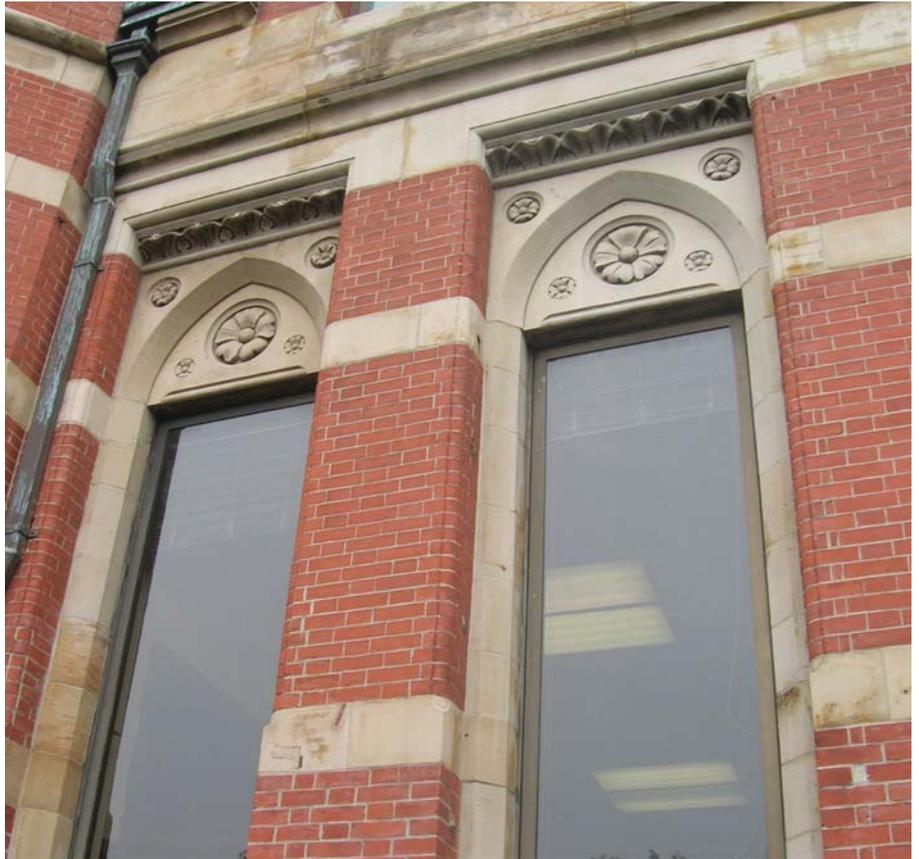
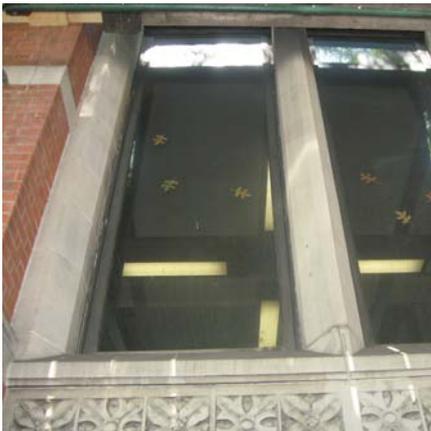
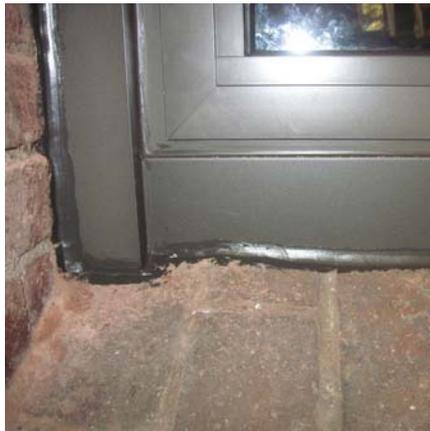
The building's aluminum frame windows represent significant alterations that were made to the building in the 1960s by architect Giorgio Cavaglieri when he converted the building from a derelict courthouse building to a branch of the NYC Public Library. The intent of the current restoration was to preserve the windows rather than replace them. Some maintenance was required on several of these very large, substantial, solidly built windows to restore operability, as they had not been rehabilitated in quite some time. At the basement level aluminum windows were replaced to match the existing. Stained glass windows affected by the stone mullion repairs were removed, restored off site and reinstalled at completion of stone restoration work.

Top left: Stained glass windows after restorations. Top right, bottom left and center: Aluminum windows dating from the 1960s were repaired as necessary.
