The New York Landmarks Conservancy  
Lucy G. Moses Preservation Awards  
Nomination

St. Paul's Chapel  
209 Broadway  
New York, New York

Exterior Restoration

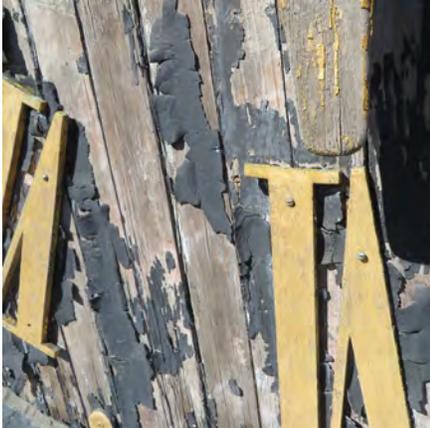
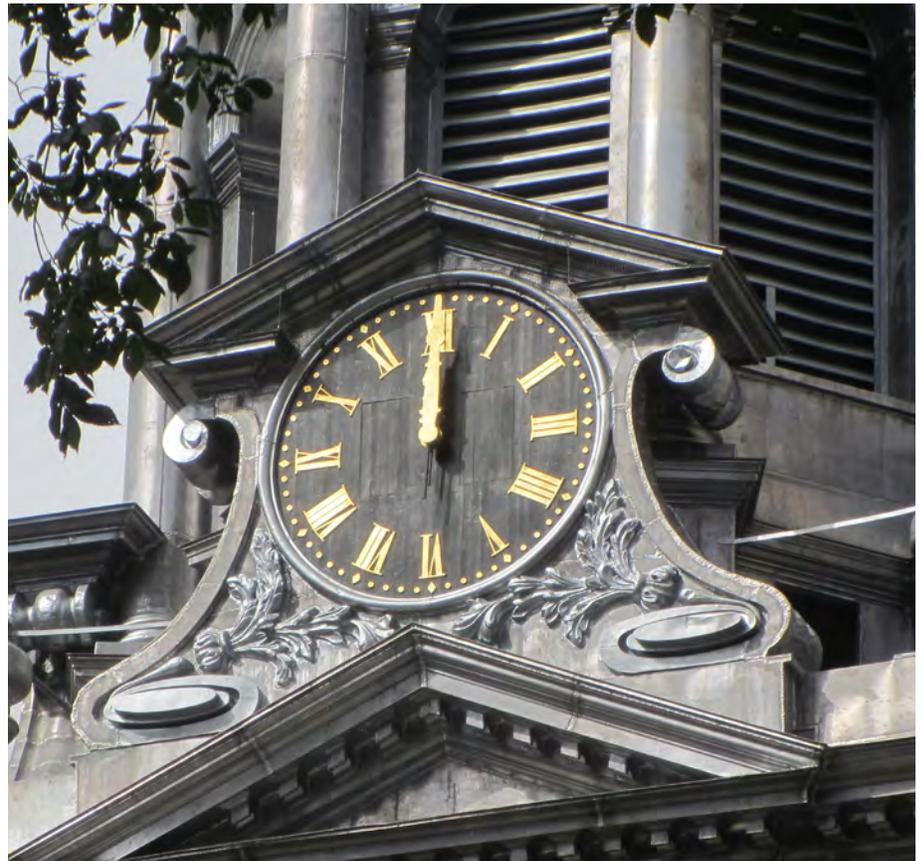
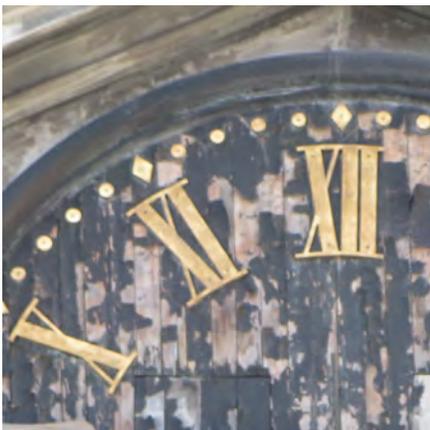
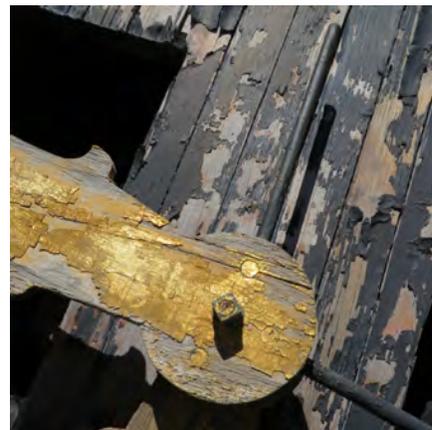
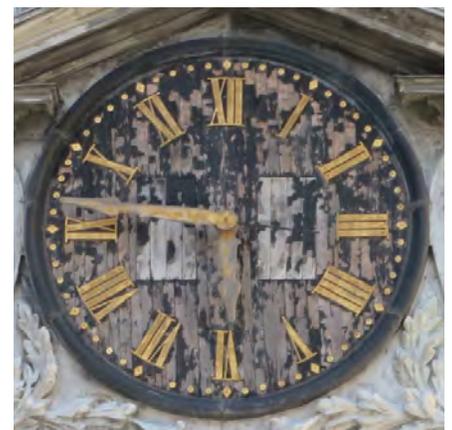
The steeple clock was no longer functional and its four faces exhibited various amounts of deterioration, some severe. Existing tongue and groove boards on three clock faces were repaired using a wood consolidation system. Prior to consolidation, the wood was cleaned and primed. All the wooden tongue and groove slats on the eastern clock face were replaced with cedar slats. SUPERSTRUCTURES' conservator conducted research and analysis to determine the appropriate wood species and grain. All access doors on all elevations were replaced with cedar. The clock hands at all clock faces were replaced with cedar clock hands (4 short and 4 long hands), then gilded. The other brass elements (numbers and minute track

*Top left and bottom row: Clock faces before restoration: Top right: Clock face after restoration.*

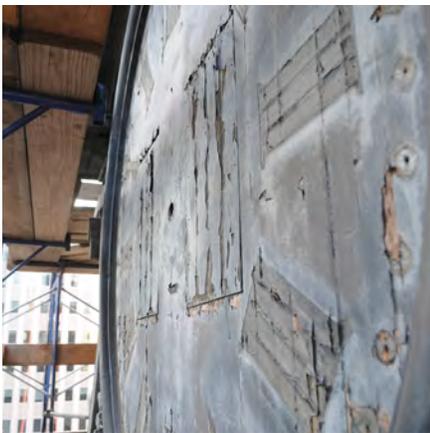
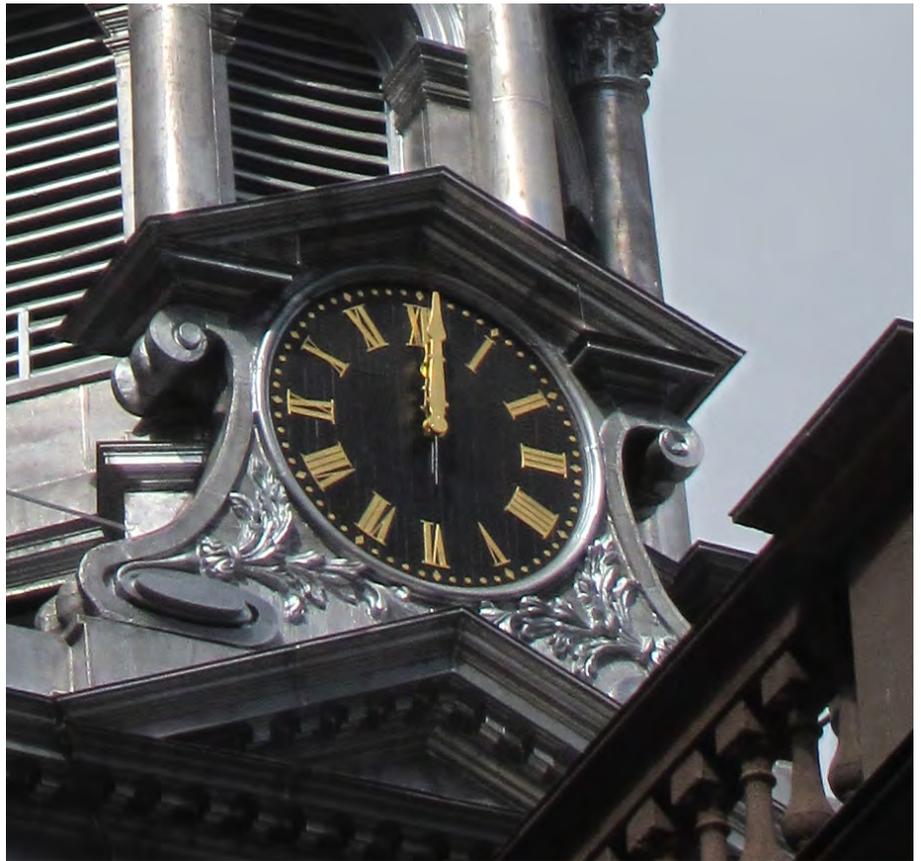
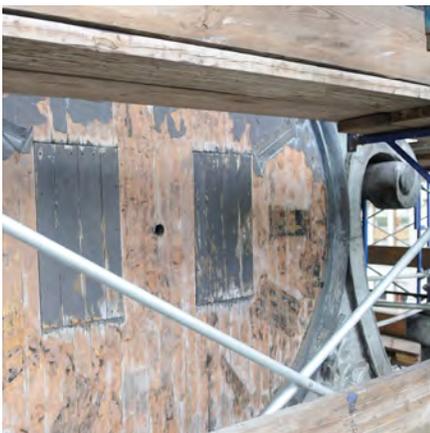
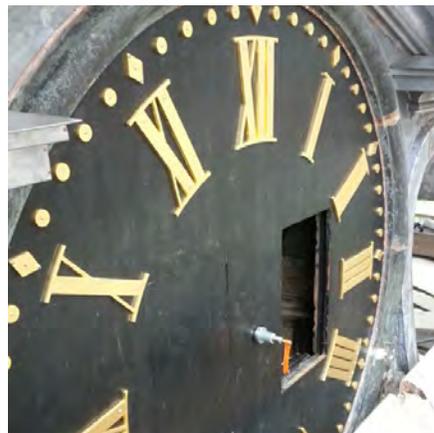
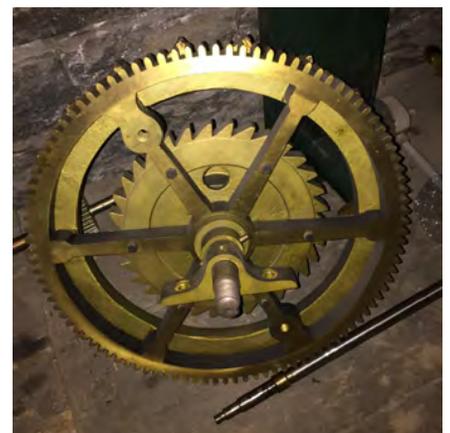
The mechanics of the clock were replaced. A new digital system was installed by Elderhorst Bells, Inc. The bells were maintained and some of the original mechanical elements were turned over to the Owner for preservation as artifacts.

*Top and bottom left, bottom center: Clock faces during restoration. Top right: Restored clock face. Bottom right: Parts of former clock mechanism retained for parish archives.*

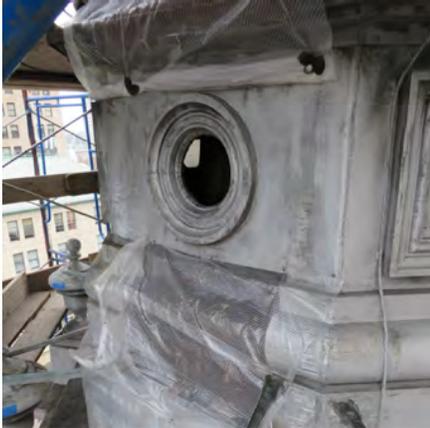
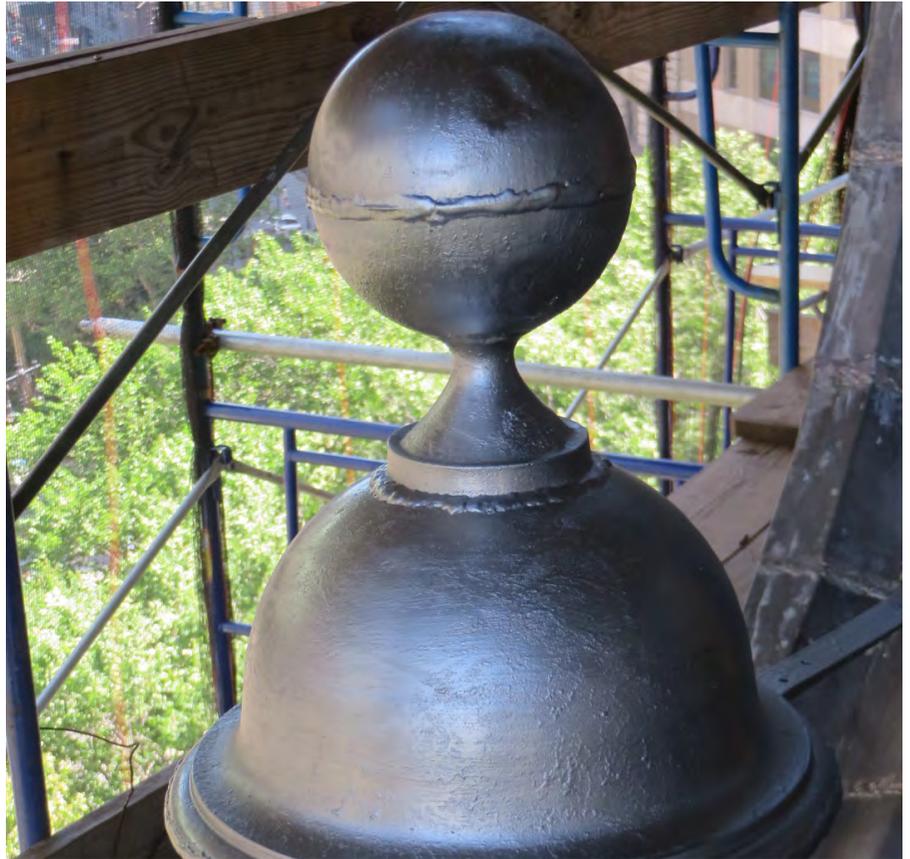
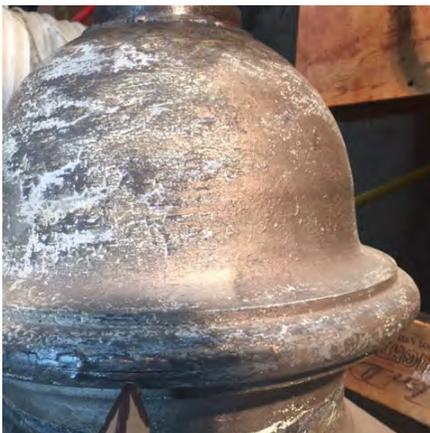
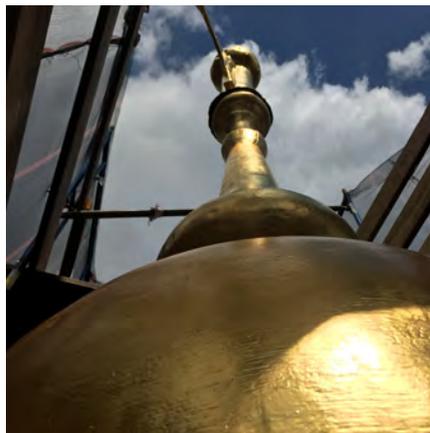
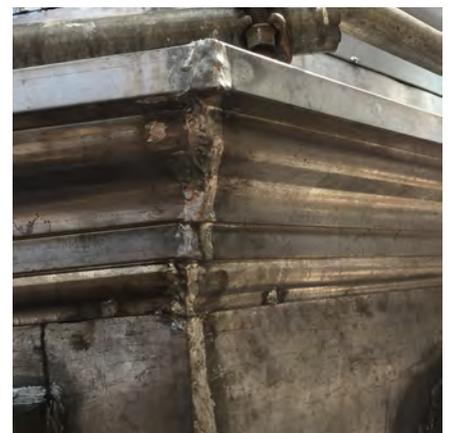
The cladding of the steeple is lead coated copper. The original intent was to replace all the cladding but on investigation it was determined that much of it was in good condition and many decorative elements were deemed worthy of preservation. The upper portion of the steeple cladding was retained and restored by tightening seams and resoldering open joints as appropriate. The lower portion of the roof was replaced and coated to match the original lead-coated copper appearance. Minor damage on the weathervane was repaired and the entire assembly was gilded.

*All photos on this page: Steeple cladding decorative elements and gilded weathervane during restoration. Following page: Steeple after restoration.*

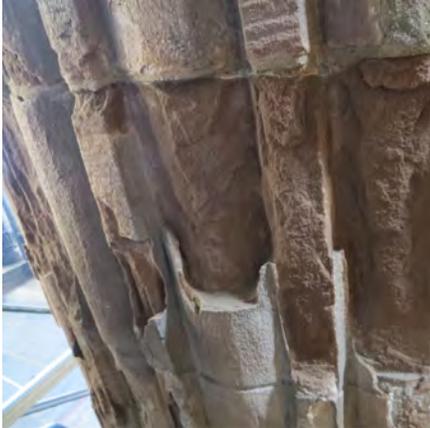
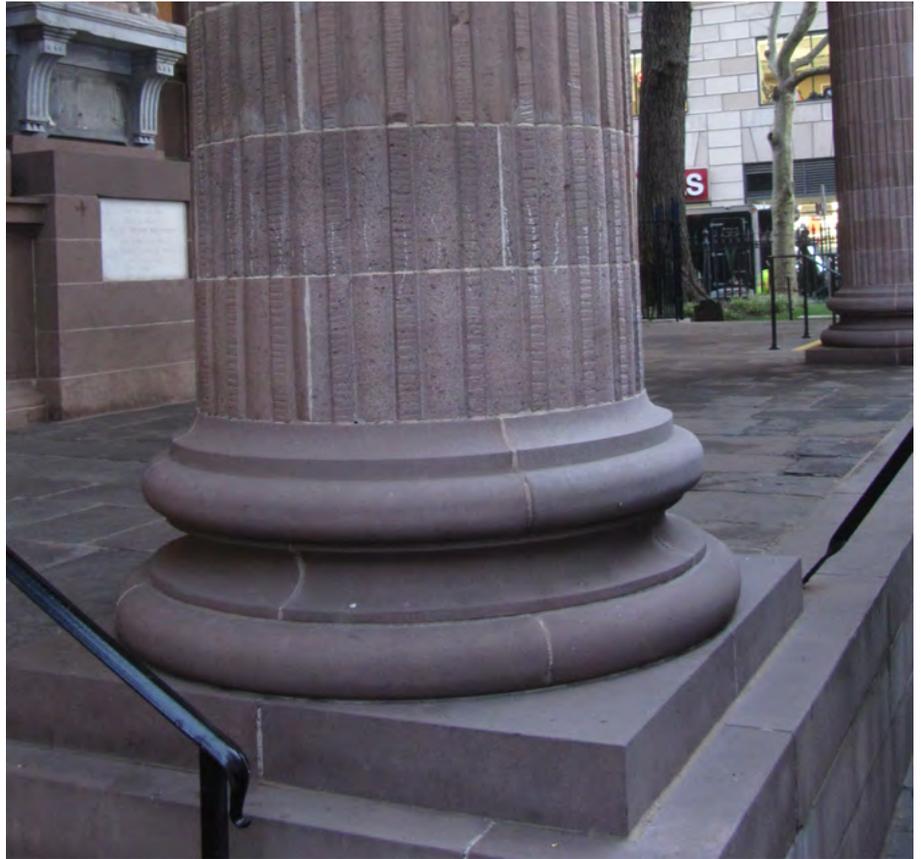
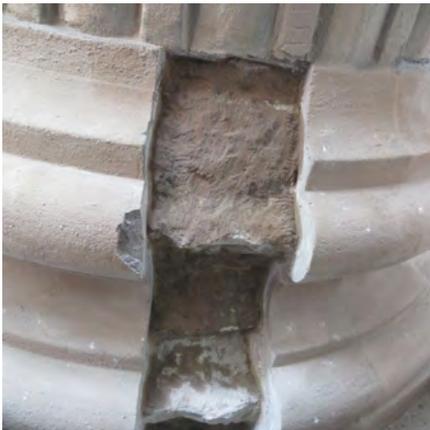
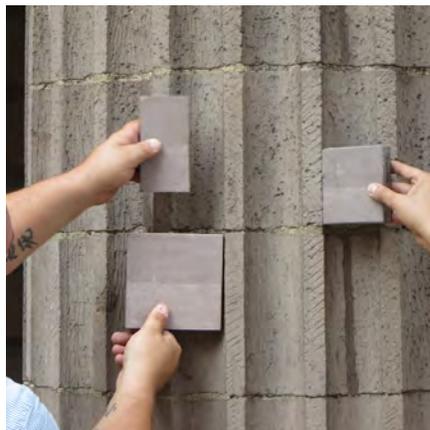
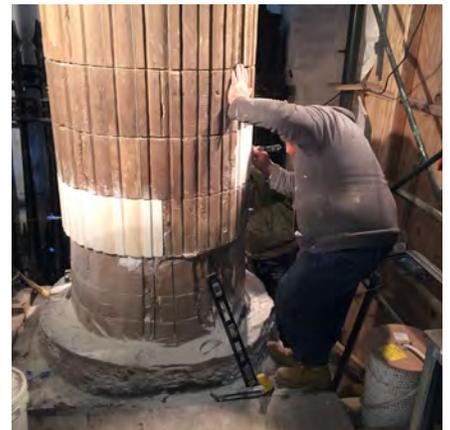
Sandstone was used for the columns at the east portico, as well as the stone around the windows, doors, and quoins. Significant restoration of this sandstone was done, including replacement, patching and dutchmen as appropriate. Comprehensive re-pointing was also done. Though various mortars had been applied over time, a conservator's analysis of underlying mortar established that the original mortar was white. SUPERSTRUCTURES' in-house conservators conducted an analysis to replicate the mortar formula containing the correct proportions of lime,

*Top and bottom left: Sandstone columns before restoration. Bottom center and right: Columns during restoration. Top right: Restored column.*

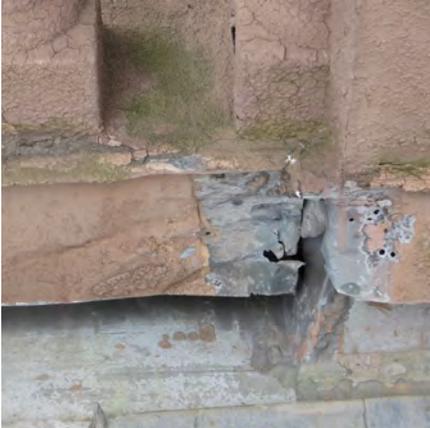
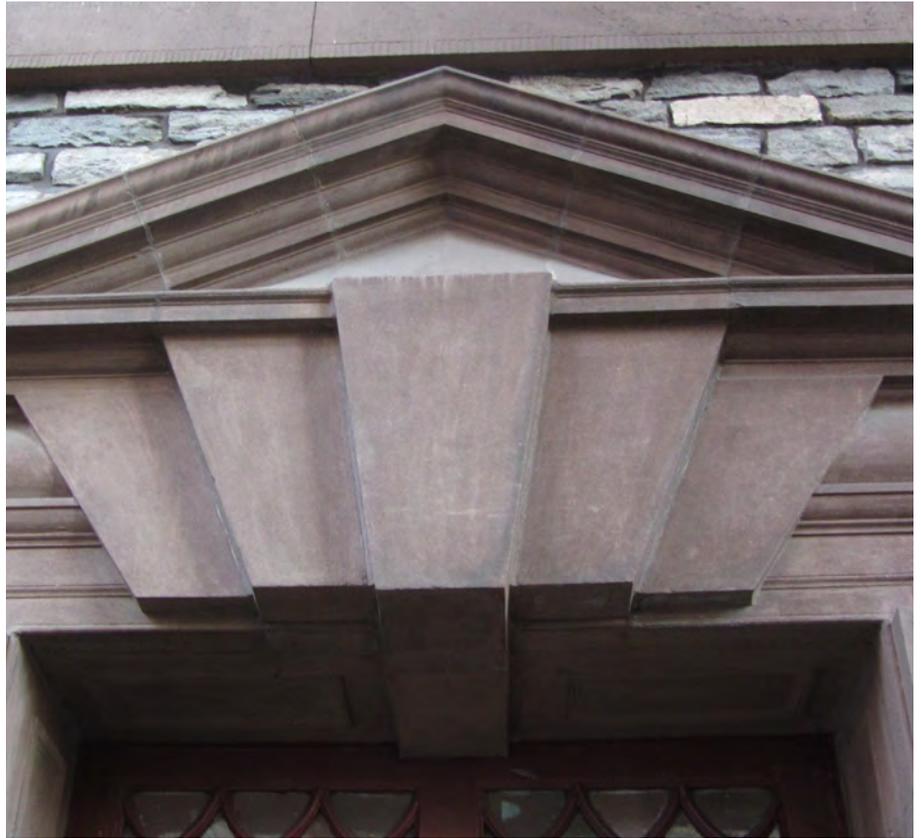
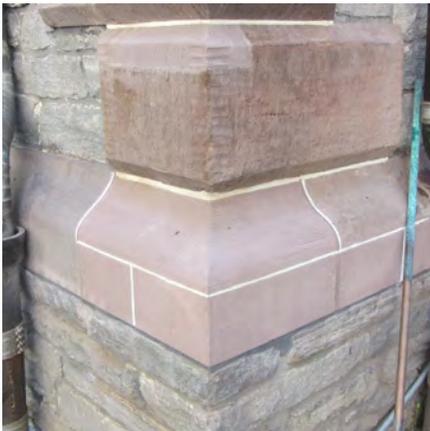
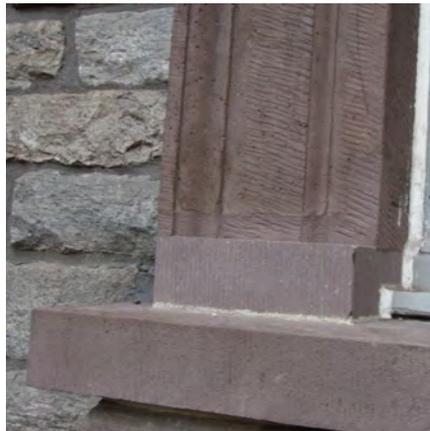
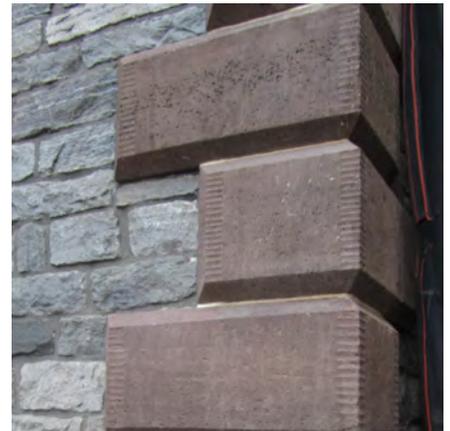
mortar, and sand as well as match the color and texture of the original mortar. Previously installed patches of improper materials were causing damage to the mother stone and were replaced with softer, more appropriate repair mortar and tooled to match the existing finish.

*Top left: Sandstone around window before restoration. Top right, bottom left, right and center: Restored sandstone.*

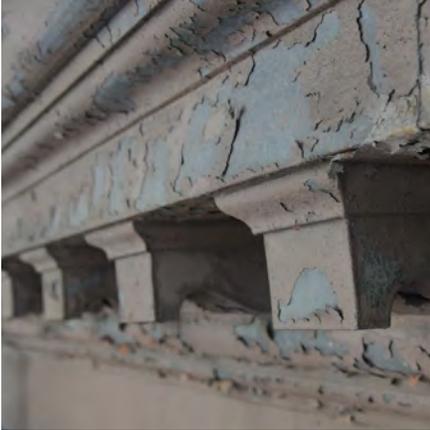
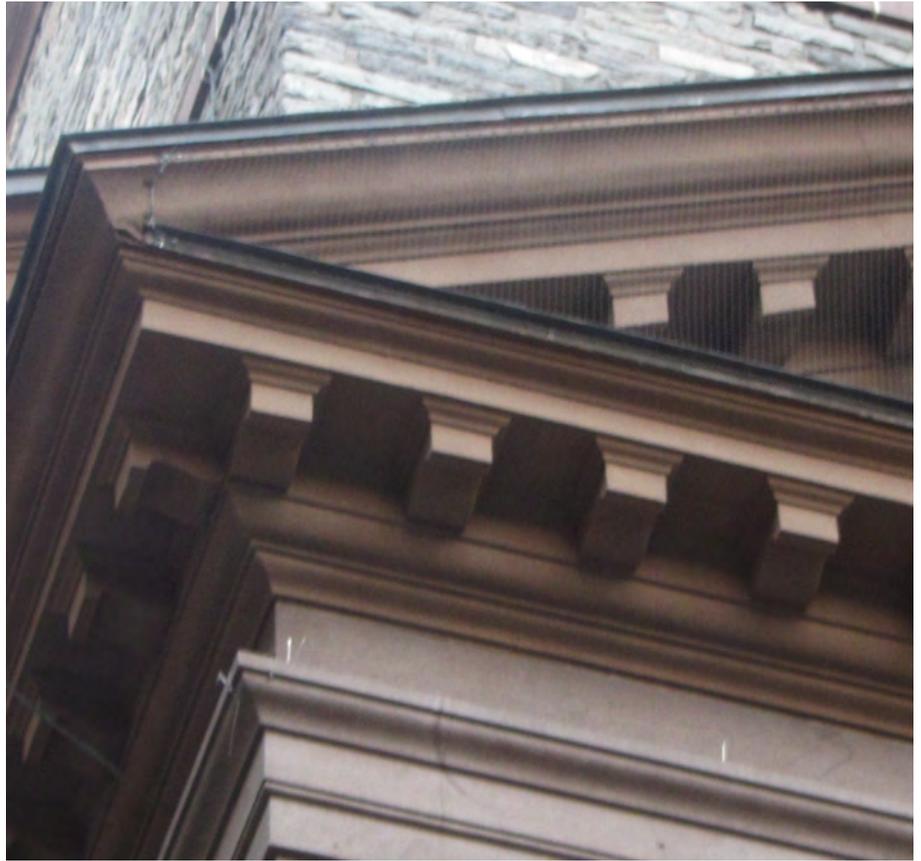
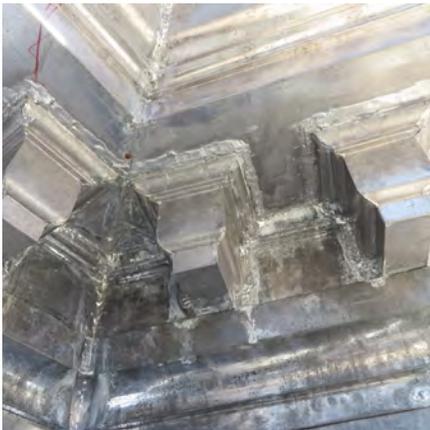
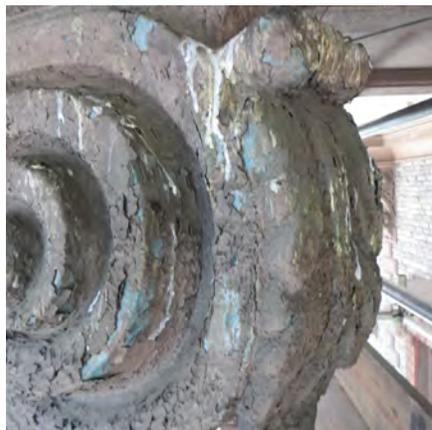
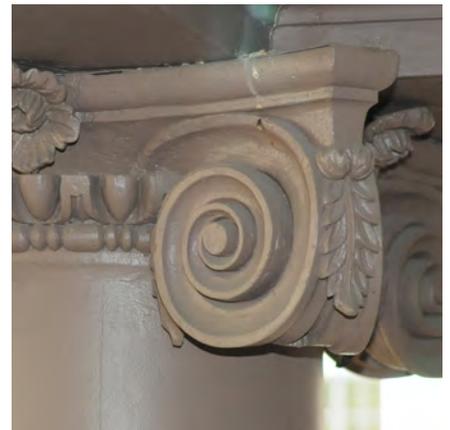
Sheet metal cornices were restored on the east and west elevations, including those framing the tympanum, and on the north and south sides of the porticos. The metal cornices had been installed over wooden cornices in 1929 and mimicked their shape. The dentils were removed from the wooden cornices to allow installation of the sheet metal. This was one of the factors leading to selection of the 1929 exterior as the model for the present restoration. The cornices were recoated with sand-infused paint to give the appearance of surrounding sandstone, as was the intent with the original coatings on the cornices.

*Upper left: Cornice before restoration. Lower left: Cornice during restoration. Upper right: Restored cornices. Lower center: Metal column capital before restoration. Lower right: Restored capital.*

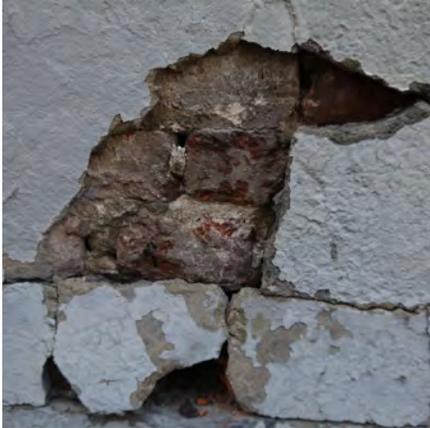
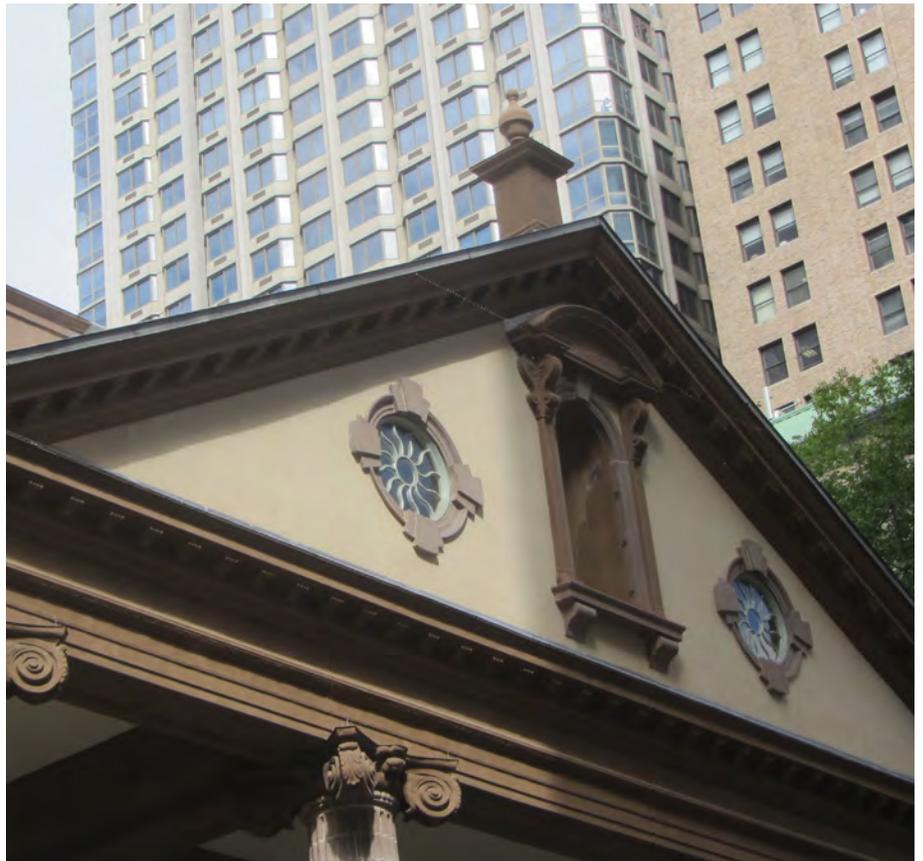
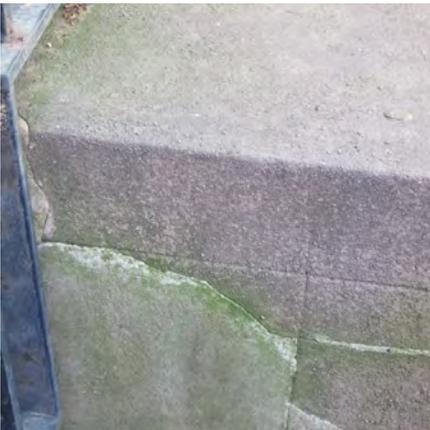
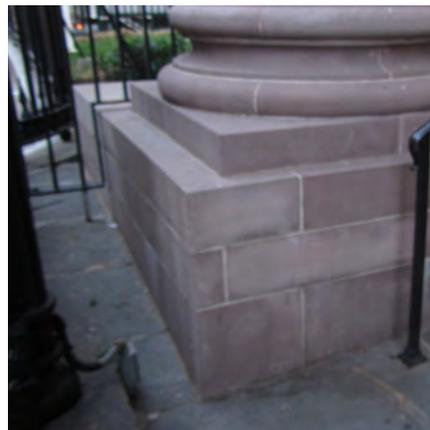
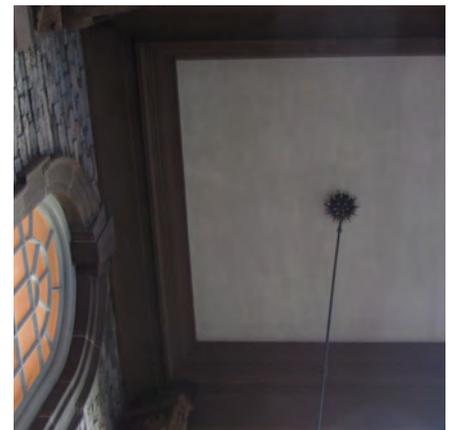
A significant portion of the plaster facade of the tympanum above the eastern portico was deteriorated. For repair of the plaster wall SUPERSTRUCTURES specified a stucco mix matching the appearance of the original plaster. The scoring marks used to give the impression of stone were freshened and the entire area was coated.

The base of the portico had been replaced with historically inappropriate concrete, which in turn was extremely deteriorated. The concrete was replaced with cast stone selected to match the original sandstone.

*Upper left: Deterioration in facade of tympanum before restoration. Upper right: Restored tympanum. Lower left: Portico base before restoration. Lower center: Portico base restored. Lower right: Portico ceiling restored.*

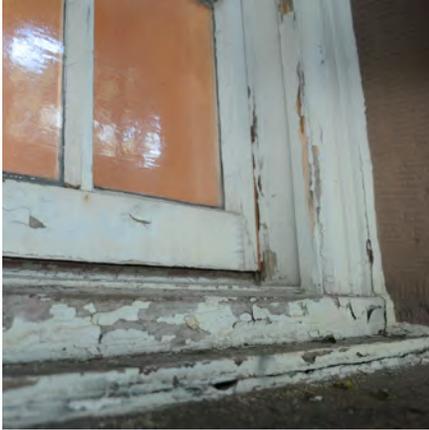
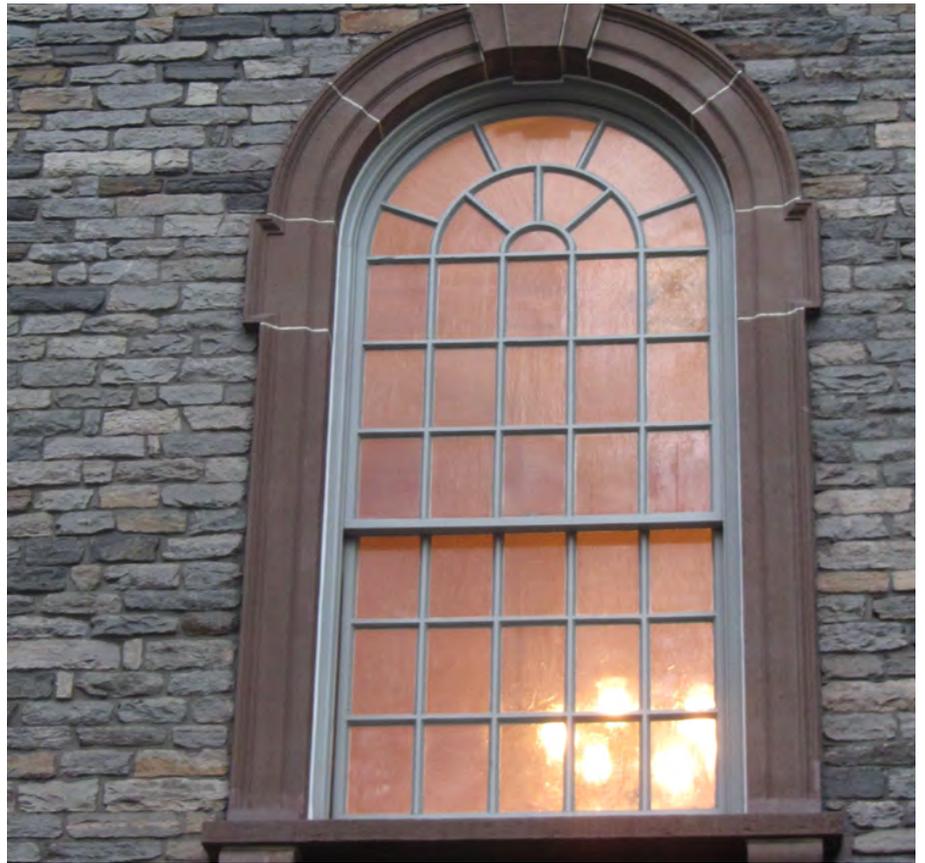
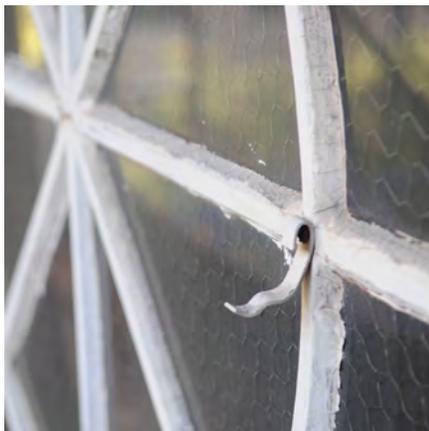
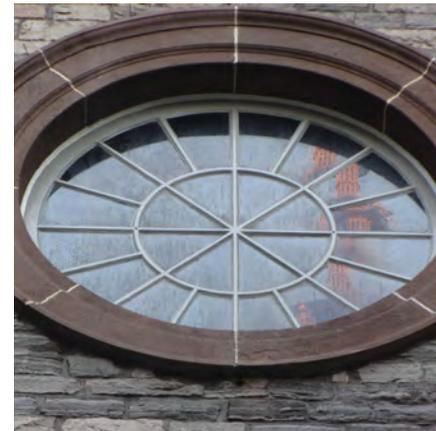
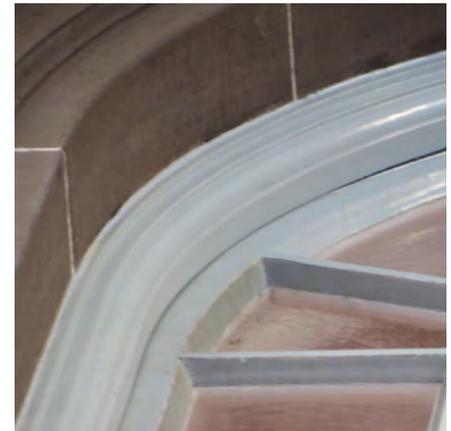
The window repair program was comprehensive. All wooden sashes were removed, stripped and repainted. Some wood consolidation was required. All the glazing was re-set. Broken panes were replaced with Restoration Glass® from Bendheim Architectural Glass for historical accuracy. Imported from Germany, the panes are mouth-blown glass and display characteristics of antique glass including mild waviness and occasional air bubbles. The window hardware was restored, including the mostly hidden operational hardware such as counterweights, chains and pulleys.

*Upper and lower left: Windows before restoration. Upper right, lower center and right: Windows after restoration.*
