The New York Landmarks Conservancy  
Lucy G. Moses Preservation Awards  
Nomination

708 Broadway  
New York, New York

Exterior Restoration

### On Broadway—Revived Facades Take the Stage at 708.

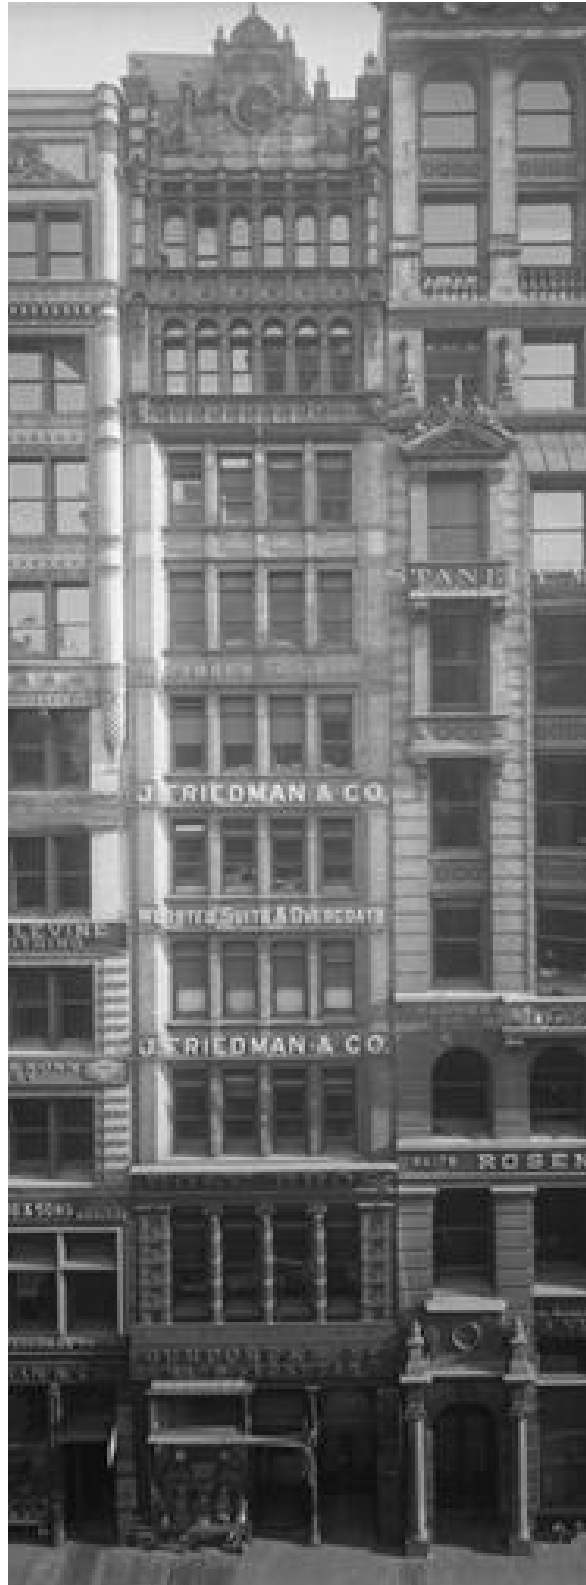
708 Broadway, November 1925; collection of the Museum of the City of New York

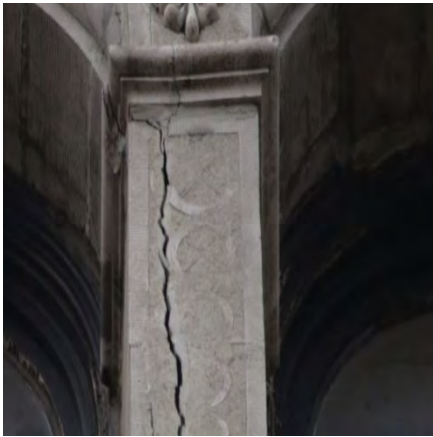
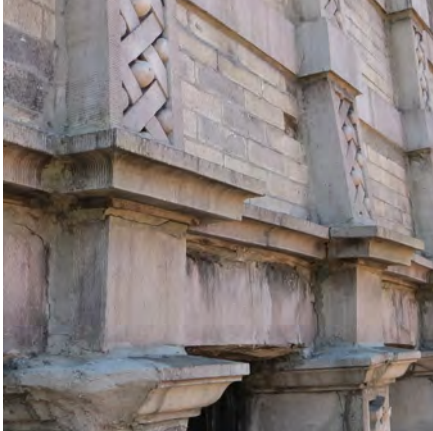
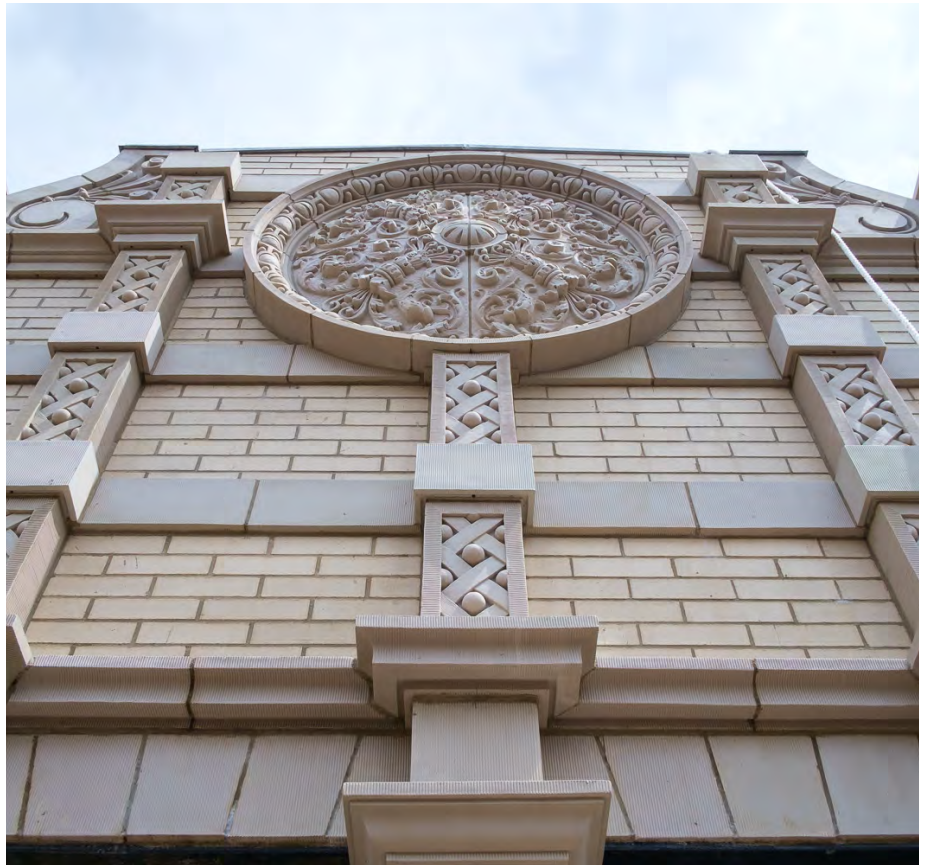
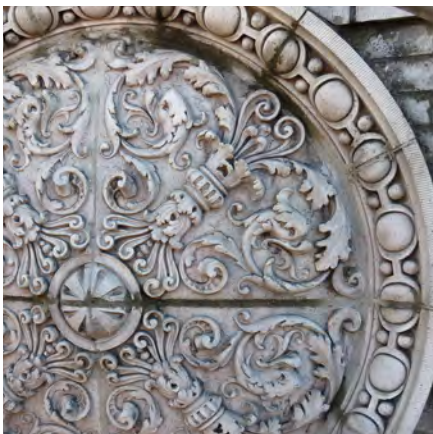
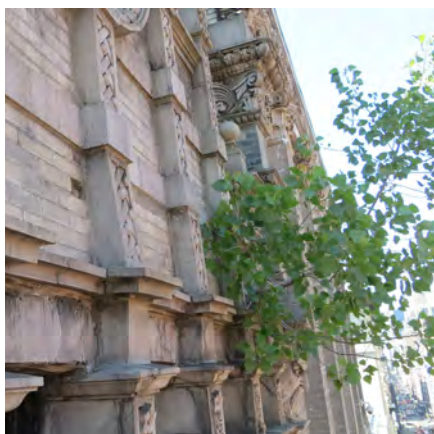
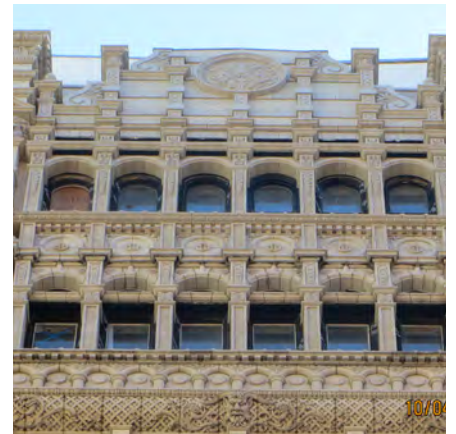
West Facade - Terra Cotta

At the time of the purchase by NYU, 708 Broadway was in poor condition, having been neglected for years. What was originally beautiful terra cotta and masonry on the Broadway-facing west facade had not been repaired for decades. The decay was so extreme that there was even a tree growing out of the side of the building.

Top, middle and bottom left: Terra cotta before restoration; Bottom middle: extensive facade deterioration resulting in vegetation growing on the building; Top and bottom right: terra cotta after restoration

The repair scope on the western (Broadway-facing) facade included extensive terra cotta replacement and repairs. Most of the existing terracotta units at the upper section of the facade were replaced with new terra cotta manufactured by Gladding McBean. The replacement units included highly decorative elements and sculptures.

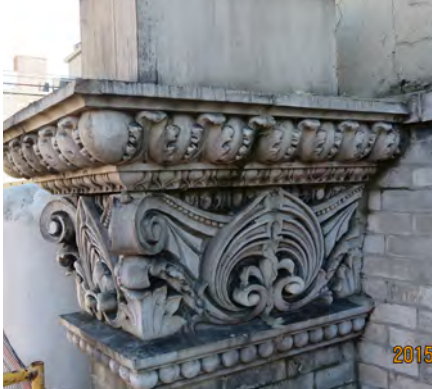
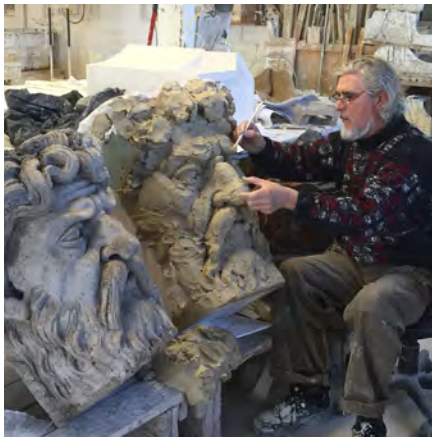
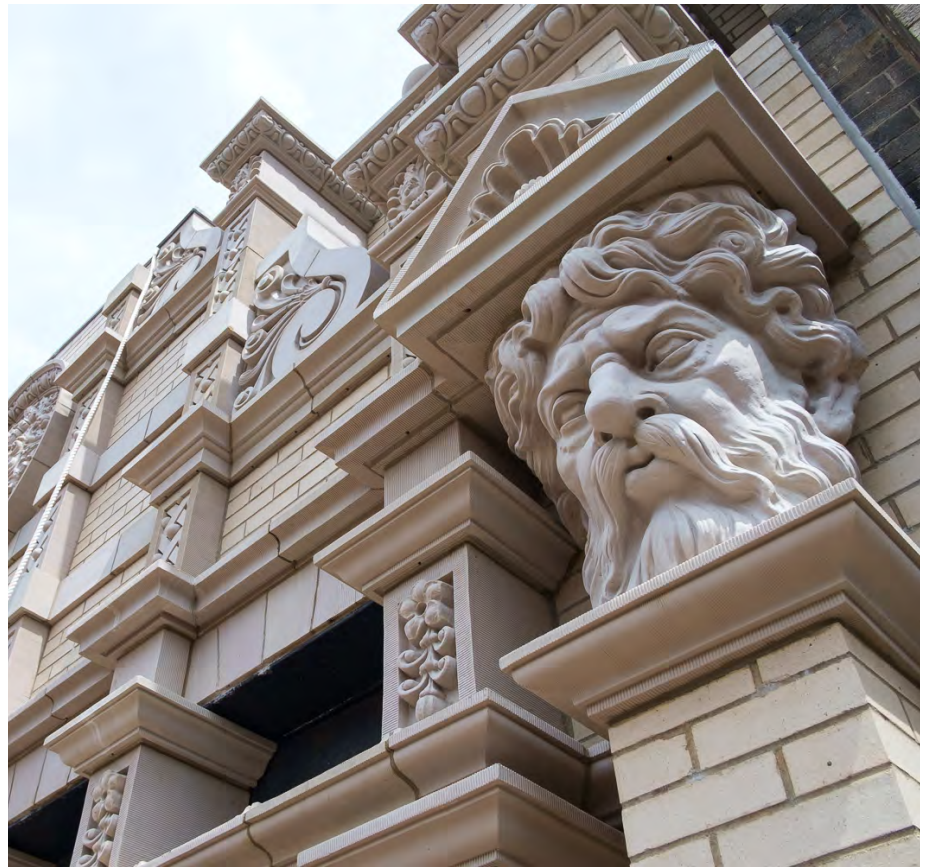
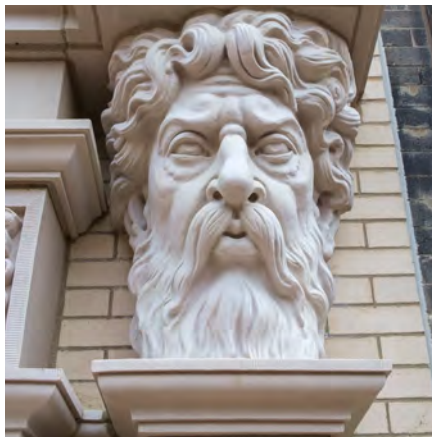
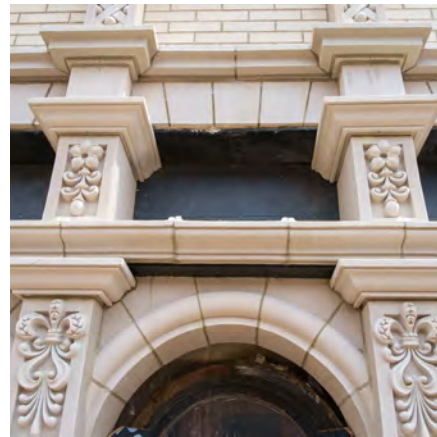
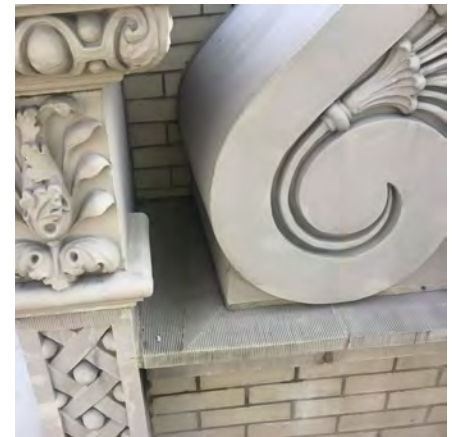
West Facade - Terra Cotta (continued)

Above: Terra cotta before restoration; Left middle: Sculptor at Gladding McBean carves replica of terra cotta sculpture as replacement; Bottom row and top right: Terra cotta after restoration.

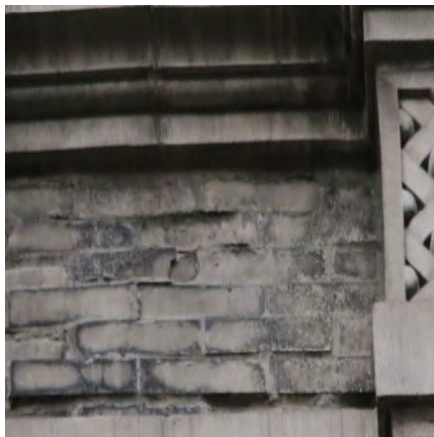
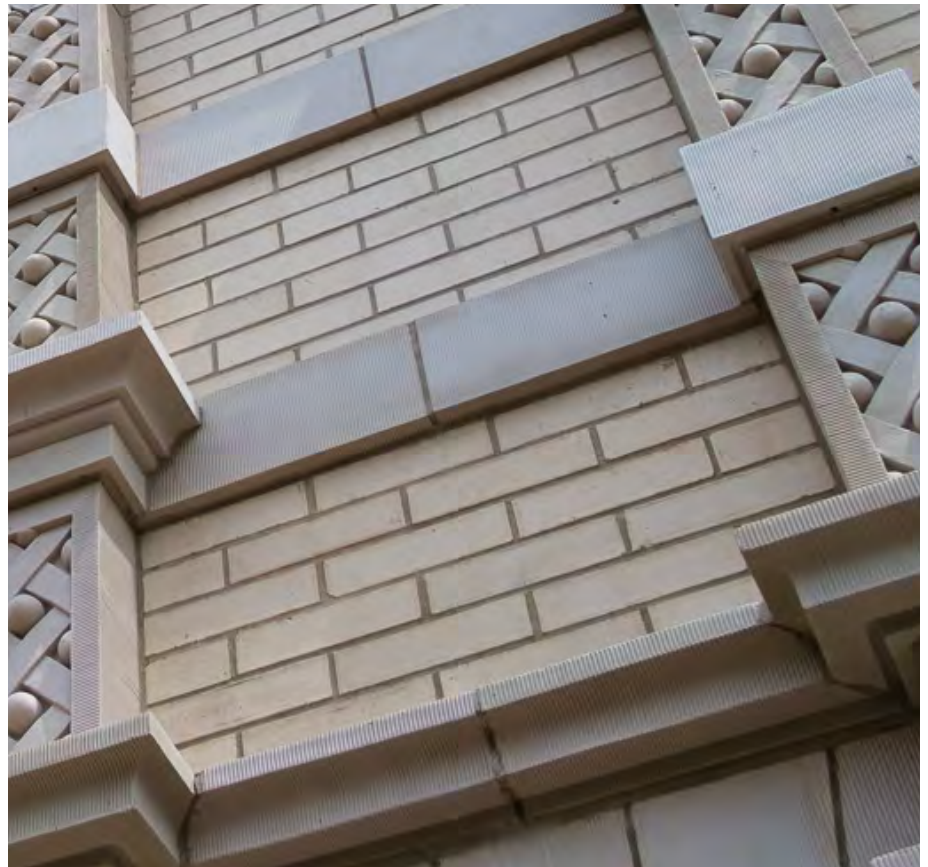
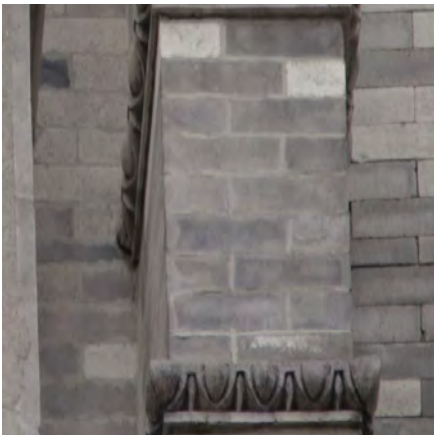
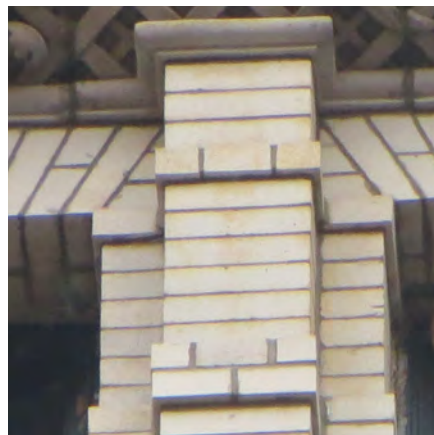
West Facade - Masonry

*Top and bottom left: Brick masonry on west facade before restoration. Top and bottom right: Brick masonry on west facade after restoration*

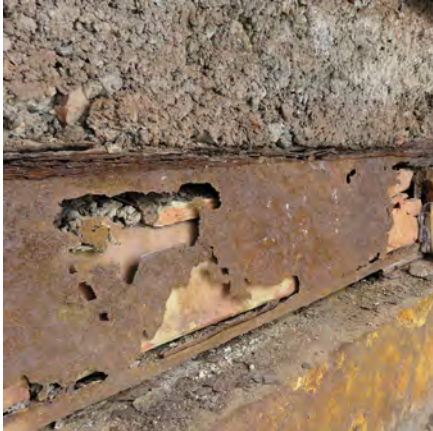
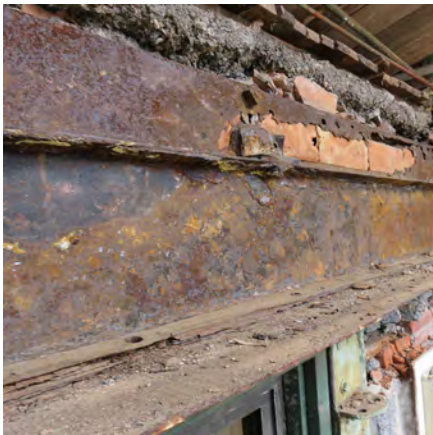
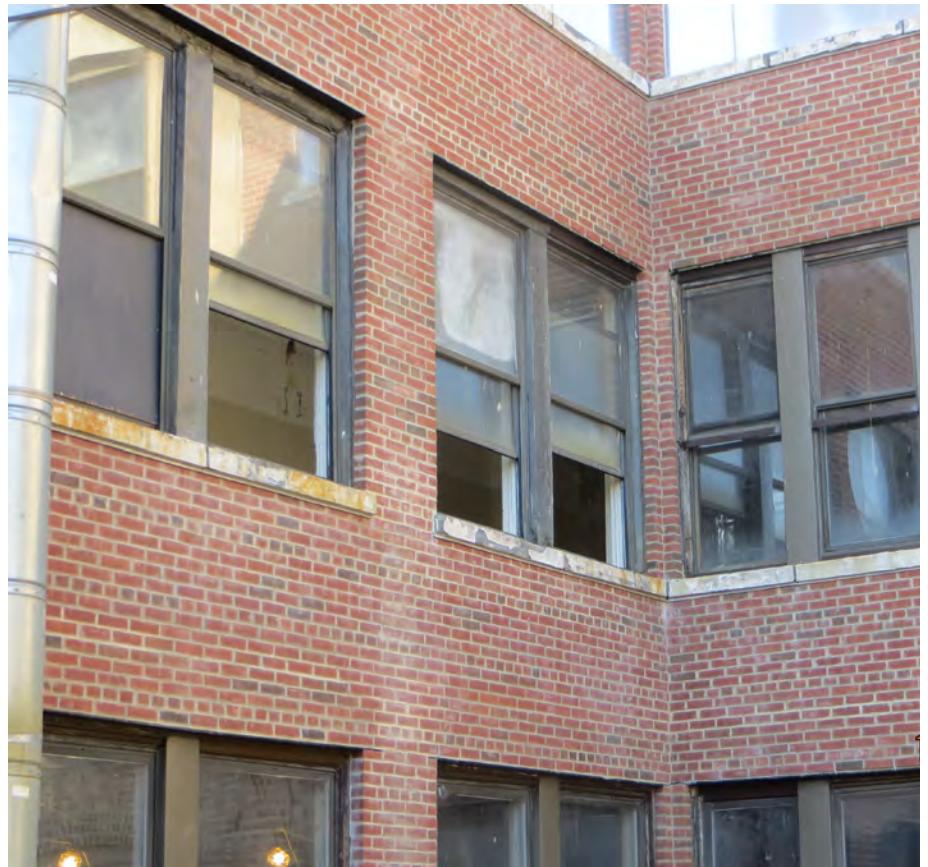
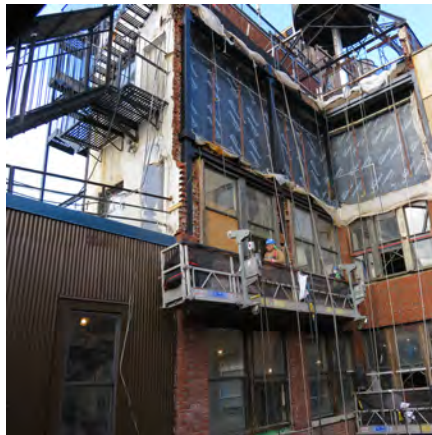
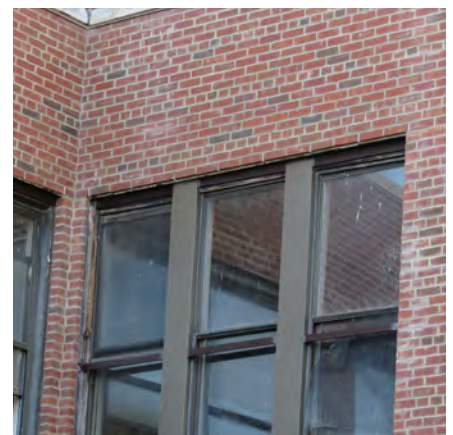
## East and North Facades - Masonry and Steel Repair

On the eastern facade facing the courtyard, the masonry was in evident need of repair. When the masonry was opened for inspection, the steel structure underneath was found to be severely eroded, which necessitated an extensive shoring project to support the interior slab structure. The top three floors were essentially rebuilt—not only the face brick but also the steel and the backup masonry.

*Top and bottom left: Deteriorated structural steel uncovered under outer brick masonry; Bottom middle: Upper floor facade under reconstruction; Top and bottom right: New brick masonry facade after reconstruction.*

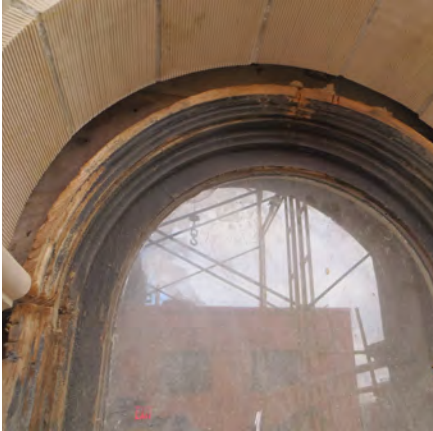
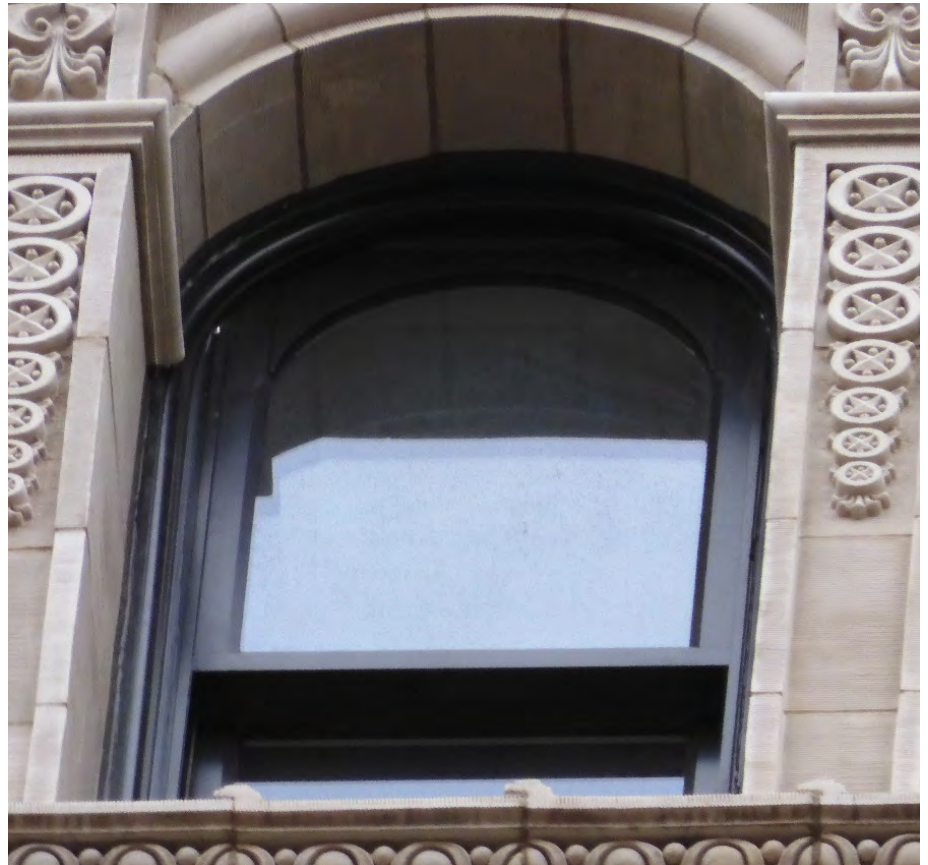
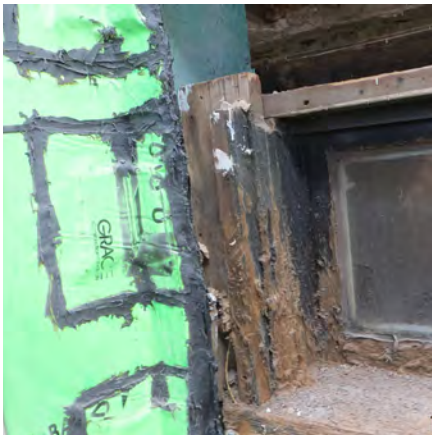
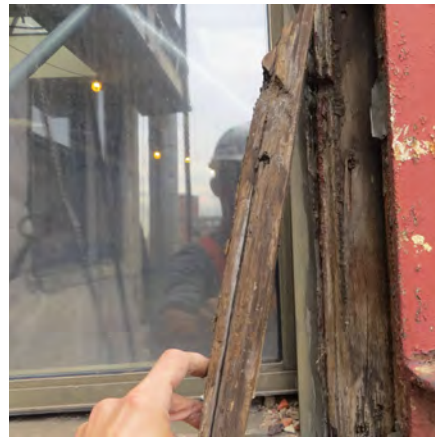
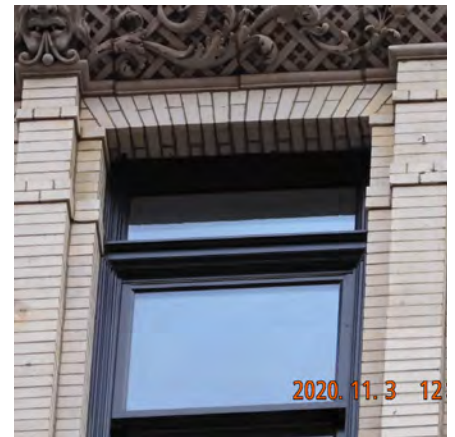
## Window Replacement

*Top left: Head condition—Deteriorated wood frame and missing brickmold on window type W2; Bottom left: Jamb condition—deteriorated wood frame and the transom, window type W1; Bottom center: Jamb condition—deteriorated wood frame and mullion; WIndow type W13; Top and bottom right: Newly installed windows.*

After work was completed on the facades, the next phase of the restoration involved replacement of the existing window sashes and wood frames with new aluminum windows, matching the original historic window profiles and shapes. The original wood windows had later been retrofitted with aluminum cladding. The windows were replaced with aluminum windows to match the historic wood profiles. The Landmarks Commission eventually ruled that arched windows, which were originally stipulated to be replaced with in-kind material, could be replaced with aluminum as well.

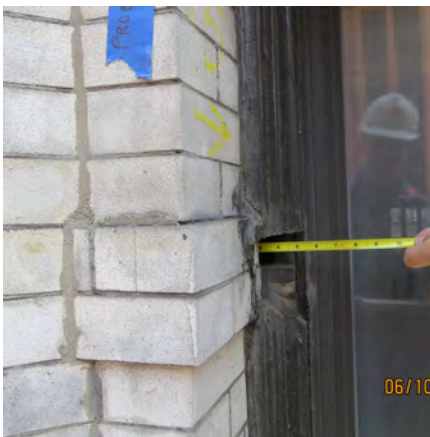
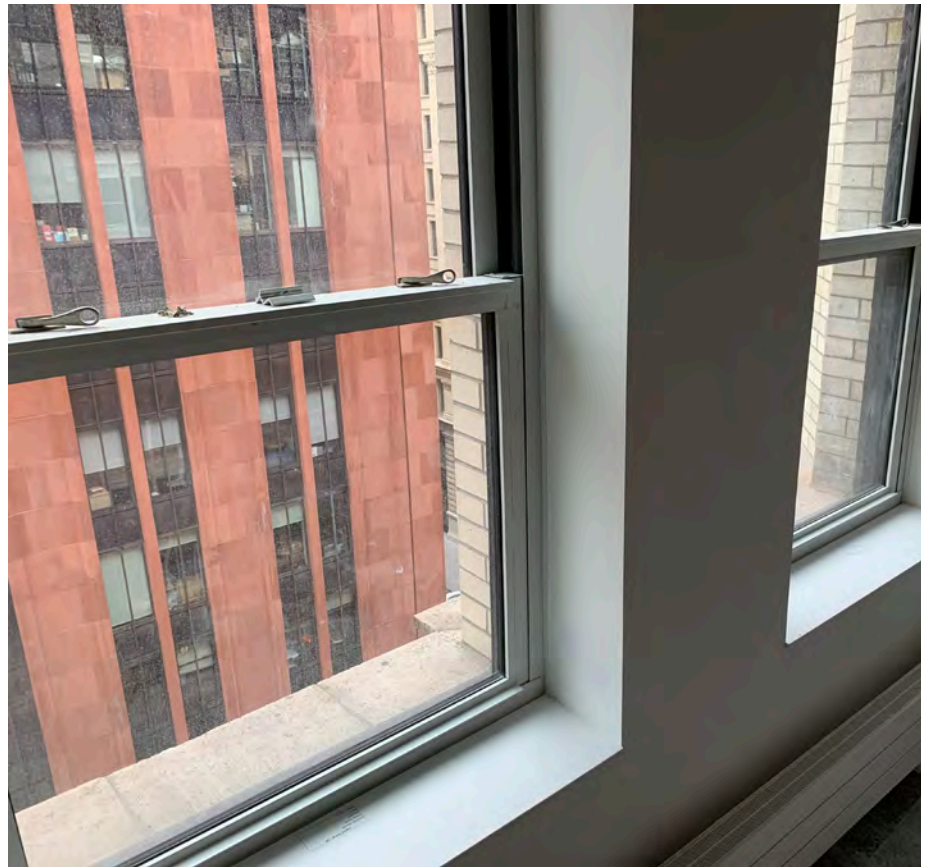
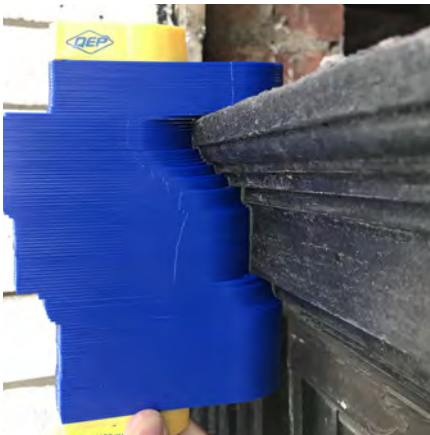
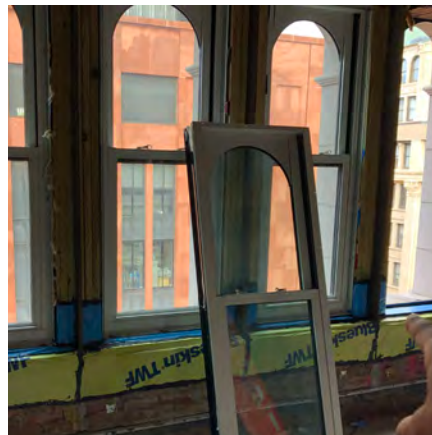
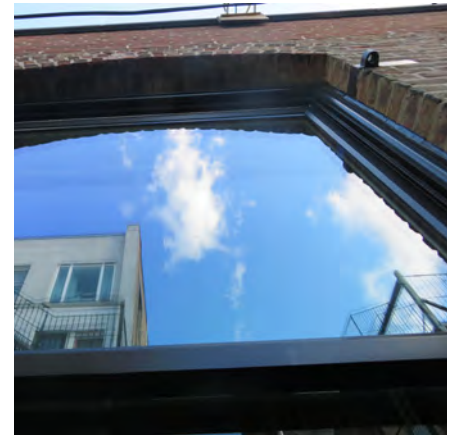
## Window Replacement

- Deterioration of aluminum panning and underlying wood frames
- Cracked or missing glazing
- Inoperable sashes
- Louvers remaining from abandoned HVAC equipment through openings
- Damage to interior finishes due to excessive water infiltration

*Top left: Probe revealed window frame embedment into external wall; Bottom left: mold for brick replacement; Bottom middle: window installation in progress; Top and bottom left: newly installed windows.*

Eighteen window types were replaced for a total of 119 window units in 83 openings along the west, east, and north facades. Replacement was required due to the following conditions:
