Low Memorial Library
Columbia University in the City of New York
535 West 116th Street
New York, New York

Interior Restoration -
Main Entrance and South Ambulatory (Foyer)

Low Memorial Library – A Treasured Interior Landmark Shines Anew

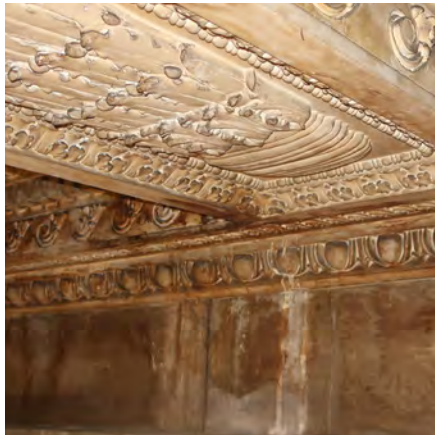
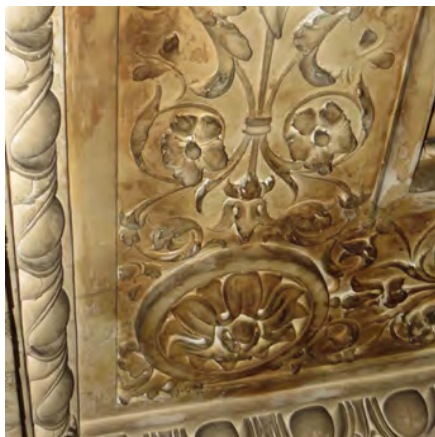
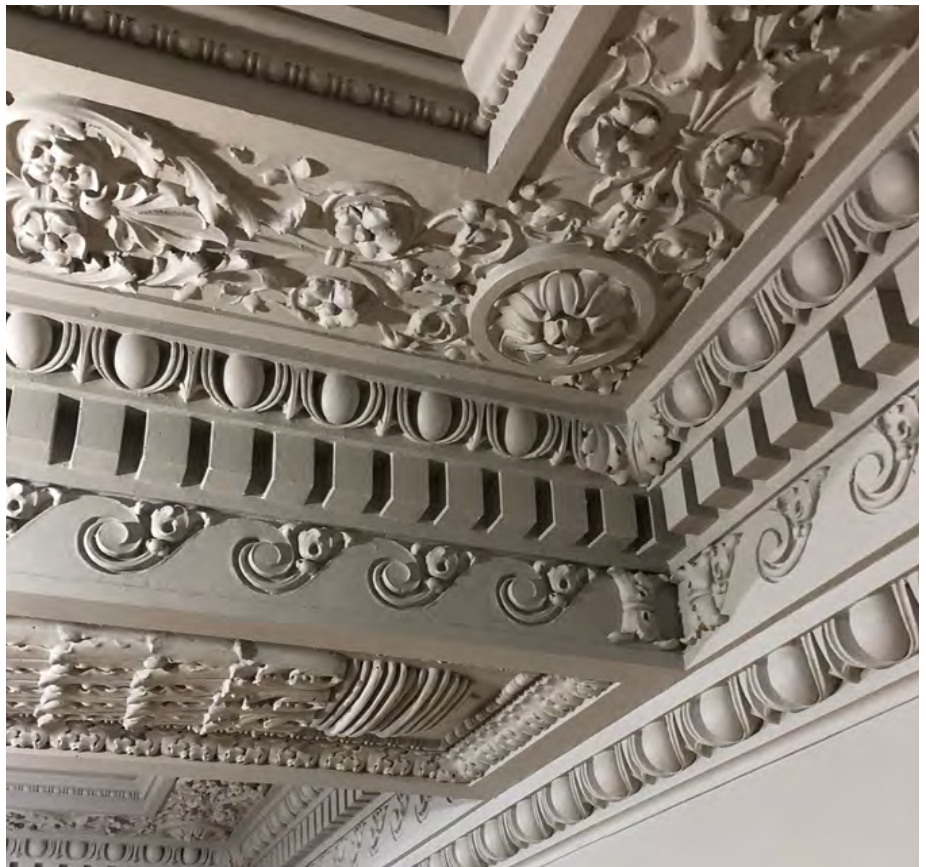
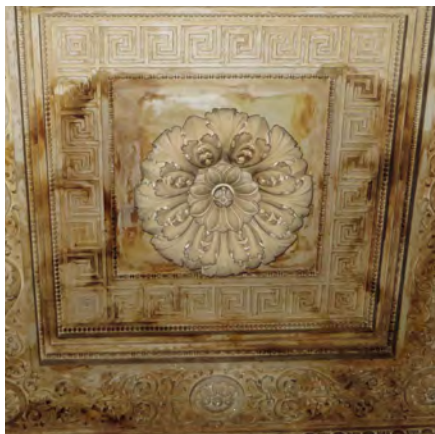
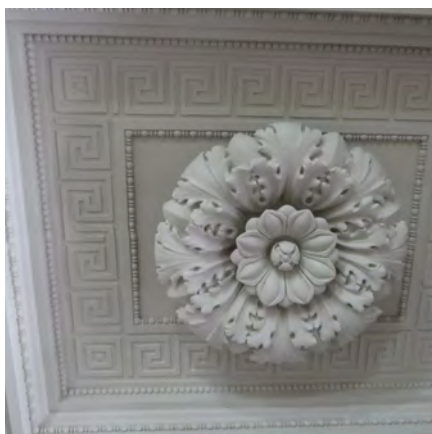
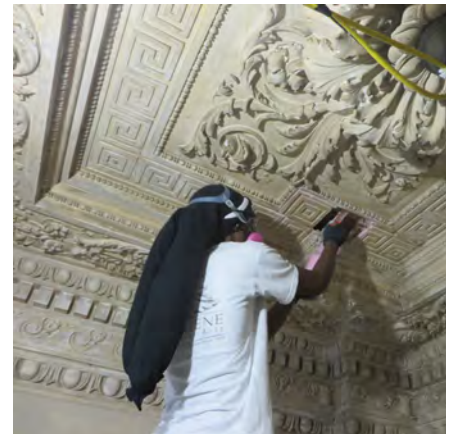
The Main Entrance decorative plaster ceiling had been subjected to water penetration in several locations and was in poor condition in these areas--exhibiting wide cracks, displacement, disaggregation, loss, and widespread staining. The ceiling had been largely untouched prior to the subject restoration, so exhibited 100 years of deterioration, dirt, and grime.

Top, middle, and bottom left: Staining and efflorescence in plaster ceiling due to water penetration; Top right: Ceilings after restoration; Bottom middle: Primed ceiling before painting; Bottom right: ceiling restoration in progress.

During restoration, friable fragments of plaster at the wide cracks in the Main Entrance were raked out and removed with hand tools leaving the surrounding plaster material intact. Wide cracks in the plaster ceiling that allowed movement upon sounding were treated to stabilize the area before plaster infill. New composite patches were installed using original materials such as hemp/burlap. Existing ceiling plaster was refinished, including cleaning, efflorescence removal, peeling paint removal, etc., prior to repainting. Existing ceiling plaster was primed and repainted to match the historic color palette.

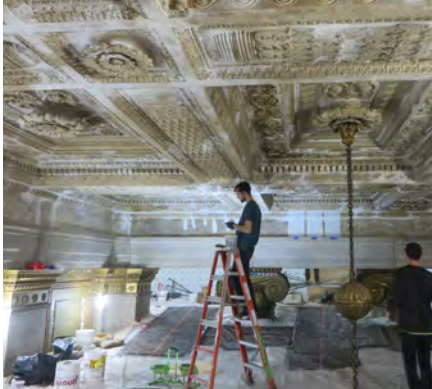
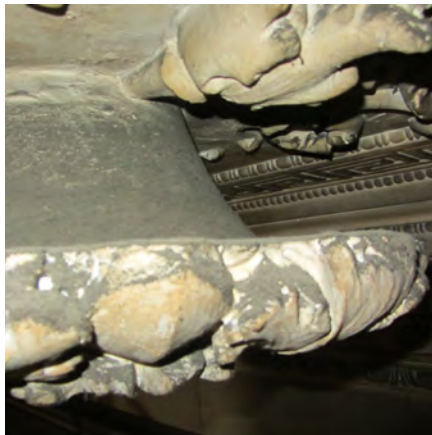
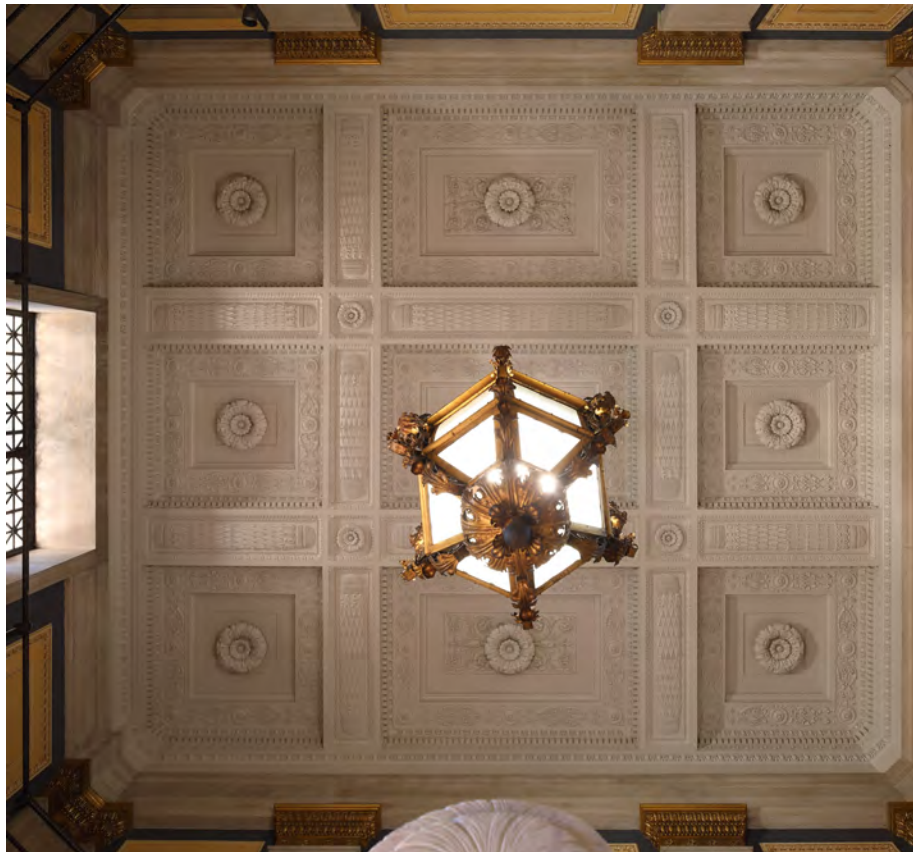
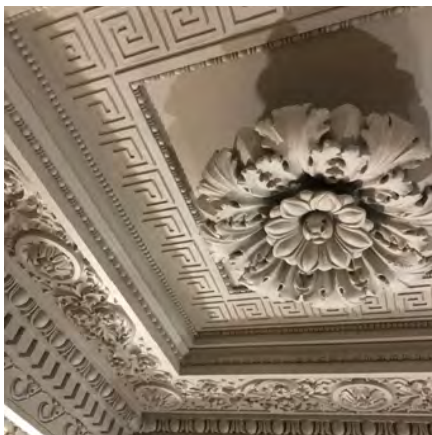
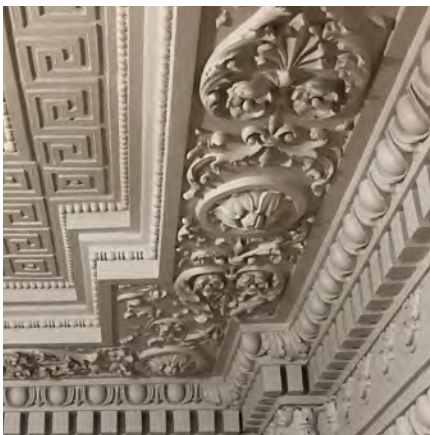
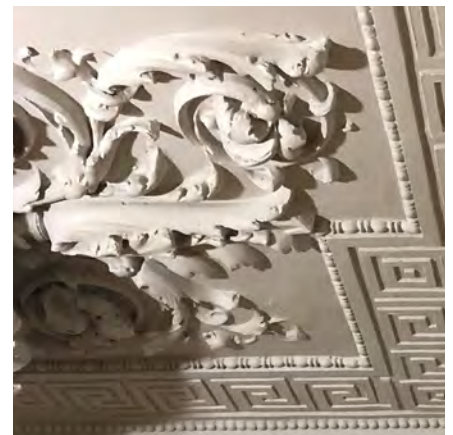
Top left: Ceiling during restoration by EverGreene; Middle left: Soiling and dust accretions noted on top of each rosette; Upper right and bottom row: Ceilings after restoration. Upper right photo: Whitney Cox

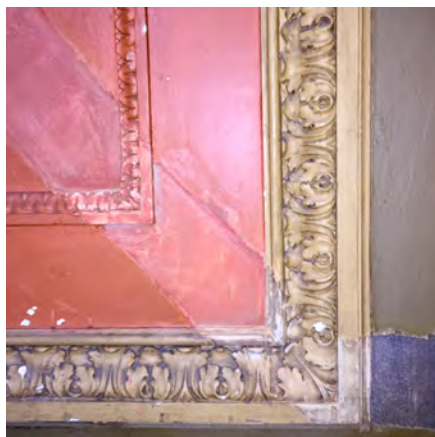
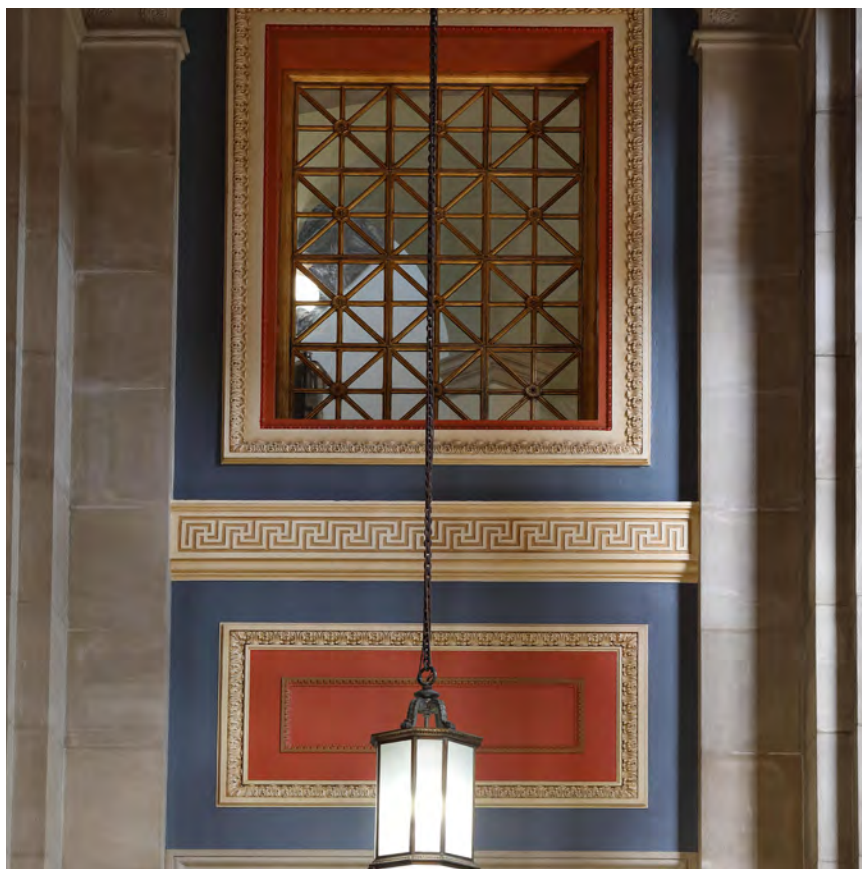
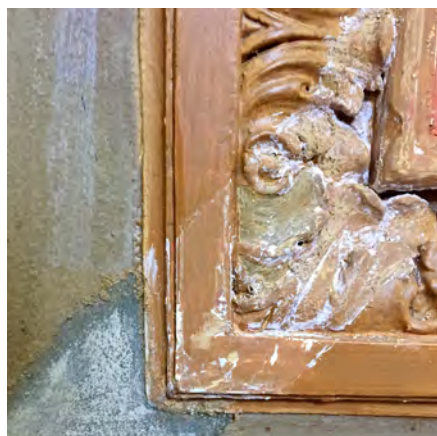
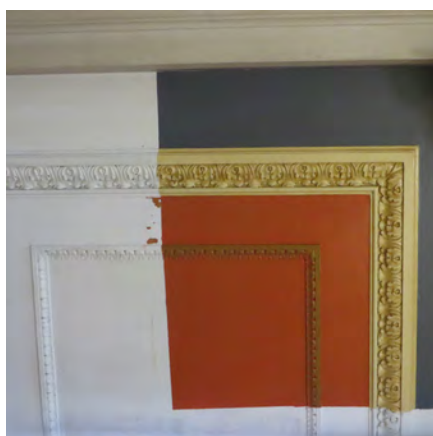
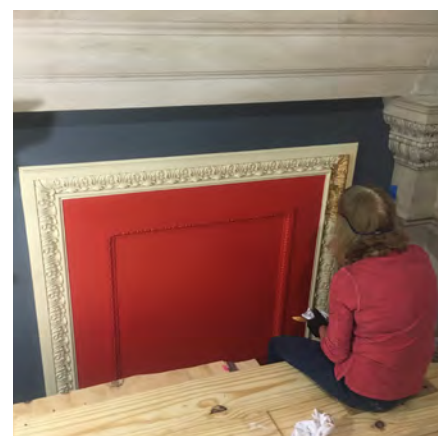
The on-site finishes investigation consisted of visual inspection of painted surfaces, extraction of over 200 samples from selected areas, and chemical and mechanical exposure to remove layers of non-historic or post-historic finishes and reveal historic paint schemes. The paint finishes were failing in several wall and ceiling areas throughout the Main Entrance and Ambulatory due to water damage. Exposures of the 1890s target-era decorative campaign were created. Various chemical products and mechanical techniques were tested for overpaint removal.

Top and bottom left: Exposures by SUPERSTRUCTURES revealing a glazed deep-red panel set in a dark-blue wall field; Bottom center and right: Paint finishes during application by EverGreene; Upper right: After restoration (photo: Whitney Cox)

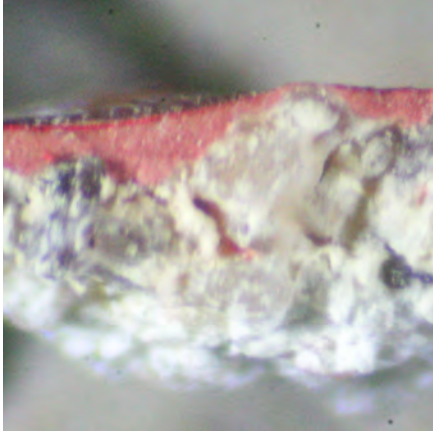
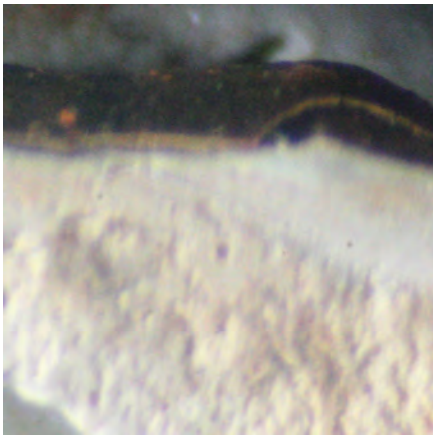
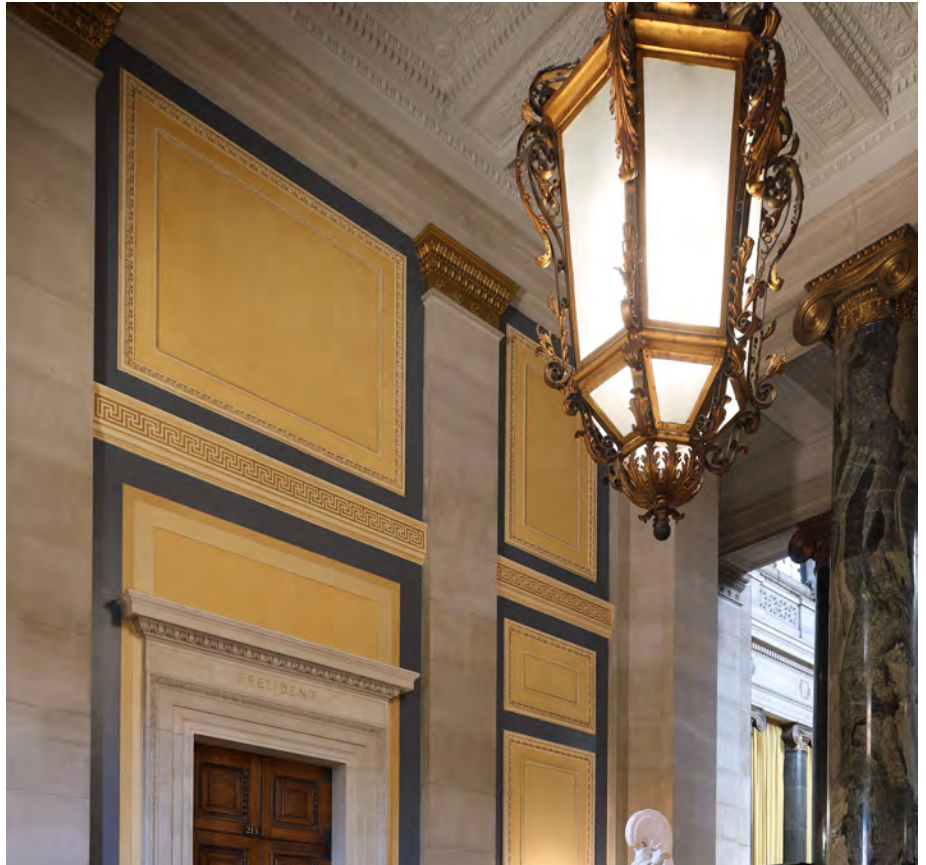
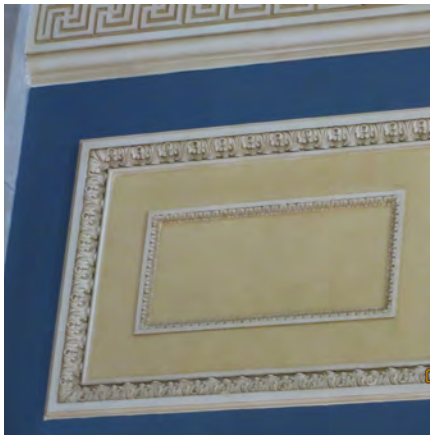
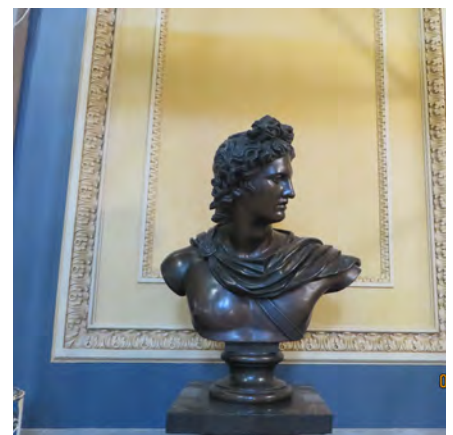
Paint microscopy and analysis was also performed to document historic paint colors. Samples were examined in the SUPERSTRUCTURES laboratory under a Meiji EMZ-5TR large-field stereo zoom microscope. The layering sequences of various areas were compared and analyzed in order to relate various historic paint campaigns and overall decorative schemes back to the earliest existing campaign. The original finishes included decorative finishes in several locations—particularly the application of metallics and decorative glazes in the Ambulatory. Existing interior plaster walls in Main Entrance and South Ambulatory were painted to match historic color palette.

Top left: Photomicrograph of paint samples removed from the panel field; Bottom left: photomicrograph of sample removed from outer molding of a wall-panel frame; Top right, bottom center and bottom right: paint finishes in Main Entrance after restoration. Top right photo: Whitney Cox

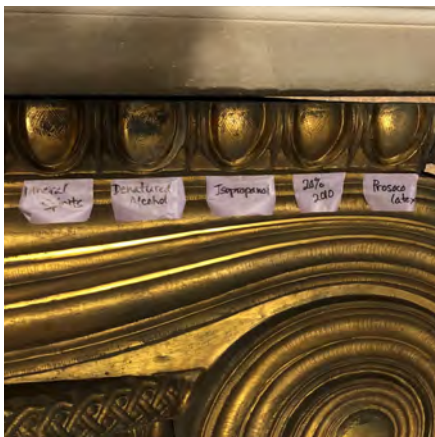
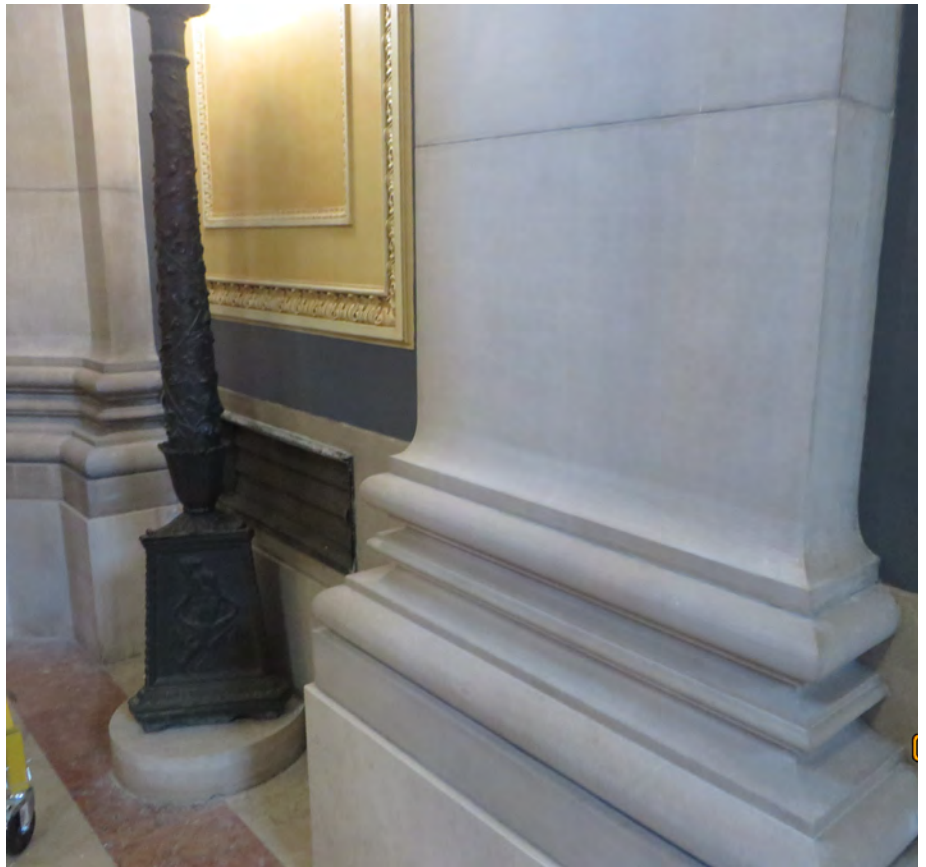
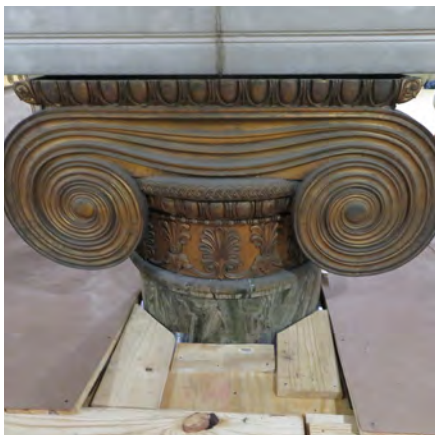
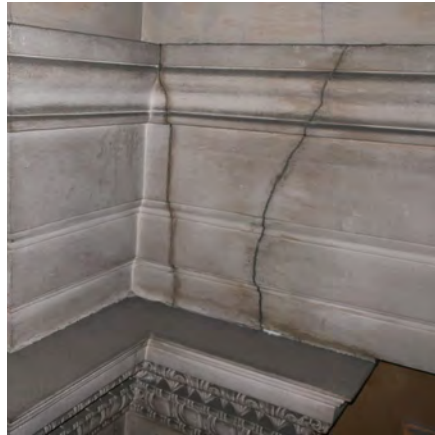
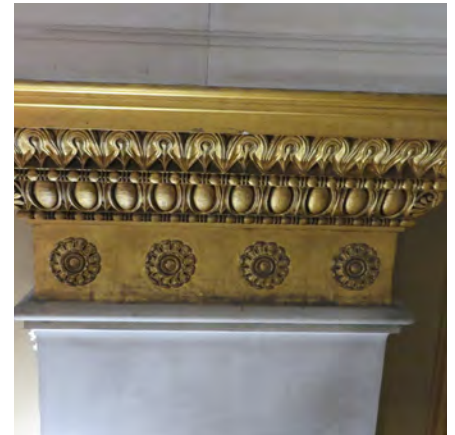
*Top left: Cleaning mock-up at plated bronze;
Bottom left: Plated bronze capital before
cleaning; Bottom middle: limestone before
repair; Top left; base of limestone pilaster af-
ter restoration; Bottom right: Gilded limestone
column capital after cleaning*

Cracks in all surrounding limestone below the ceiling were repaired. Deteriorated and loose material was removed. Infill mortar was carefully matched to the existing stone in color and texture. All limestone was cleaned, as were gold-plated bronze column capitals, gilded limestone column capitals, chandeliers in the Main Entrance and South Ambulatory, and the bronze window frame and glass over the entrance.
