The New York Landmarks Conservancy Lucy G. Moses Preservation Awards Submittal

New York City Police Museum 100 Old Slip New York, New York

Exterior Renovation

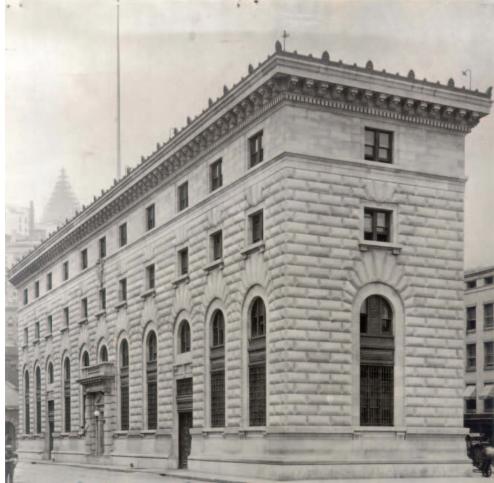
First Precinct circa 1910.

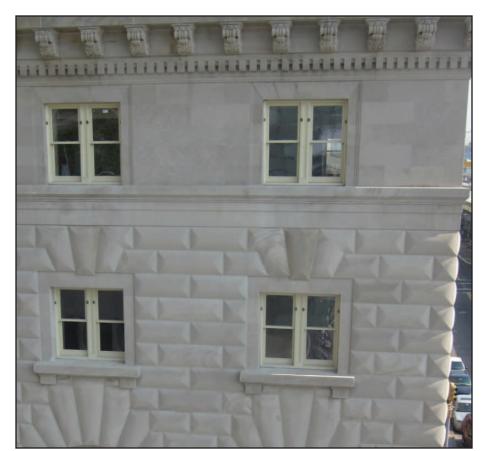
Masonry / Limestone

Despite their age, the limestone walls of the building were in good condition, though there was some staining from the water infiltration off the fifthfloor roof, atmospheric soiling and biological growth. Most of the masonry work comprised pointing and cleaning to restore the limestone to its original appearance, some stone restoration work including Dutchmen, unit replacement and crack repair. Landmarks Preservation Commission approval of mortar selection was required. During the renovation the scaffolding subcontractor was able to utilize a tension system inside the masonry window openings to stabilize the scaffolding. This unusual approach meant that no holes were required in the existing stone to anchor the scaffolding.

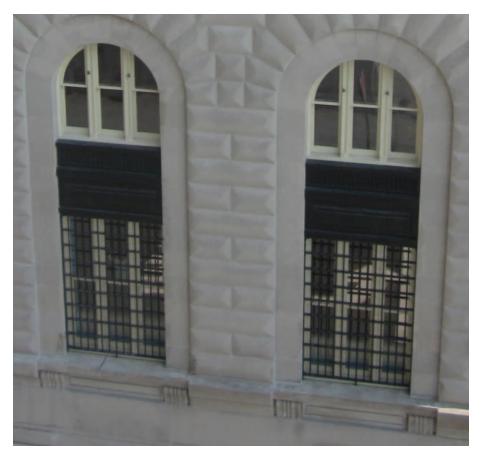
Prior to this project, the window sashes had been replaced within the original frames. The existing windows had problems with operation and with air and water infiltration. SUPERSTRUCTURES kept all the existing original wood frames in place, restoring the wood, and designed new, insulated glass replacement sashes to fit each opening. A paint analysis was done on the original frames, cast iron spandrel panels, and wrought iron grilles in order to match the original historic colors.

Top, left: Window and wrought iron grille before restoration. Bottom, left and right: Windows during restoration. Top, right: Windows, spandrel panels and grilles after restoration.

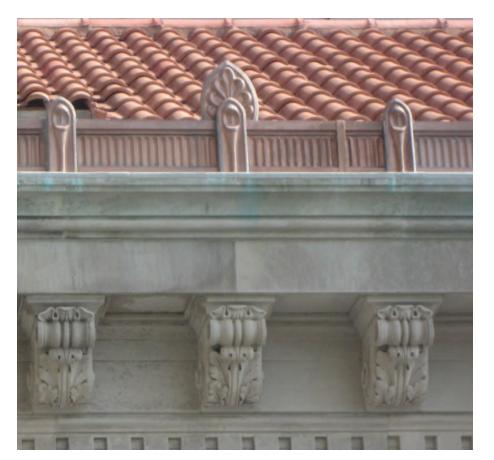
Fifth Floor

The major challenge of the restoration related to the fifth floor of the building, itself an addition done in the 1980s. The addition was positioned on top of the existing parapets, from which a copper cresting had prevoiusly been removed. No piece of the original cresting survived. The fifth floor tile roof drained onto a gutter on the parapet which was in poor condition, resulting in leakage into the interior floors below and causing staining and displacement of arch stones on the exterior. A new copper cresting to go atop the parapet was designed based on one historic photo including the original cresting and research of pressed-metal catalogs of the era. Clay mock-ups were made and were reviewed before molds were created for the copper stamping.

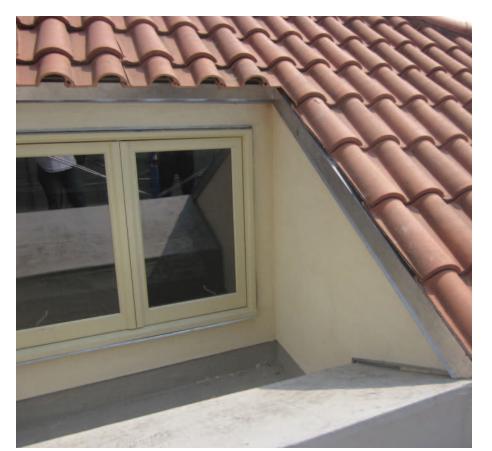
Fifth Floor - continued

Behind the new cresting, a "gutter" was created out of the back of the cresting, the existing pitch of the coping stone and built-up cement board to provide positive pitch to drain the run-off from the roof. Scuppers were relocated and one drain line added to allow for easier maintenance. Also the windows at the fifth floor, originally double-hung configuration, were replaced with casement windows, that better match the style of the historic windows below and allow easier access through the windows onto the reverse dormer roofs for maintenance of the new drains and scuppers.

Top, left: Reverse dormer window before replacement. Bottom, left: Copper cresting during installation on parapet. Bottom, right: New window leaning against old window, prior to replacement. Top, right: New casement window installed.
