The New York Landmarks Conservancy
Lucy G. Moses Preservation Awards
Submittal

The MacIntyre Building
874 Broadway
New York, New York

Facade Restoration and Roof Replacement

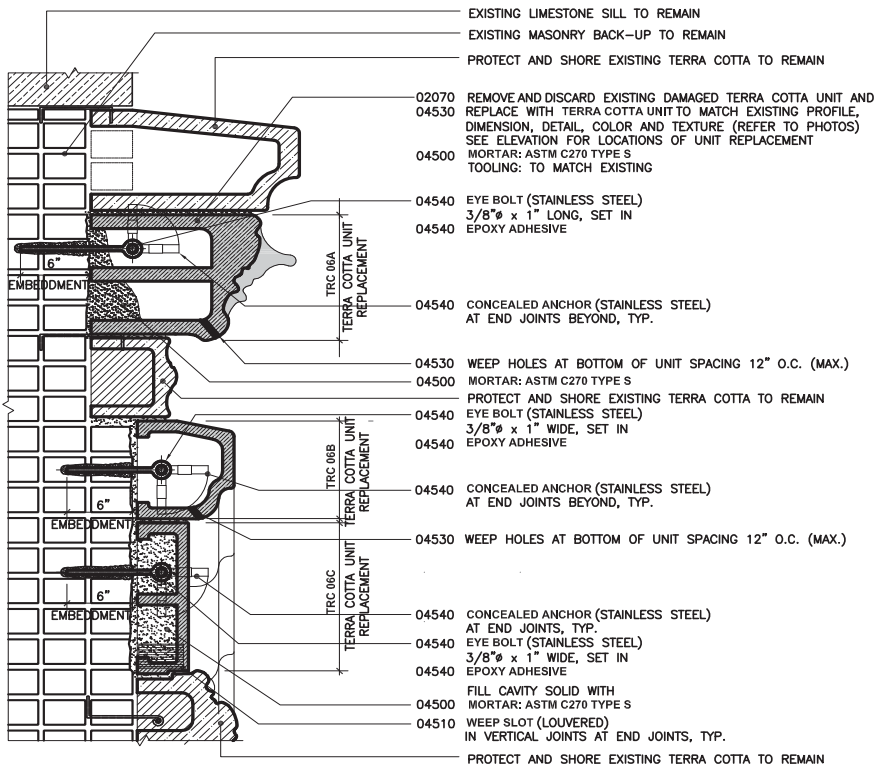
TRC 06A, 06B & 06C

TERRA COTTA UNIT REPLACEMENT : E. 18TH STREET 10TH FLOOR LEVEL

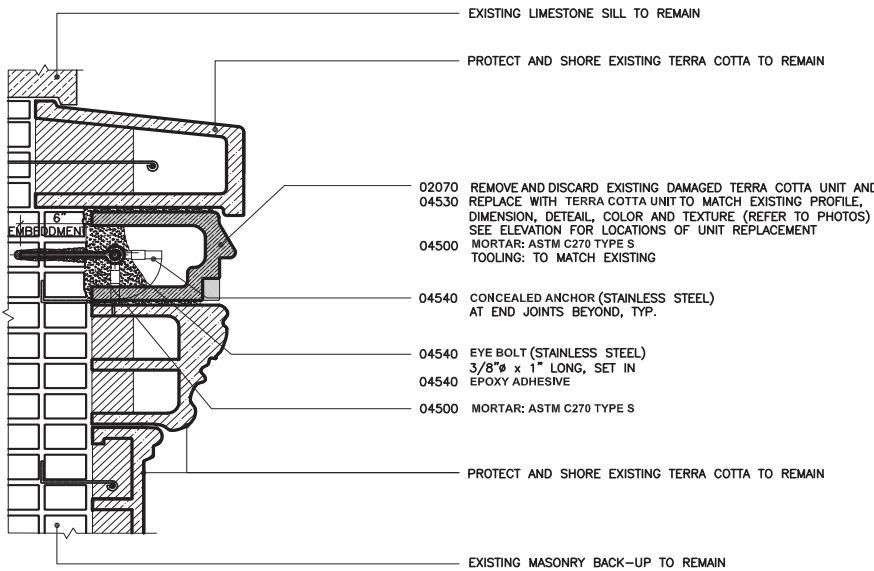
TRC 07

TERRA COTTA UNIT REPLACEMENT - DENTIL, E. 18TH STREET 9TH FLOOR LEVEL

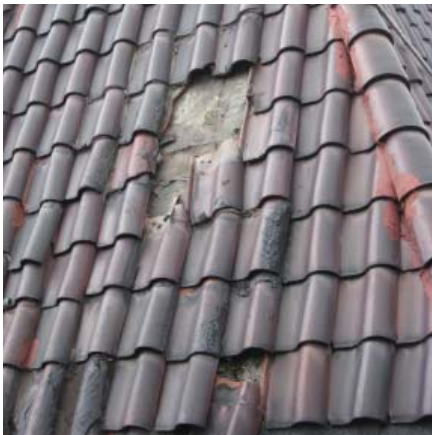
The tower is one of the most distinctive elements of the building's architecture. The Spanish-style clay tile roof was severely deteriorated and had clearly reached the end of its life span. In keeping with the Owner's budget, a facsimile tile of formed metal was originally considered. The Landmark's Preservation Commission staff took an interest in the roof and suggested the roof design might be approved, and the delay and expense of a full Commission hearing avoided, if the clay terra cotta roof was replaced in kind.

Below, top: Roof tile, before. Below, bottom: Pull test in progress. At right: Roof tile, after.

Custom-manufactured tile was deemed impractical for the project given the small size of the roof and the short construction schedule. Therefore all 15 domestic manufacturers of this type of tile were contacted in order to find the closest matching tile. The tile manufacturer Ludowici supplied a tile with the closest profile, only millimeters larger than the original, with the size difference not perceptible from the street. The new tiles' glaze closely replicated the mottled, almost smoky, finish of the aged tiles being replaced.

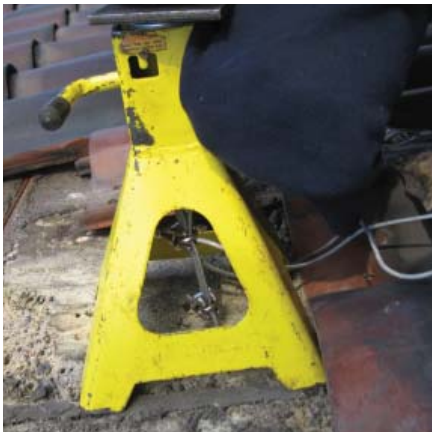
The roof tiles sit on the original gypsum concrete roof deck. This substrate is softer than materials used today, so pull tests were conducted for five different types of fasteners to determine which would work most effectively for this particular application.

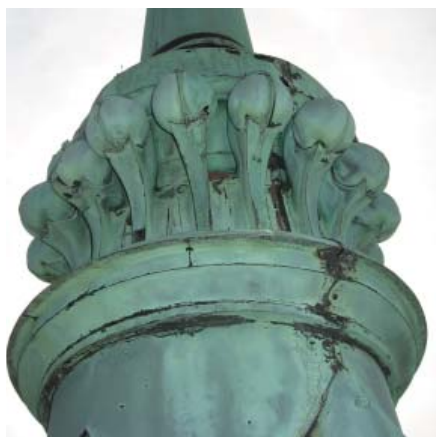
The copper spire, like many components of the building, was showing its age. The original fabric was retained where possible; elsewhere, new copper was “stitched” in. Due to the difficulty of accessing the spire, a copper patina-colored waterproofing coating was applied to minimize the possibility of future leakage. Copper was also used as roof flashing, gutter and downspouts.

Below, top: Copper spire, before. Below, bottom: Copper flashing being applied. Right, top and bottom: New copper installation in progress.

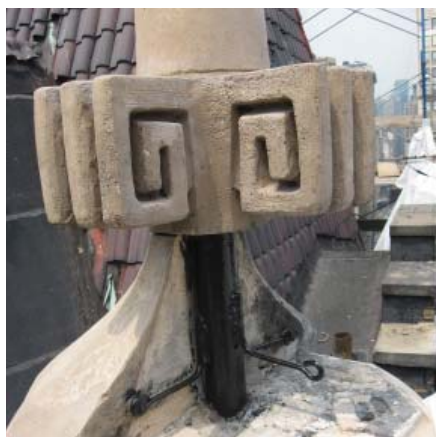
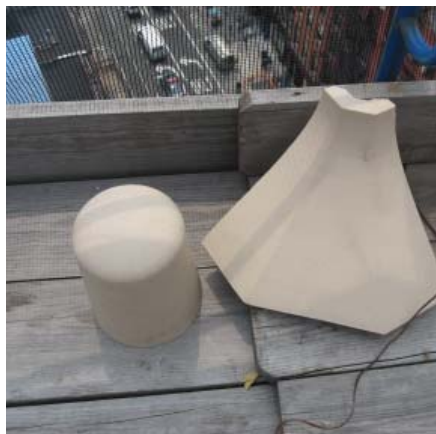
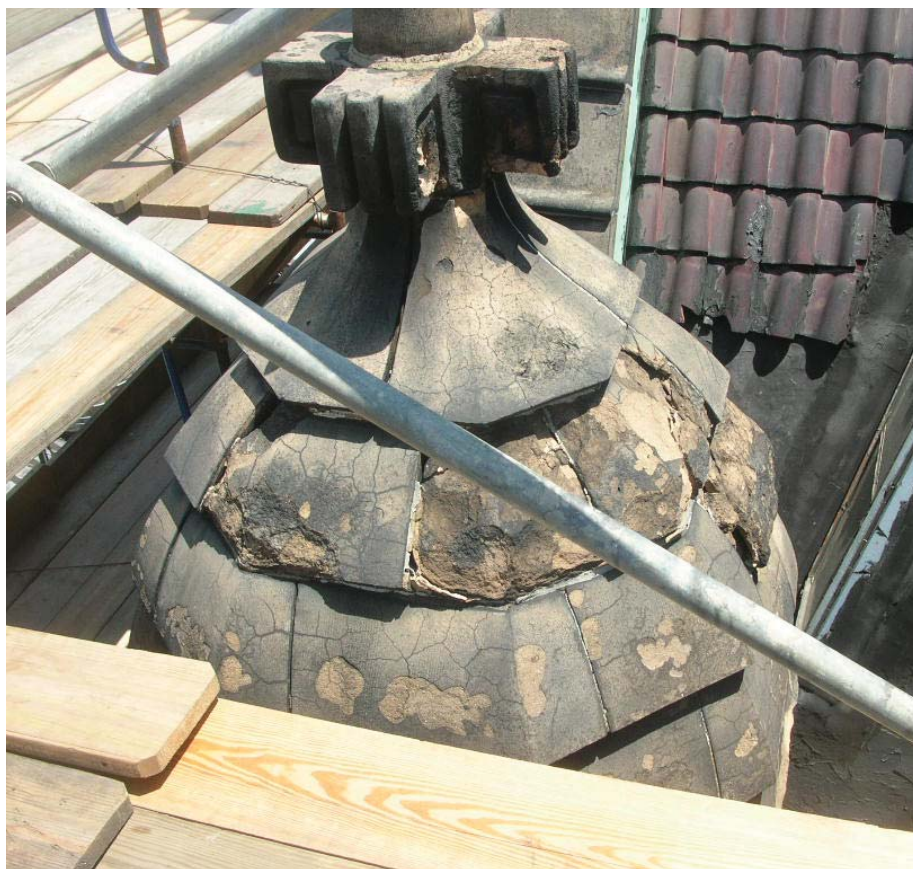
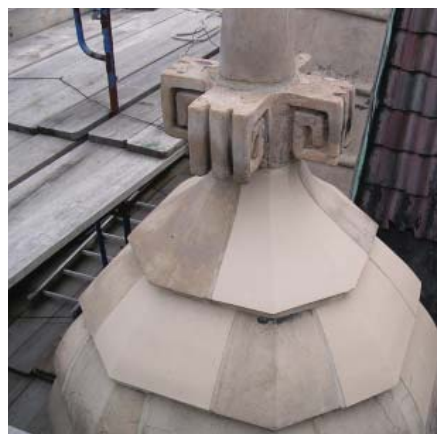
At right: Finial, before. Below, top: finial restoration in progress. Below, bottom: new cast elements. Right, bottom: Finial after.

The MacIntyre's Building exterior masonry work includes blocks, panels, polished columns and carved ornament in terra cotta, limestone, bluestone, granite and marble. Each material presented a variety of conditions. During conditions assessment, each defect was specified individually. Repair methods included pinning, patching, crack injections and replacement in kind. Whenever possible the original building materials were conserved in situ.

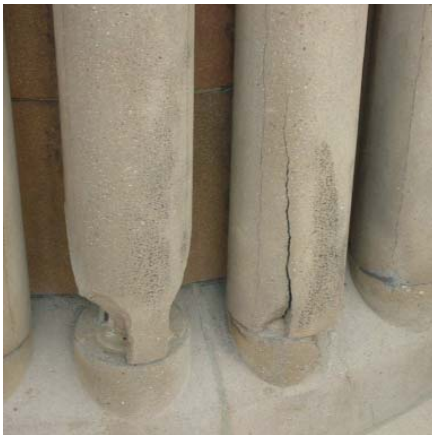
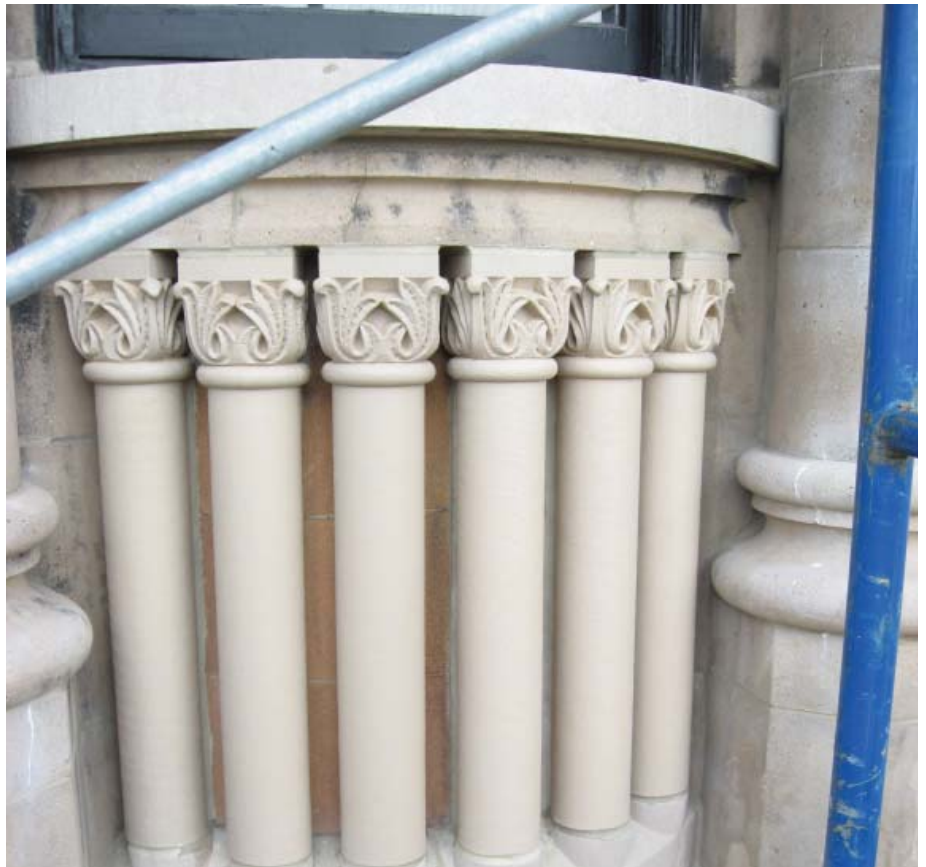
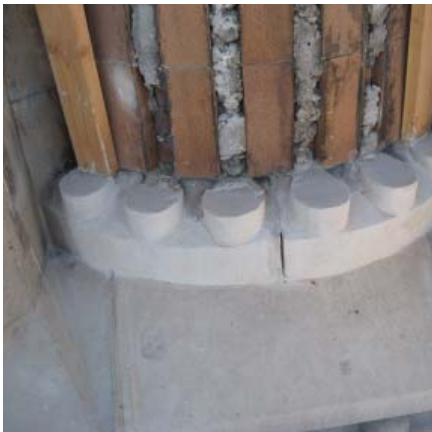
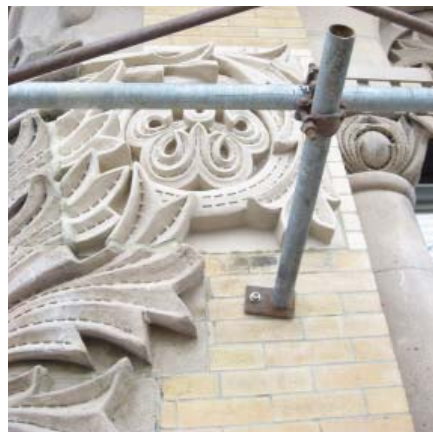
Below, top: Stone balustrade, before. Below, bottom: Balustrade restoration in progress. Right top: Balustrade, after. Bottom: Ornamental cast stone installation in progress.

In instances where stonework had deteriorated beyond repair, molds were made and new cast stone was put in place.

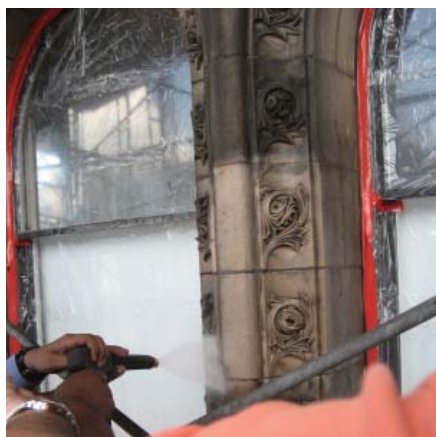
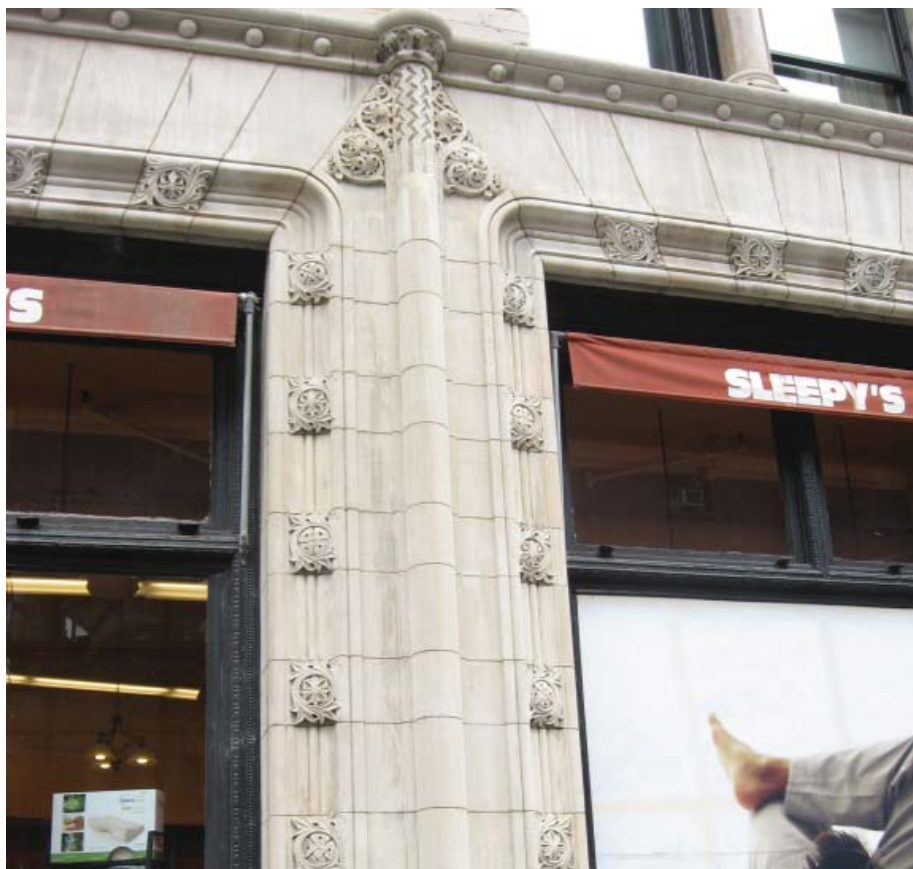
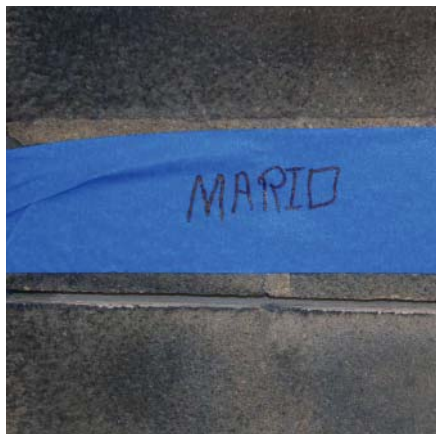
The building was completely cleaned. Under the direction of Joan Berkowitz, SUPERSTRUCTURES' Director of Conservation, conservators conducted tests on each type of material and monitored the execution. In one instance it was determined through absorption testing that some terra cotta had been partially de-glazed, so a special coating was specified that will preserve and protect the porous material from the elements.

Below, top: Limestone, being cleaned. At right: Limestone, after cleaning. Below, bottom: sample brick masonry labeled with applicant mason's tag.

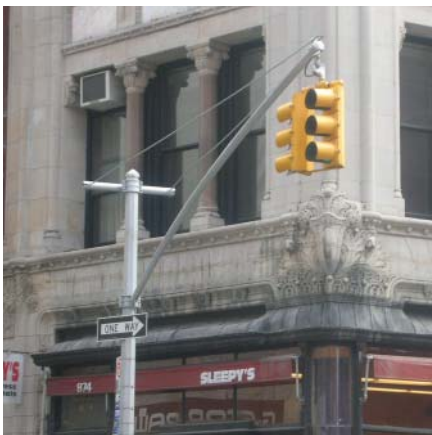
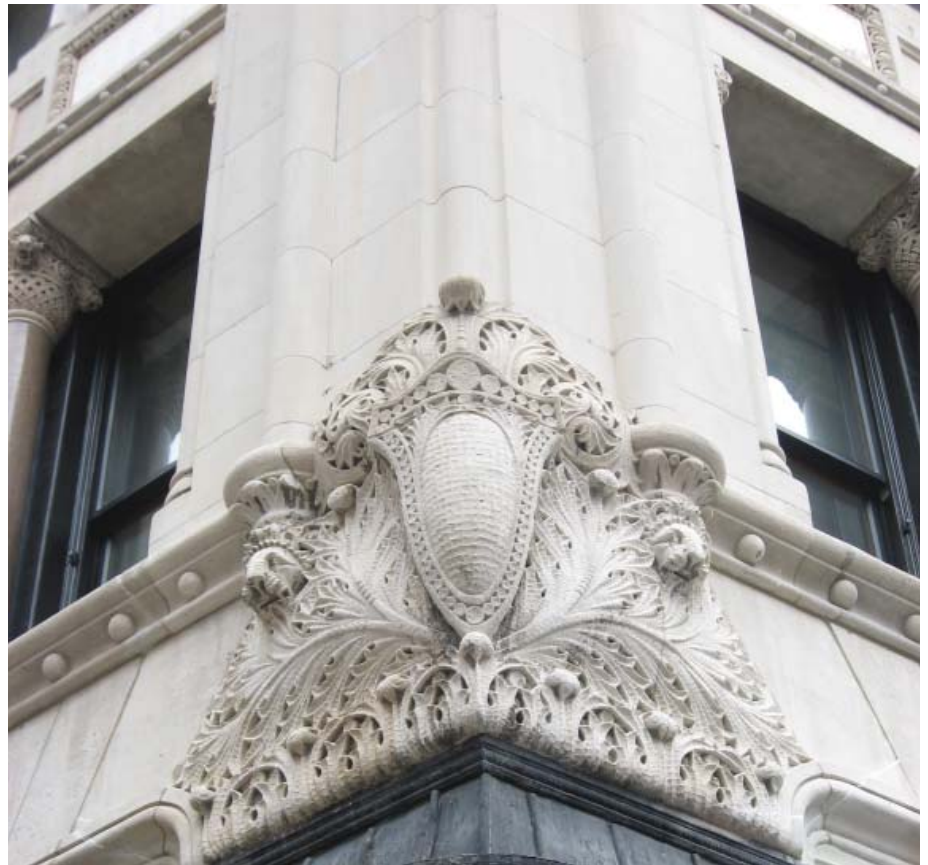
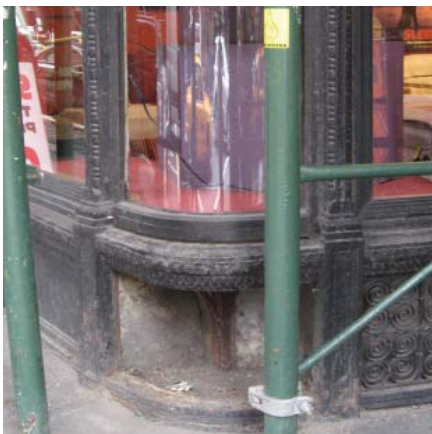
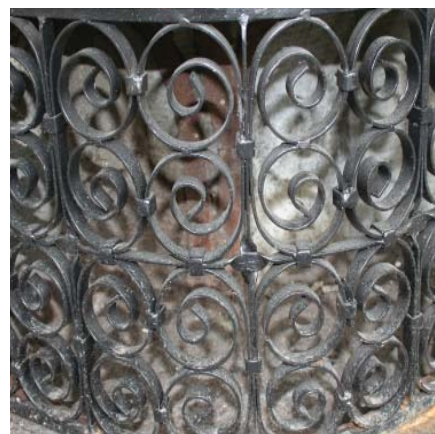
Below, top: Ornamental stone, before cleaning. At right: Stone, after cleaning. Below, bottom: ornamental grate missing. Right, below: Ornamental grate replacement.

At projects' end, the sidewalk bridge was removed and finishing touches were completed. For example, ornamental grates were fabricated to replace those that were missing.
