The New York Landmarks Conservancy Lucy G. Moses Preservation Awards Submittal

Rod Rodgers and Duo Multicultural Arts Center 62 East 4th Street New York, New York

Exterior Restoration

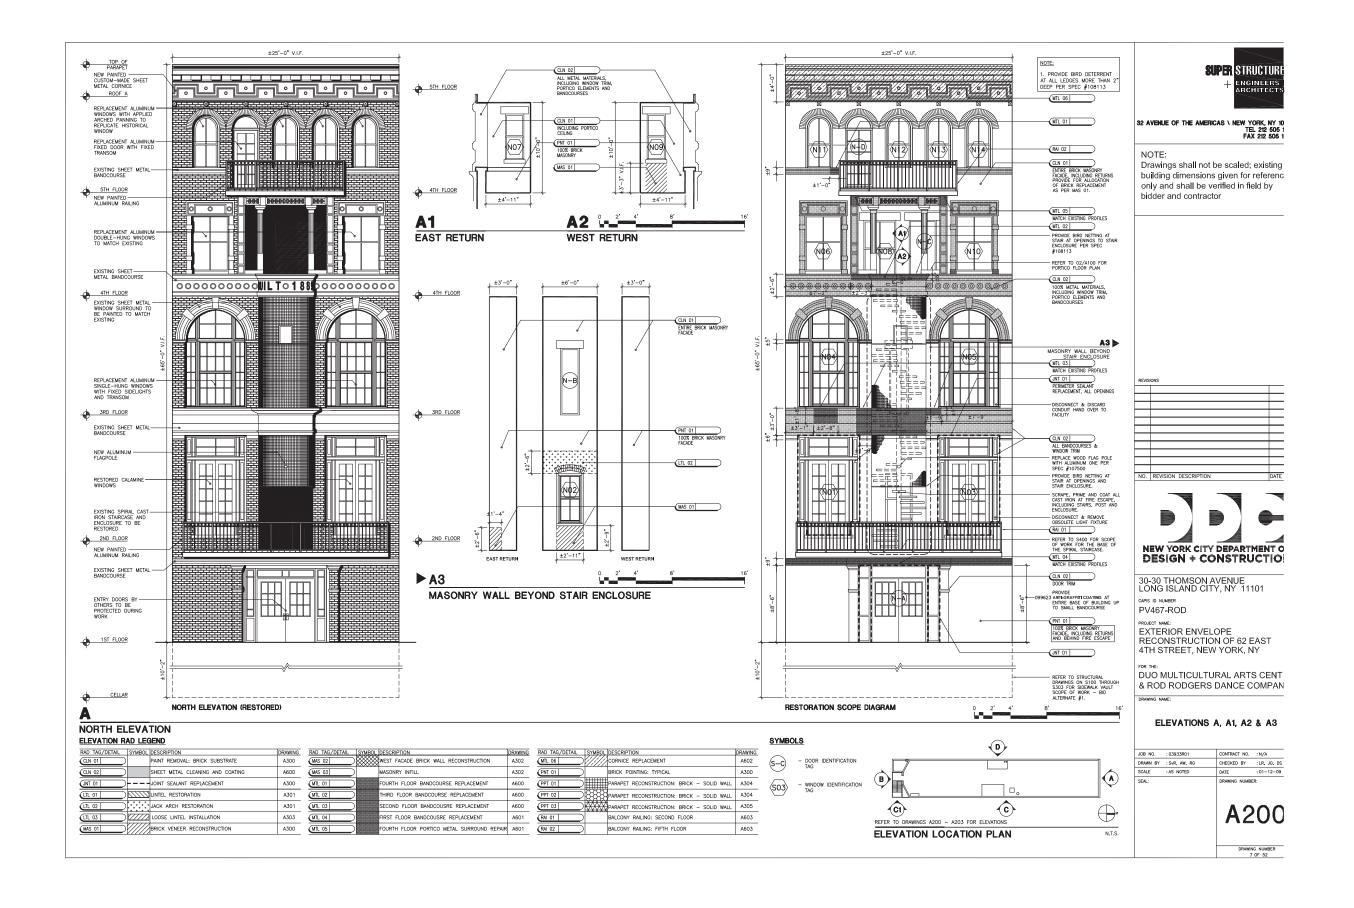
Front Spiral Staircase and Rear Fire Escape

It was discovered that the steel supporting the circular iron fire escape stairway on the front facade of the building was extremely deteriored. The entire stairway was shored up to allow for replacement of the steel. Restoration of the staircase also involved cast iron and steel repairs to cracked and missing sections, though nearly all of the original fabrication was retained. The deteriorated rear fire escape was replaced with a new steel stair. Paint analysis guided the final coating of the staircase and lattice cage, which were meticulously scraped of all existing rust.

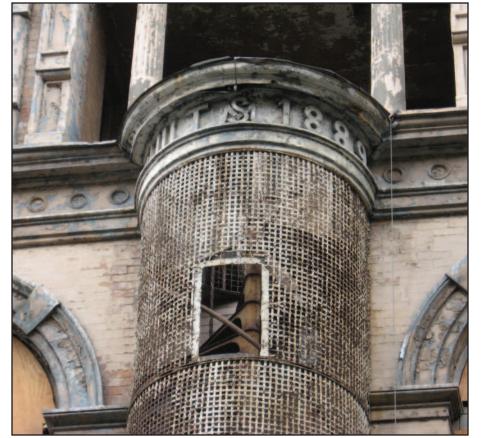
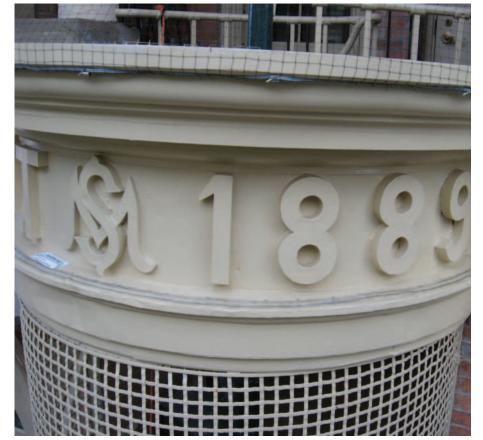
Sheet Metal Restoration and Cornice Recreation

Top, left: Ornamental sheet metal before restoration. Top, right: Ornamental sheet metal, after restoration. Bottom, left: Lintel above 4th floor columns, before restoration. Bottom, center: Lintel above 4th floor columns, after restoration. Bottom, right: New cornice installed.

The cornice missing from the top of the building was re-designed using a tax photo from 1948 (which appears on the first page of narrative above). All ornamental steel bandcores were repaired or replaced when not salvageable. Color matching was done for all the paint used on the restored and replaced sheet metal work. The ornamental detailing on the stamped metal lintel above the columns on the fourth floor logia was removed, cleaned and reinstalled on a new sheet-metal backup.

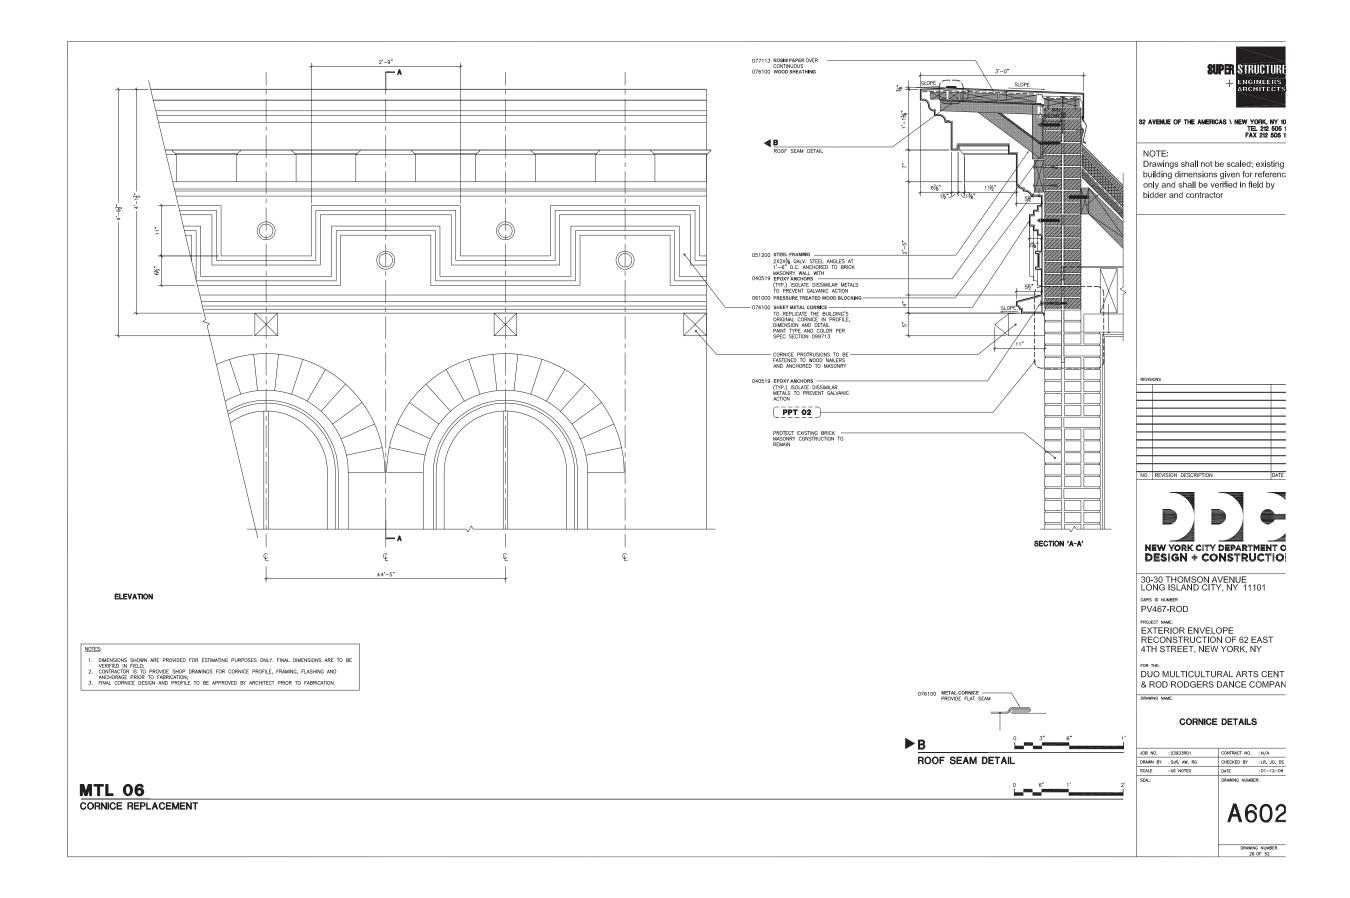
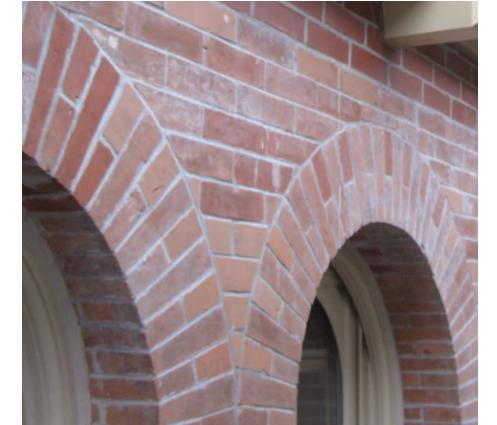
Masonry

Top, left; bottom, right and left: Brick wall before restoration. Top, right: After restoration.

The project involved stripping multiple layers of paint and coating from the brick walls. Deteriorated arches were rebuilt, defective masonry was replaced and abandoned elements were removed. Marquee boards were built into the masonry on the ground floor. Mockups were done as part of the process of re-finishing the brick masonry to achieve the best possible brick and mortar match.
