The New York Landmarks Conservancy
Lucy G. Moses Preservation Awards
Submittal

Jefferson Market Library
425 Avenue of the Americas
New York New York

Exterior Renovation

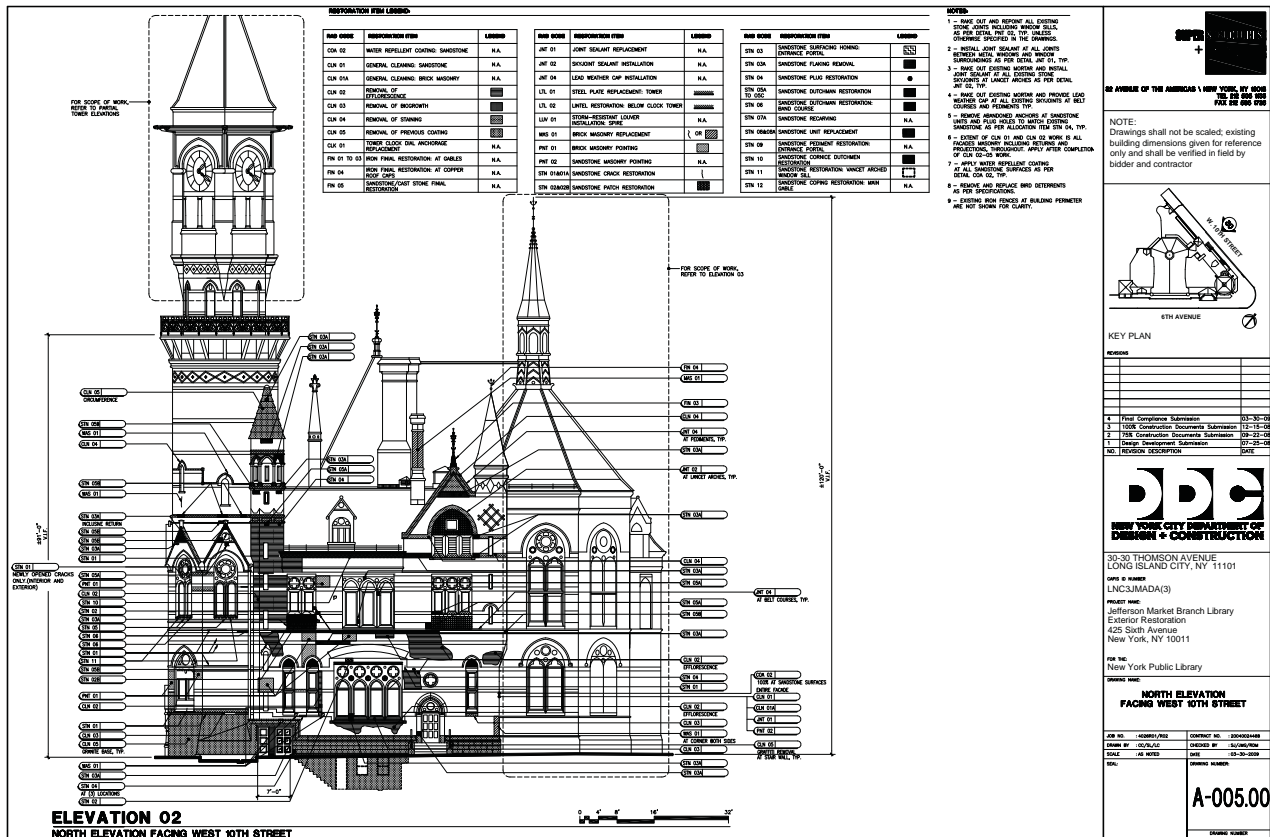
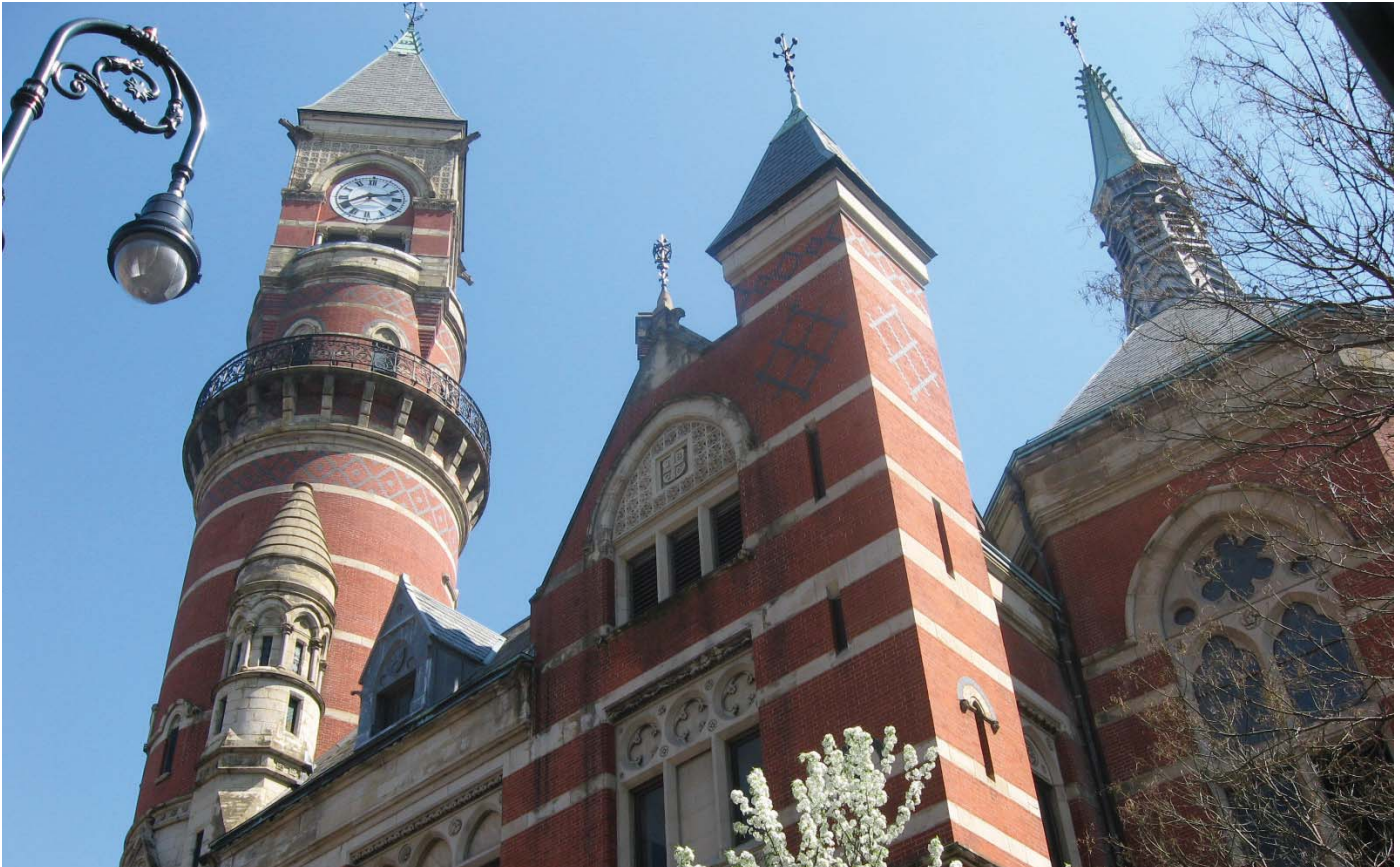
425 Avenue of the Americas prior to restoration

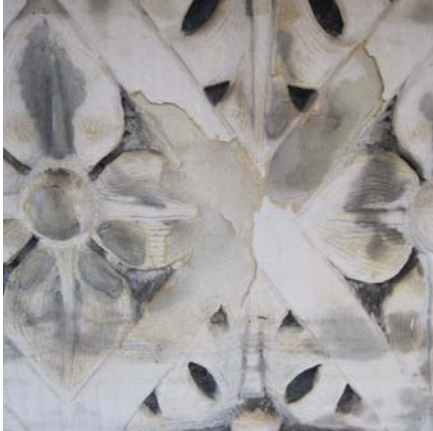
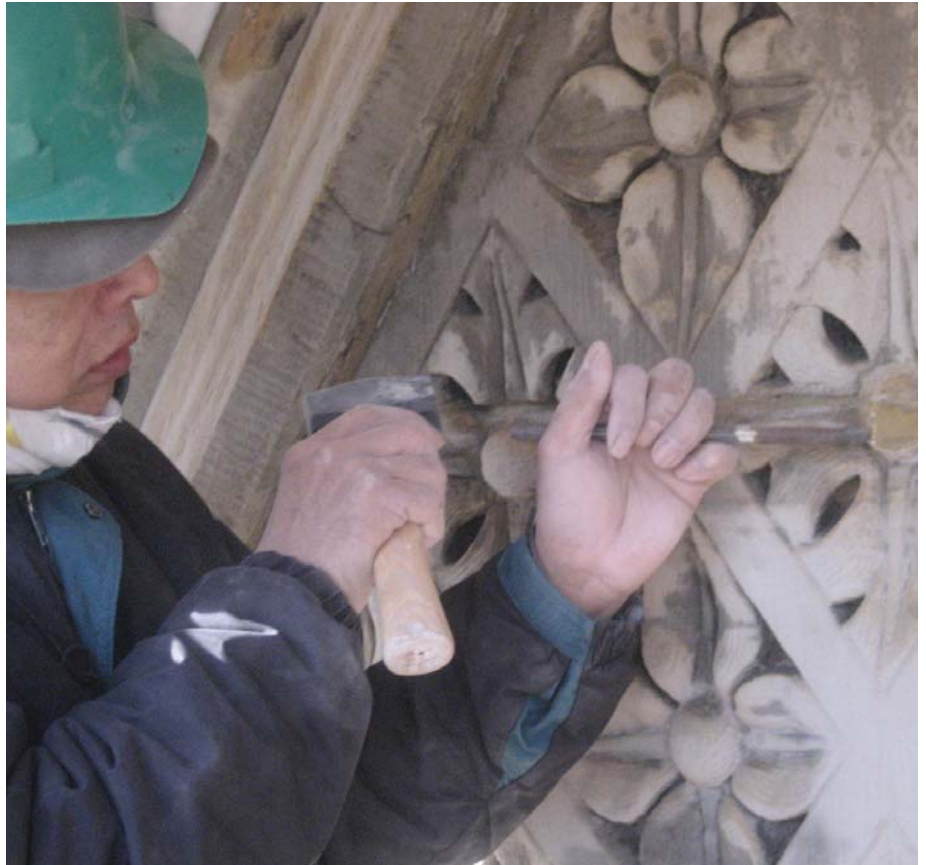
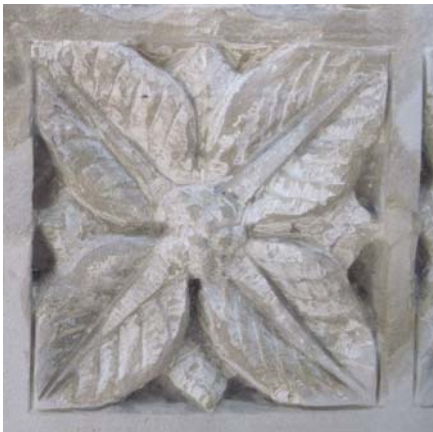
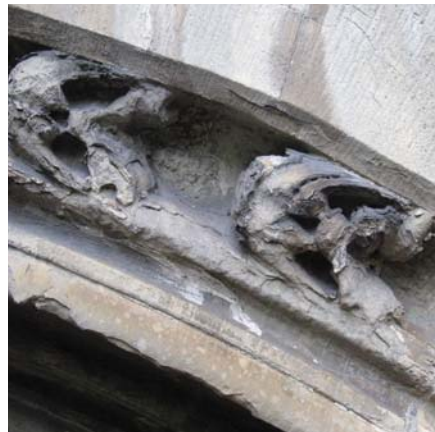
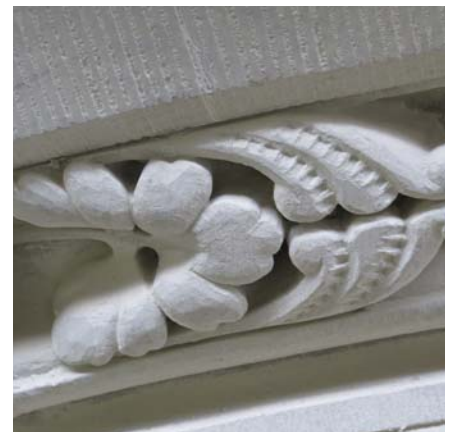
Stone Ornamentation

One of the glories of the Library's façade is the extensive Ohio sandstone ornamentation. The sandstone was found to be crumbling in many places due to age, weathering, and pollution. Though the condition of the stone varied widely, with some in perfect condition after 140 years, even some of the sandstone that did not appear deteriorated crumbled away when tapped. The goal was to keep the original material wherever possible, so extensive re-carving was done in place by skilled artisans to match the original as much as possible and preserve the sense of definition. Where stone replacement was deemed necessary, for instance the City seal, replacement pieces were carved out of the same Ohio sandstone used originally.

Top left: Deteriorated stone before restoration. Bottom left: Stone ornament after re-carving. Top right: Re-carving stone in place. Bottom center: Deteriorated stone before. Bottom right: Newly carved stone ornament replaces highly eroded original carving.

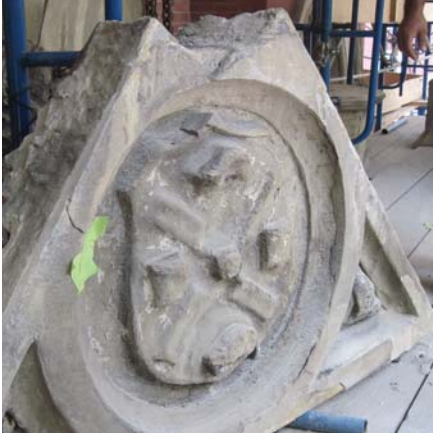
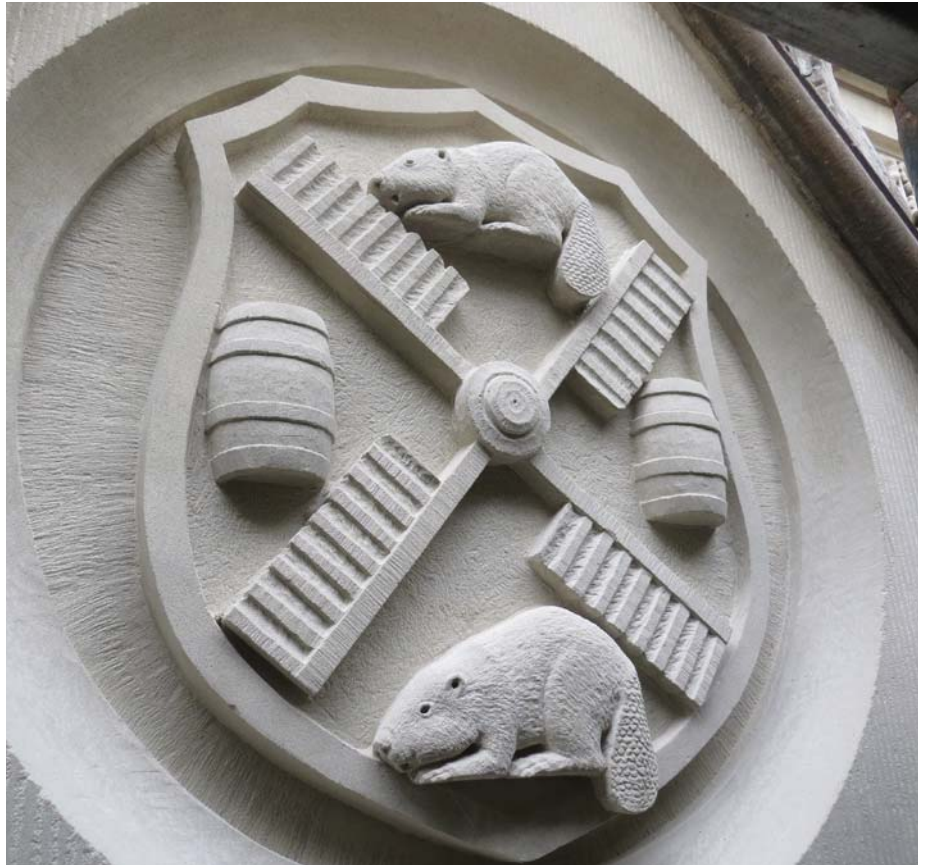
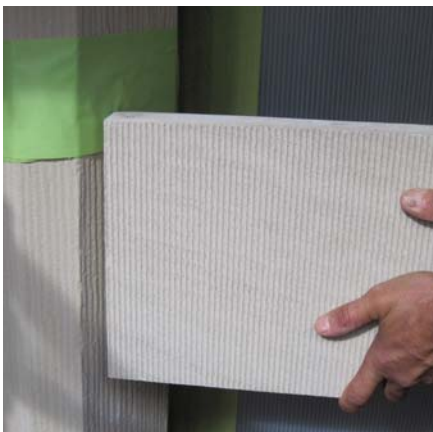
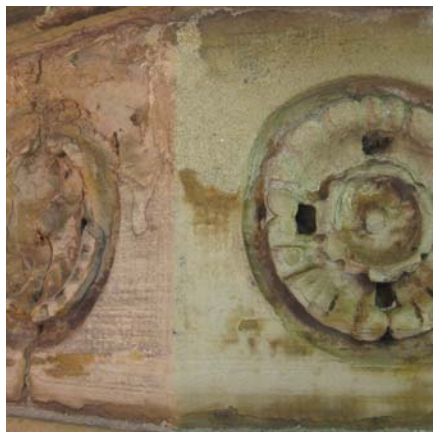
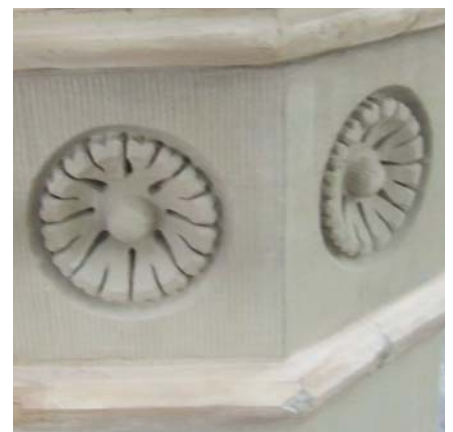
Stone Ornamentation (continued)

Retooling and honing addressed the prevalent flaking of ashlar stone. Dutchmen were used where spalling was more substantial. Dozens of cleaning techniques were tested for removing the existing staining on the building's stonework. On analysis the staining was determined to be a combination of ferrous oxide leaching (rusting) from the interior of the stone, staining from pollutants and possibly previous conservation treatments. Much of the staining was removed but it was not possible to remove all of it.

Top left: Worn sandstone gable ornament before. Top right: Replacement sandstone gable ornament. Bottom left: Matching tooled sandstone. Bottom center: Sandstone ornament before. Bottom left: Sandstone ornament after.

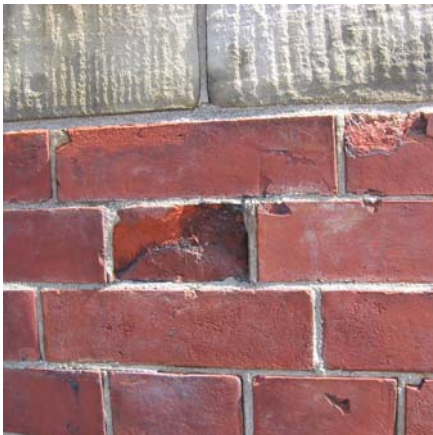
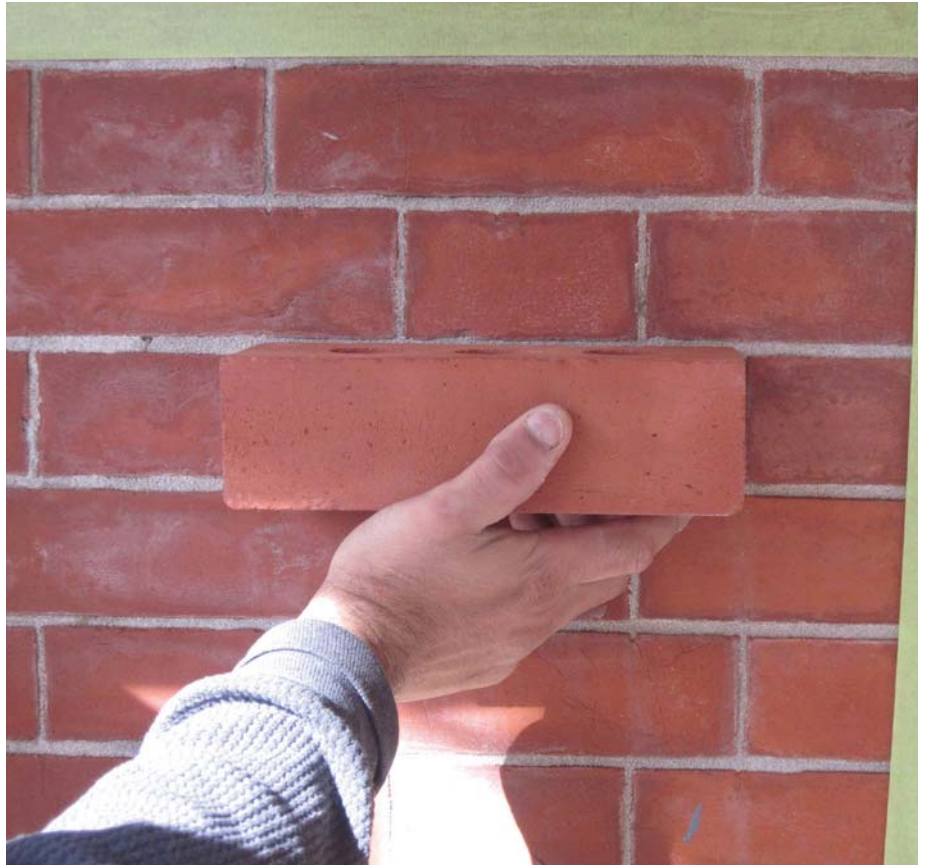
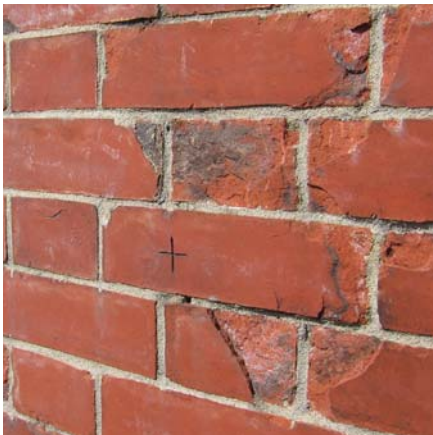
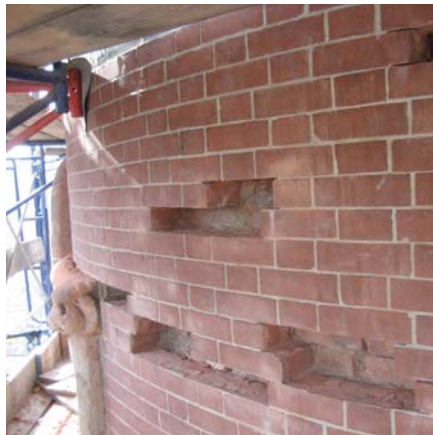
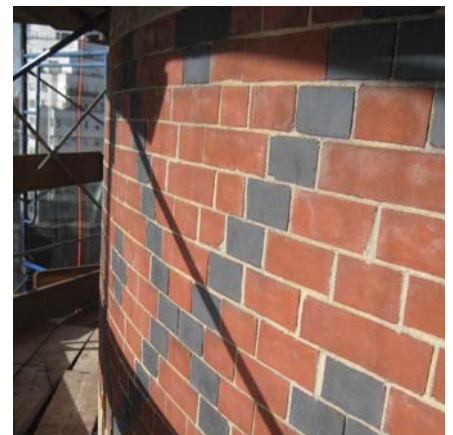
Brick Masonry

One of the signature design elements on the façade of the Library is the deep-red Philadelphia brick which provides appealing contrast with the light-colored sandstone ornamentation. Brick masonry restoration included spot repointing and cleaning of the brick. Badly deteriorated bricks were replaced in kind.

Top left: Deteriorated brick before. Top right: Matching brick in kind. Bottom left: Brick spalling. Bottom center: Brick on tower during replacement. Bottom right: Brick after.

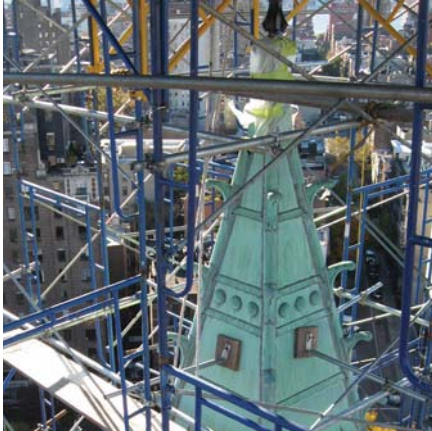
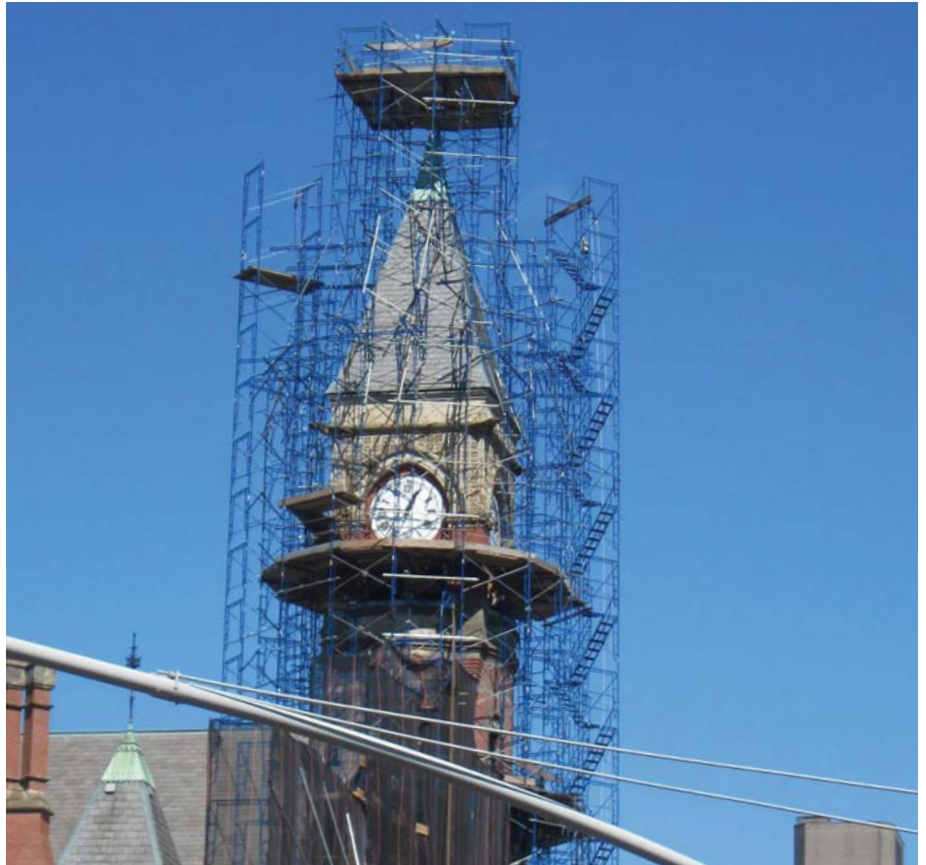
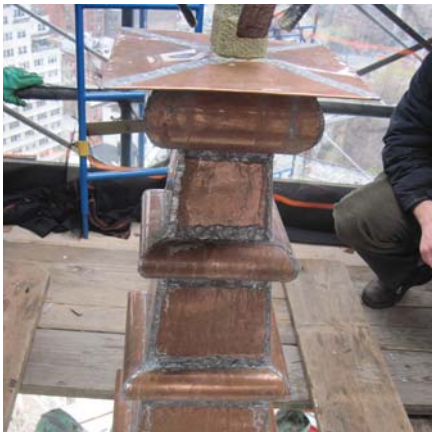
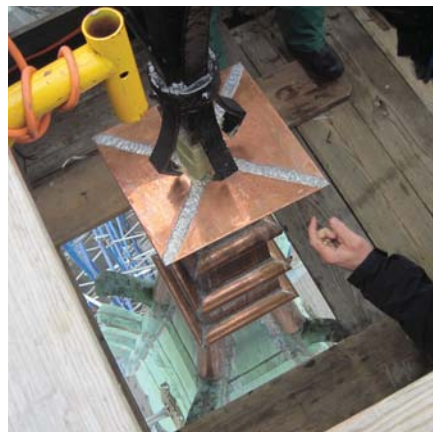
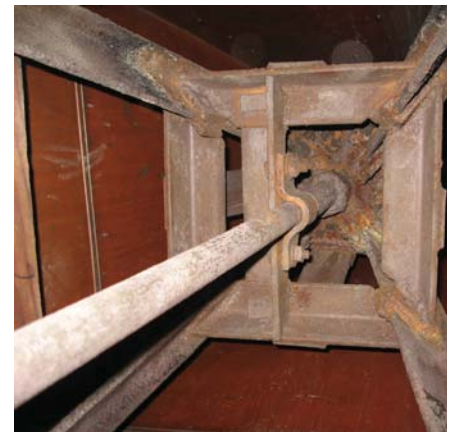
Structural Engineering

The project addressed several structural issues. Among them was the main tower's finial which, due to structural deterioration, was not properly supported to resist wind loads. In order to secure it, copper cladding at the top of the slate roof had to be opened up so that the finial could be tied back to the tower substructure. Accessing the work was its own design challenge: an elaborate pipe scaffolding was erected around the top of the tower, supported by the tower itself.

Top left: Tower cap during restoration. Top right: Scaffolding allowing work to be done on tower cap and finial. Bottom left and center: Newly fabricated copper finial on tower cap during restoration. Bottom left: Interior of tower cap.

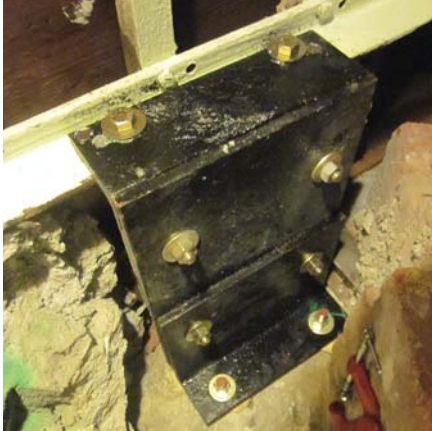
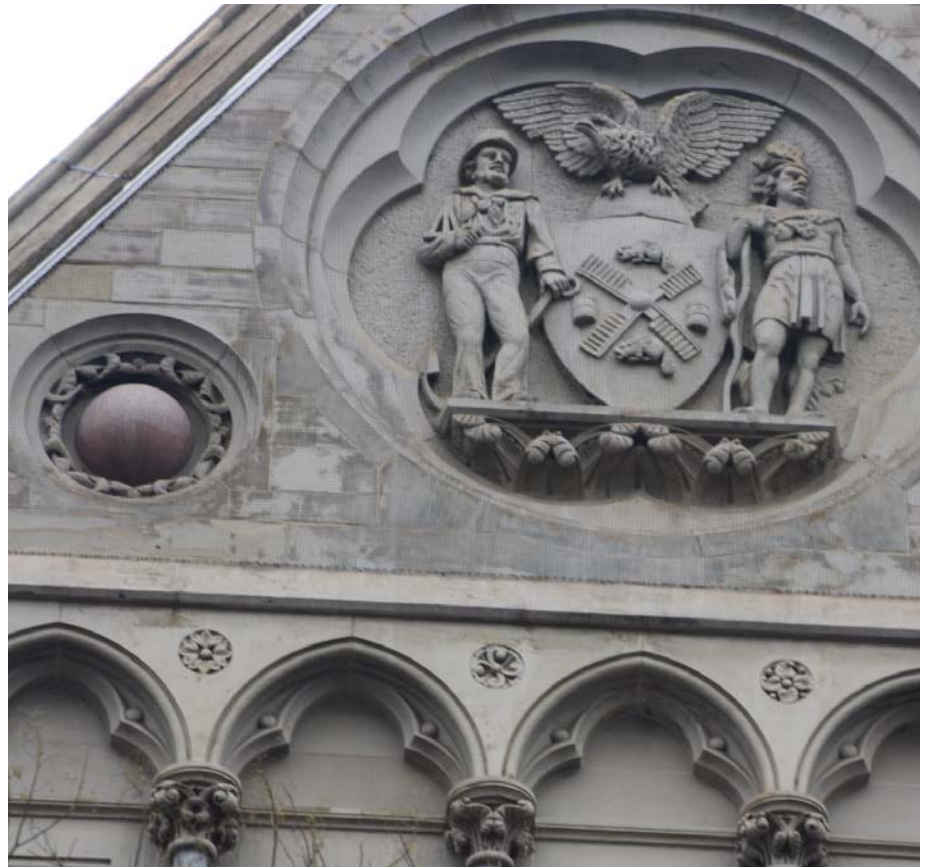
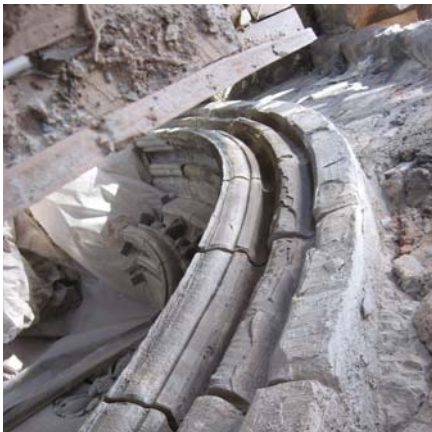
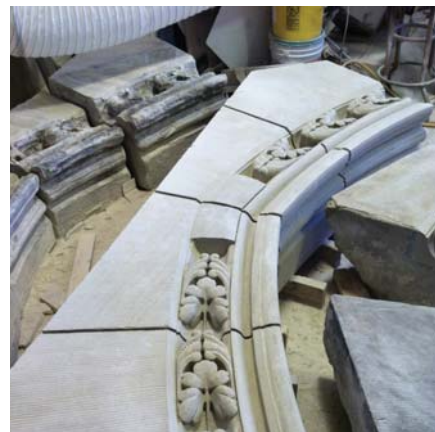
Structural Engineering (continued)

The main gable at the east elevation had displaced over time. Stone anchors and tension rods were installed to ensure the gable's and roof diaphragm's structural stability. The entryway gable had also displaced over time due to lack of proper ties to the building substructure. The scope included rebuilding the displaced stonework and installing structural ties.

Top left: Main gable being strapped to substructure. Top right: Main gable after stabilization. Bottom left and bottom center: Entry gable during reconstruction.

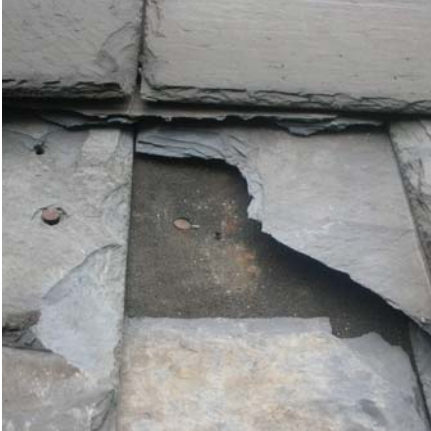
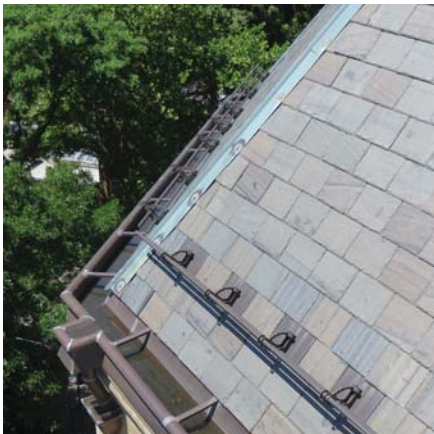
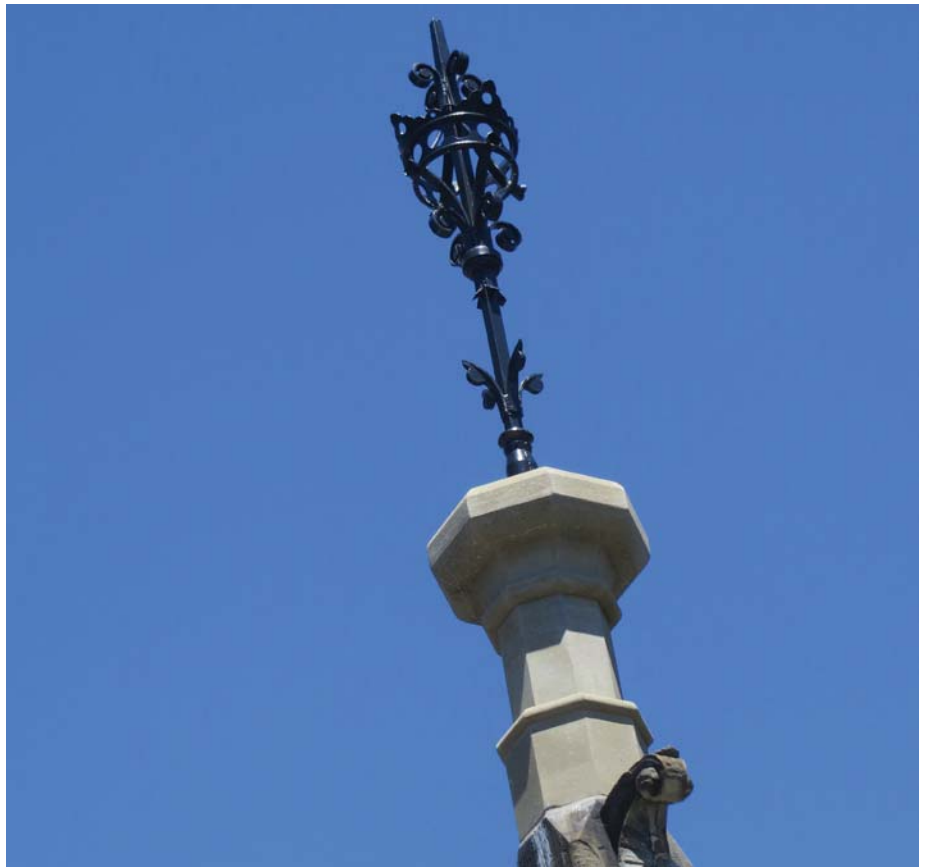
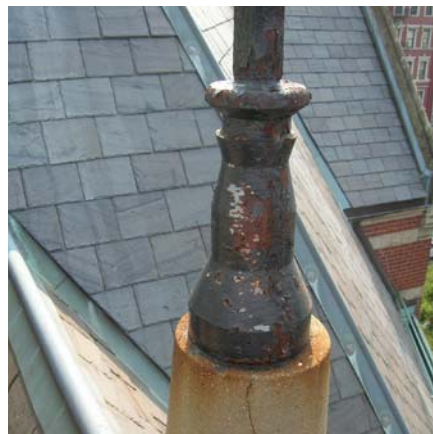
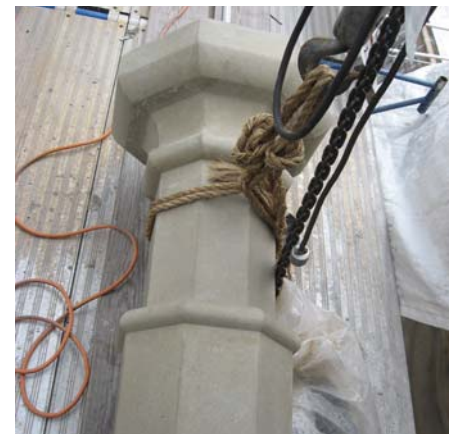
Roofs and Finials

Spot repairs to the slate roof were performed, including replacing missing and broken slates throughout. The existing flat sheet metal roof was replaced with a new flat-seam copper roof.

The finial bases were spalling and breaking up because of the corrosion of the finial ironwork. New stone blocks were installed and the finials were re-set. Finials were restored as necessary off site. The drawing on the following page details additional repairs to sandstone and iron elements of various of the many finials on the building.

Top left: Slate roof before. Bottom left: Slate roof after. Bottom center: Finial before restoration. Bottom right: Restored finial base. Top right: Finial after.

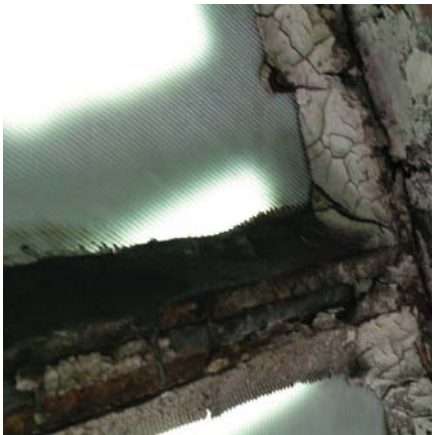
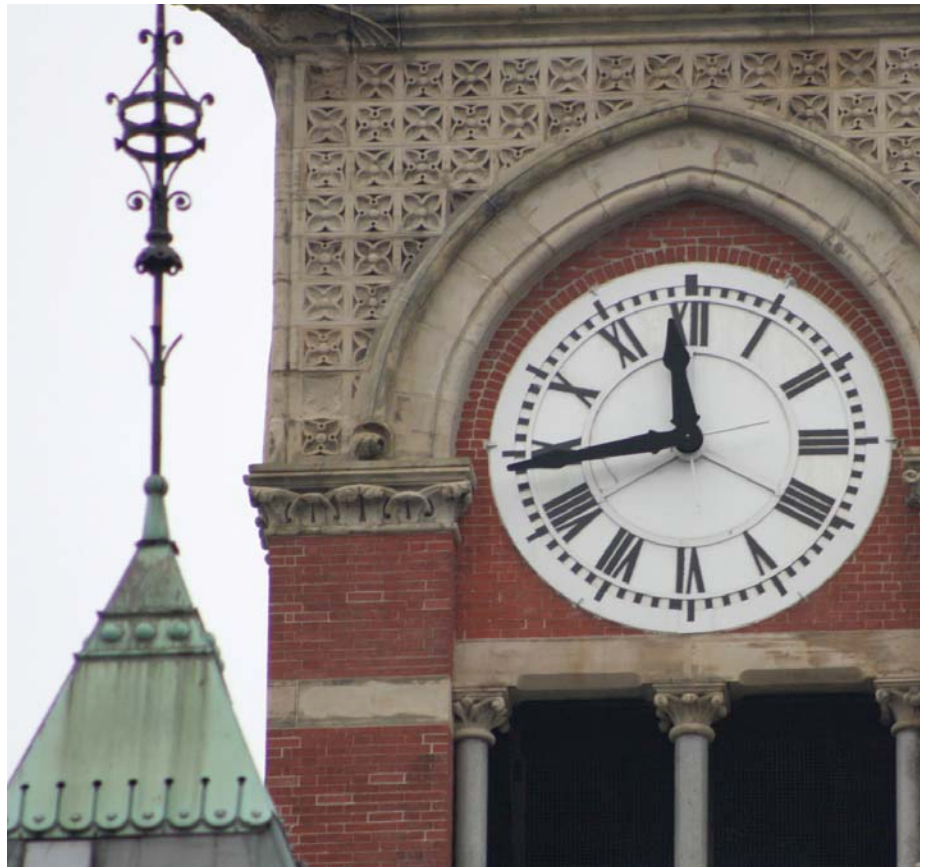
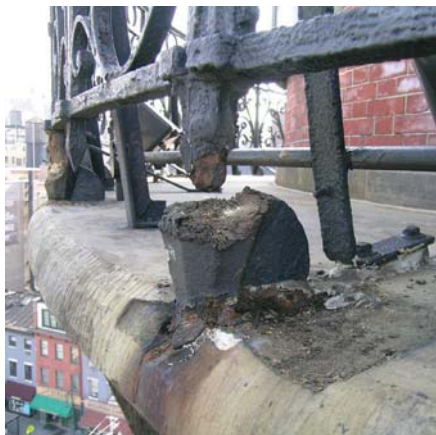
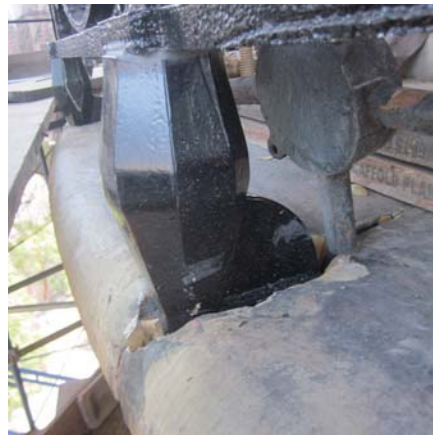
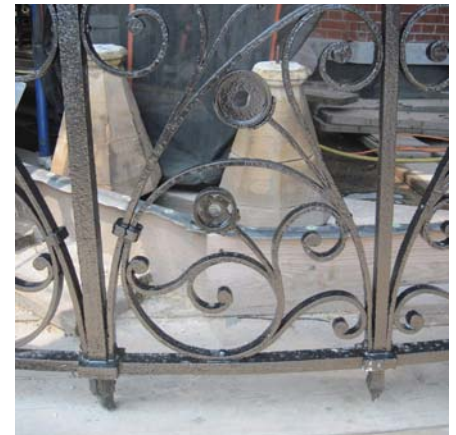
Tower Railing and Clock Faces

The wrought iron balcony railing on the tower was removed and repaired offsite by an ironworker and then remounted.

Restoration and repair of the clock faces was carried out by a specialist in clock restoration. In the 1960s it was a campaign to get the clock running again which initiated the eventually successful movement to save the building itself.

Top left: Detail of clock face interior before restoration. Top right: Clock face after restoration. Bottom left: Deteriorated wrought iron railing. Bottom center: New supports in restored railing. Bottom right: Railing after.

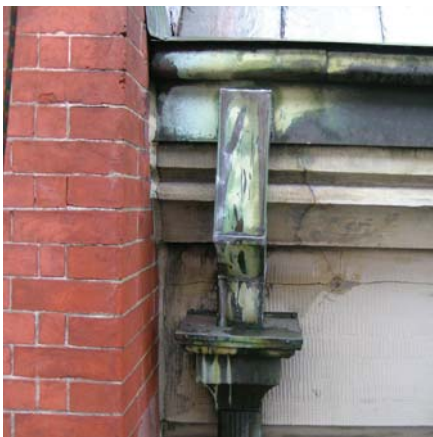
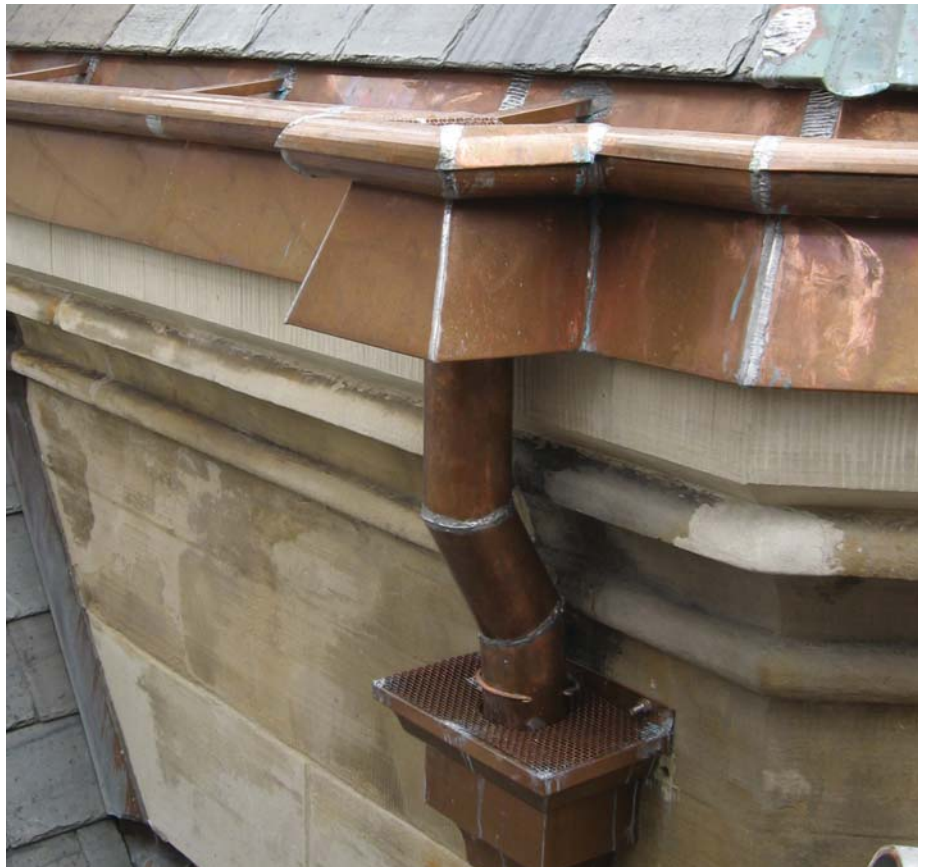
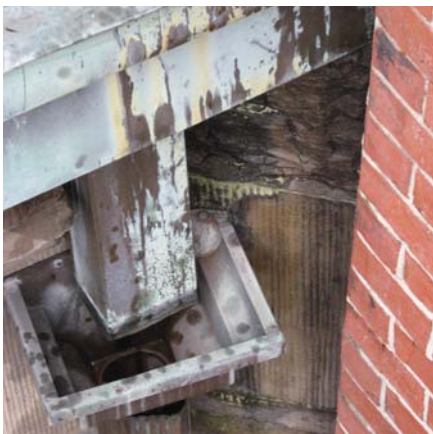
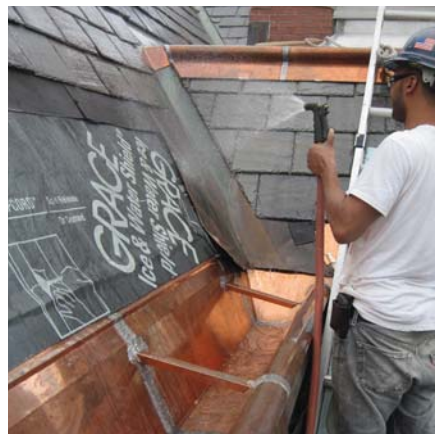
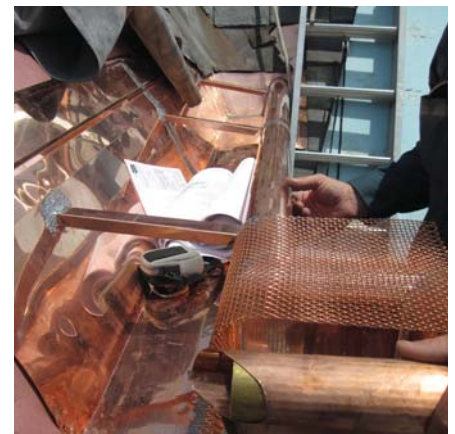
Gutters and Leaders

The existing gutters and leaders (downspouts) were highly deteriorated. They were replaced in kind with new copper. In some cases the interior leaders were experiencing ongoing leaking and were deteriorating the building's interior stonework, so leaking leaders were removed to the outside of the building.

Top left and bottom left: Gutters and leaders before. Bottom center and right: New copper gutters during installation. Top right: Gutter and leader after.

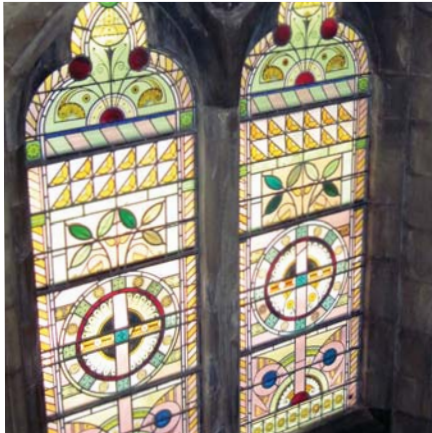
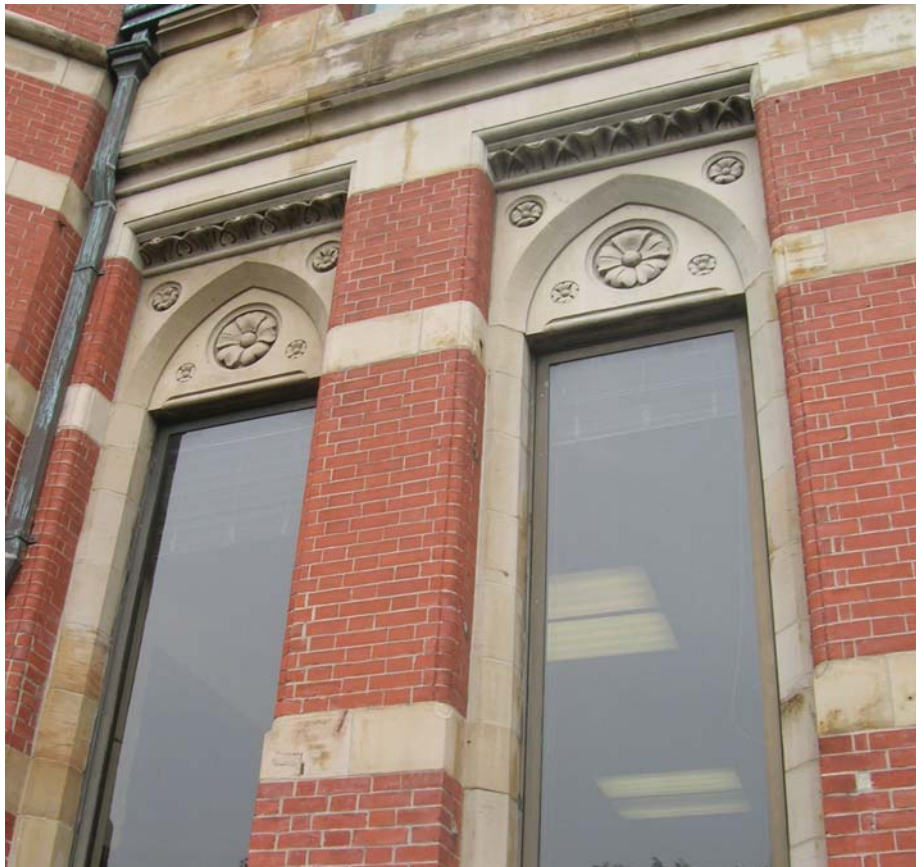
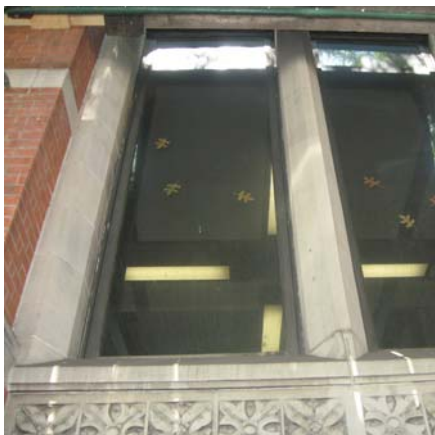
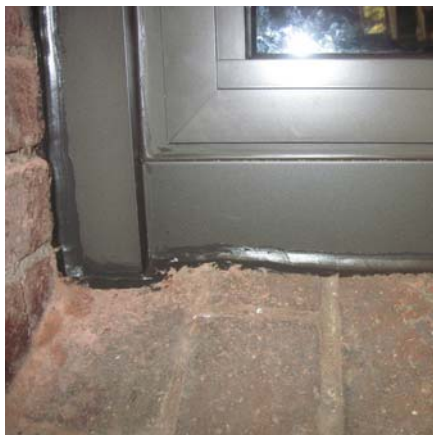
Windows

The building's aluminum frame windows represent significant alterations that were made to the building in the 1960s by architect Giorgio Cavaglieri when he converted the building from a derelict courthouse building to a branch of the NYC Public Library. The intent of the current restoration was to preserve the windows rather than replace them. Some maintenance was required on several of these very large, substantial, solidly built windows to restore operability, as they had not been rehabilitated in quite some time. At the basement level aluminum windows were replaced to match the existing. Stained glass windows affected by the stone mullion repairs were removed, restored off site and reinstalled at completion of stone restoration work.

Top left: Stained glass windows after restorations. Top right, bottom left and center: Aluminum windows dating from the 1960s were repaired as necessary.
