The New York Landmarks Conservancy  
Lucy G. Moses Preservation Awards  
Nomination

St. Paul's Chapel  
209 Broadway  
New York, New York

Exterior Restoration

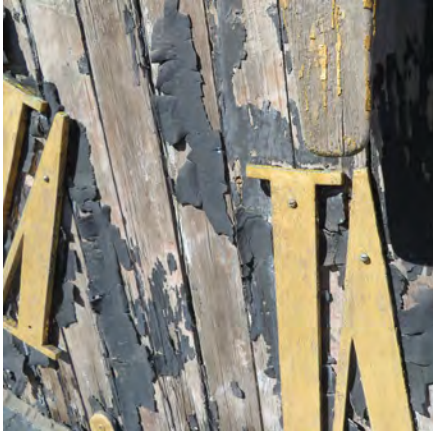
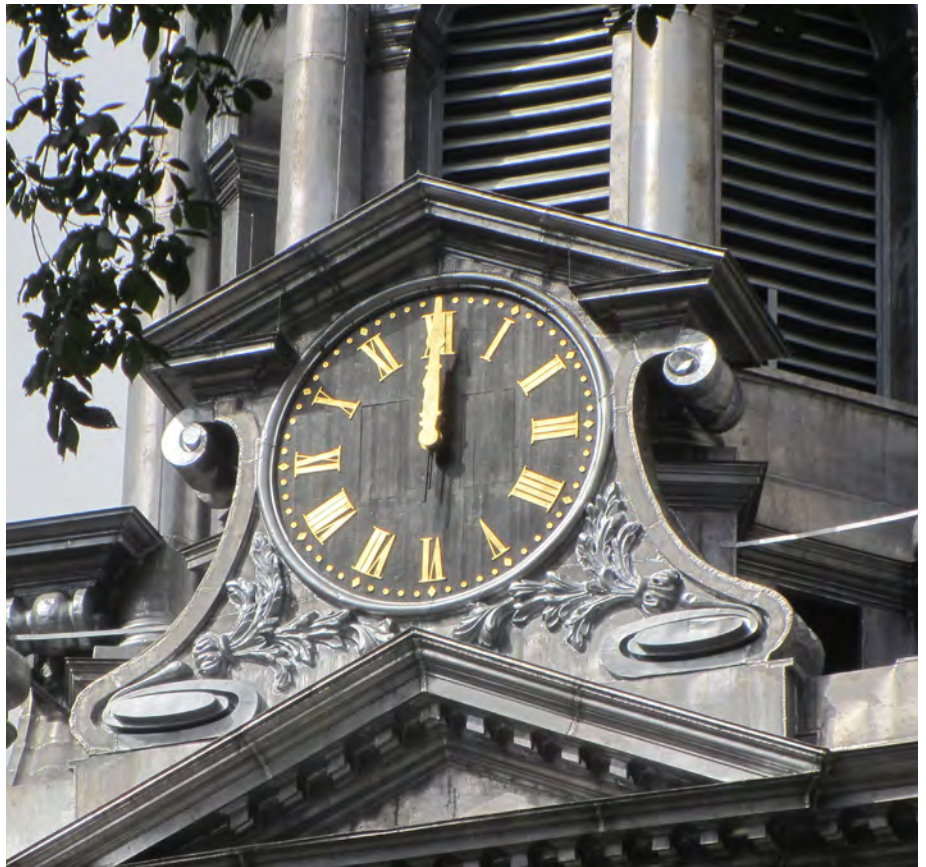
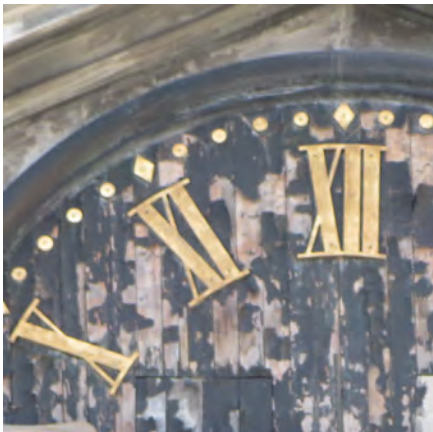
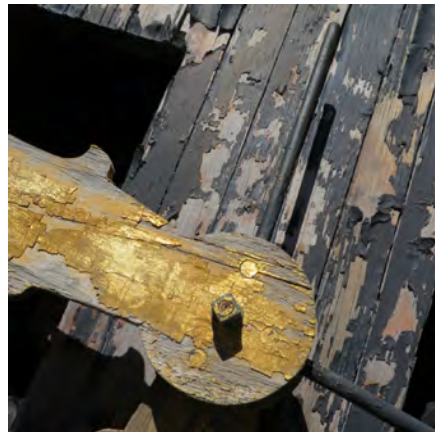
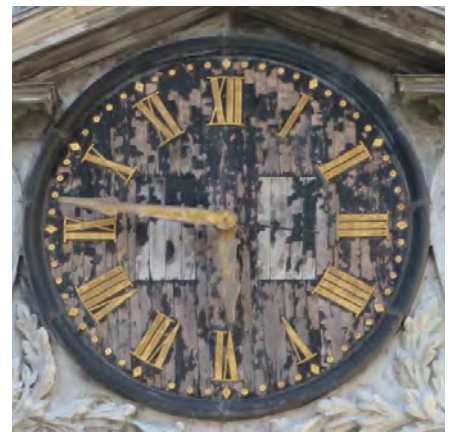
The steeple clock was no longer functional and its four faces exhibited various amounts of deterioration, some severe. Existing tongue and groove boards on three clock faces were repaired using a wood consolidation system. Prior to consolidation, the wood was cleaned and primed. All the wooden tongue and groove slats on the eastern clock face were replaced with cedar slats. SUPERSTRUCTURES' conservator conducted research and analysis to determine the appropriate wood species and grain. All access doors on all elevations were replaced with cedar. The clock hands at all clock faces were replaced with cedar clock hands (4 short and 4 long hands), then gilded. The other brass elements (numbers and minute track

*Top left and bottom row: Clock faces before restoration: Top right: Clock face after restoration.*

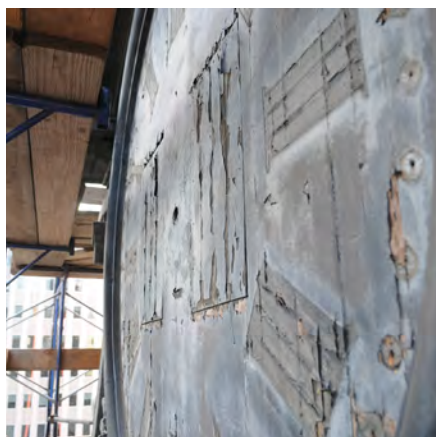
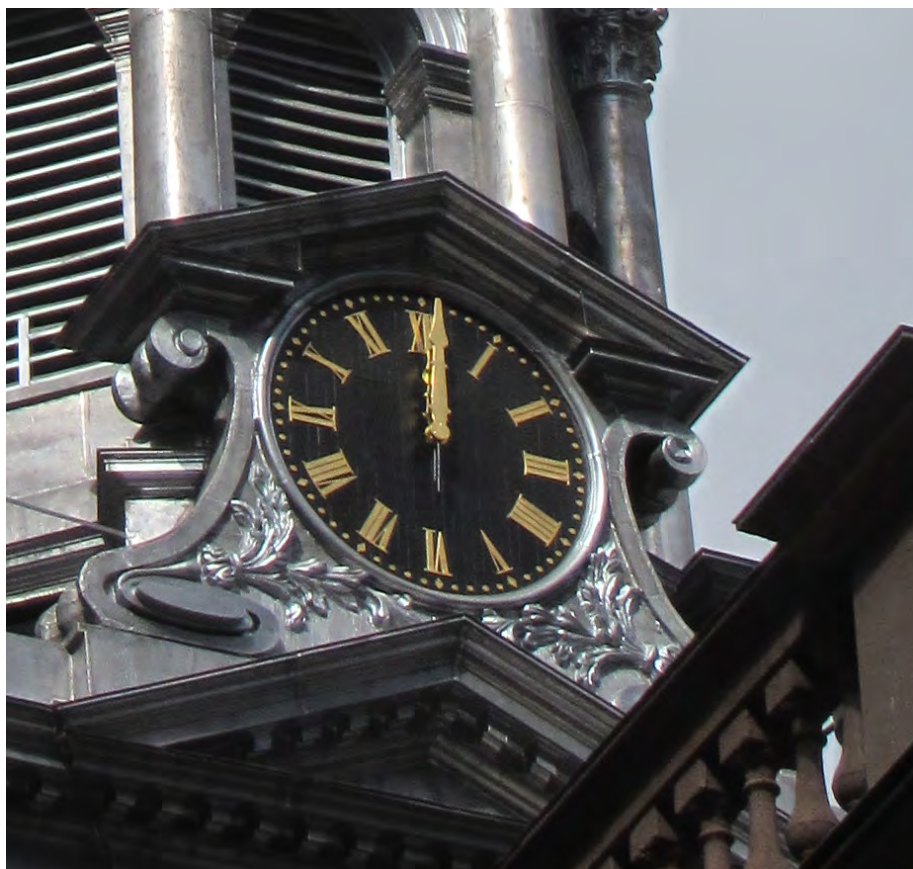
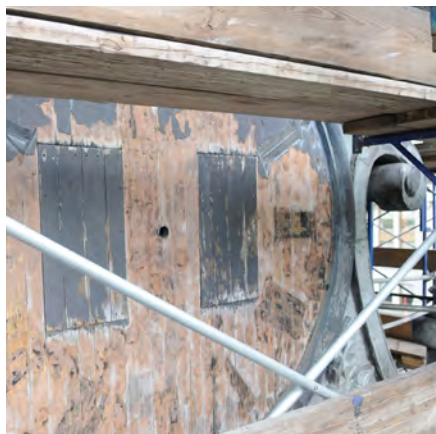
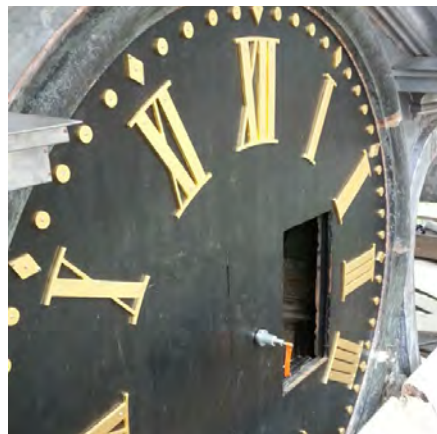
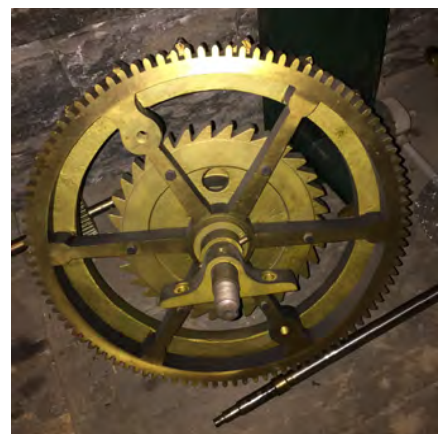
elements) were cleaned, treated for corrosion, primed, and gilded with gold leaf.

The mechanics of the clock were replaced. A new digital system was installed by Elderhorst Bells, Inc. The bells were maintained and some of the original mechanical elements were turned over to the Owner for preservation as artifacts.

*Top and bottom left, bottom center: Clock faces during restoration. Top right: Restored clock face. Bottom right: Parts of former clock mechanism retained for parish archives.*

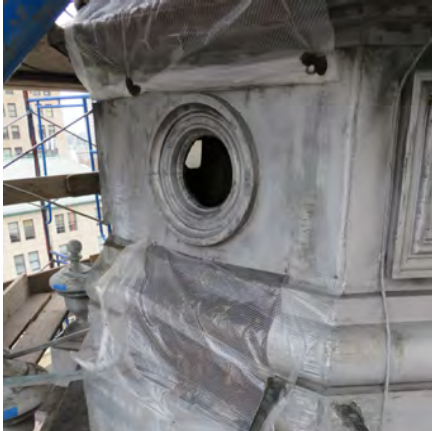
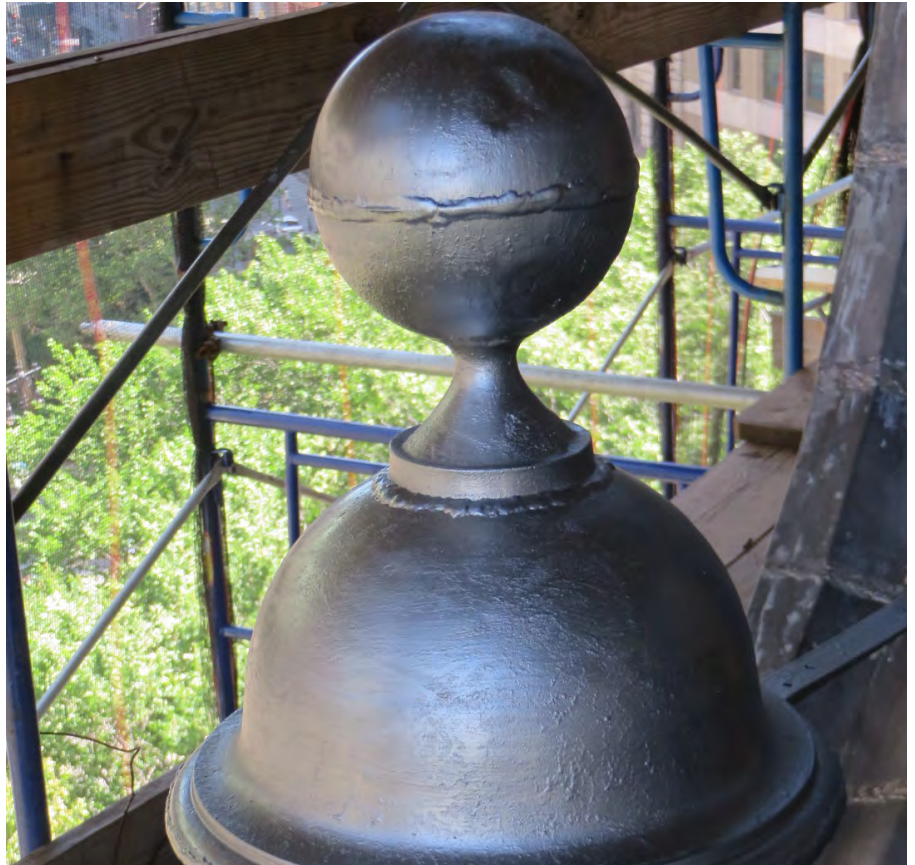
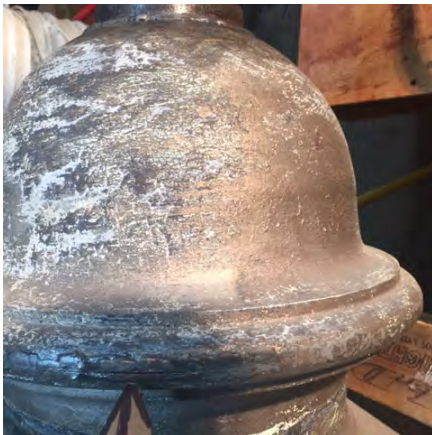
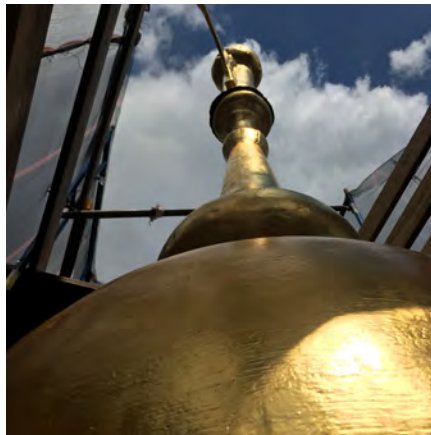
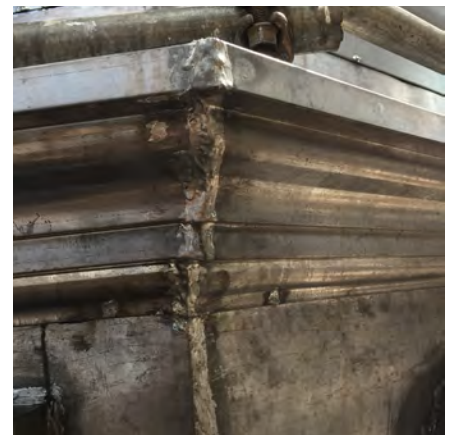
The cladding of the steeple is lead coated copper. The original intent was to replace all the cladding but on investigation it was determined that much of it was in good condition and many decorative elements were deemed worthy of preservation. The upper portion of the steeple cladding was retained and restored by tightening seams and resoldering open joints as appropriate. The lower portion of the roof was replaced and coated to match the original lead-coated copper appearance. Minor damage on the weathervane was repaired and the entire assembly was gilded.

*All photos on this page: Steeple cladding decorative elements and gilded weathervane during restoration. Following page: Steeple after restoration.*

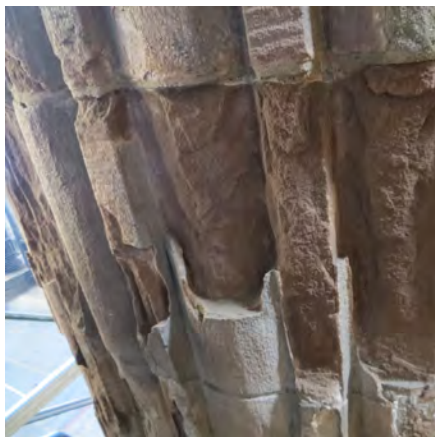
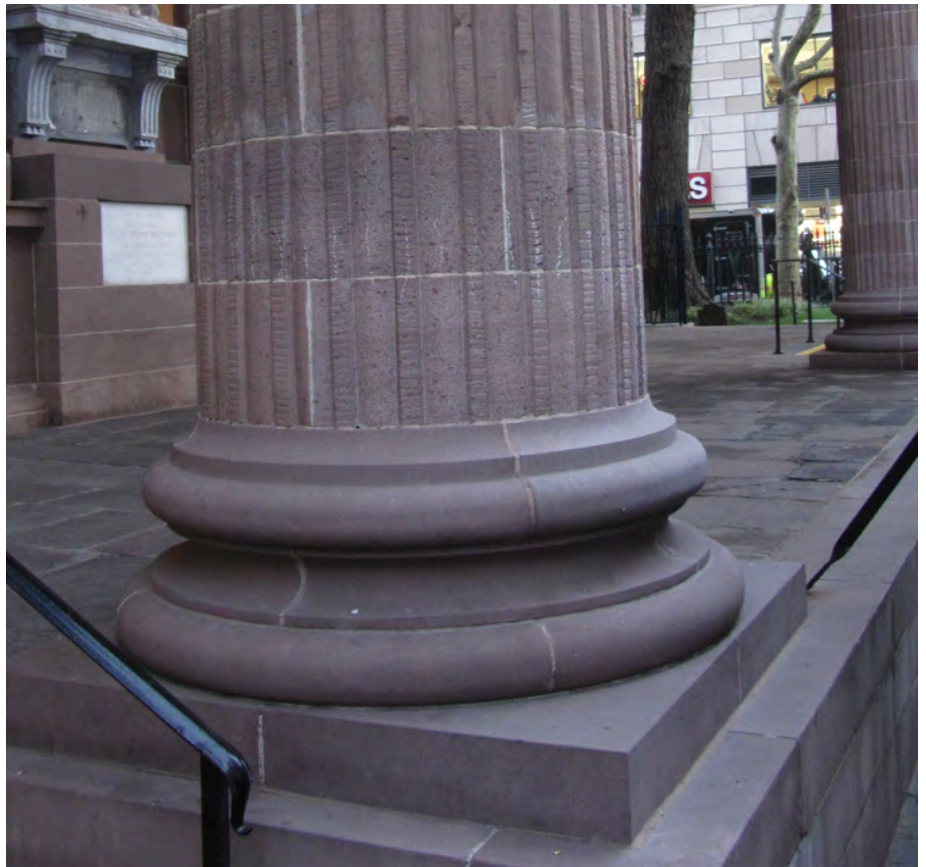
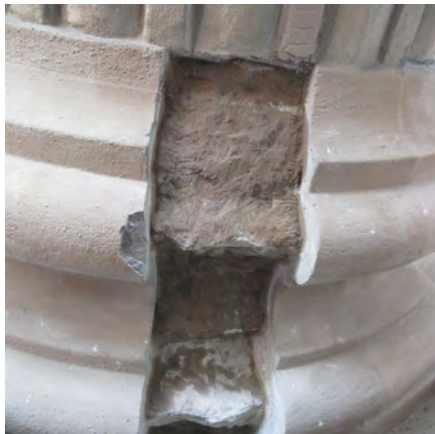
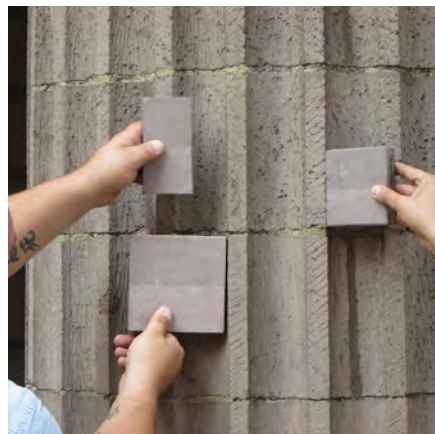
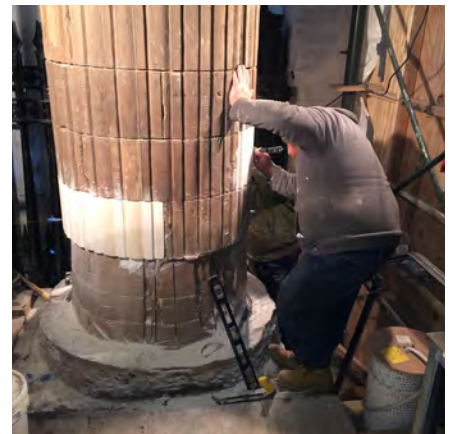
Sandstone was used for the columns at the east portico, as well as the stone around the windows, doors, and quoins. Significant restoration of this sandstone was done, including replacement, patching and dutchmen as appropriate. Comprehensive re-pointing was also done. Though various mortars had been applied over time, a conservator's analysis of underlying mortar established that the original mortar was white. SUPERSTRUCTURES' in-house conservators conducted an analysis to replicate the mortar formula containing the correct proportions of lime,

*Top and bottom left: Sandstone columns before restoration. Bottom center and right: Columns during restoration. Top right: Restored column.*

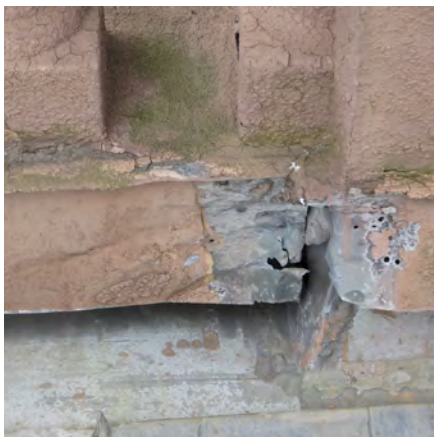
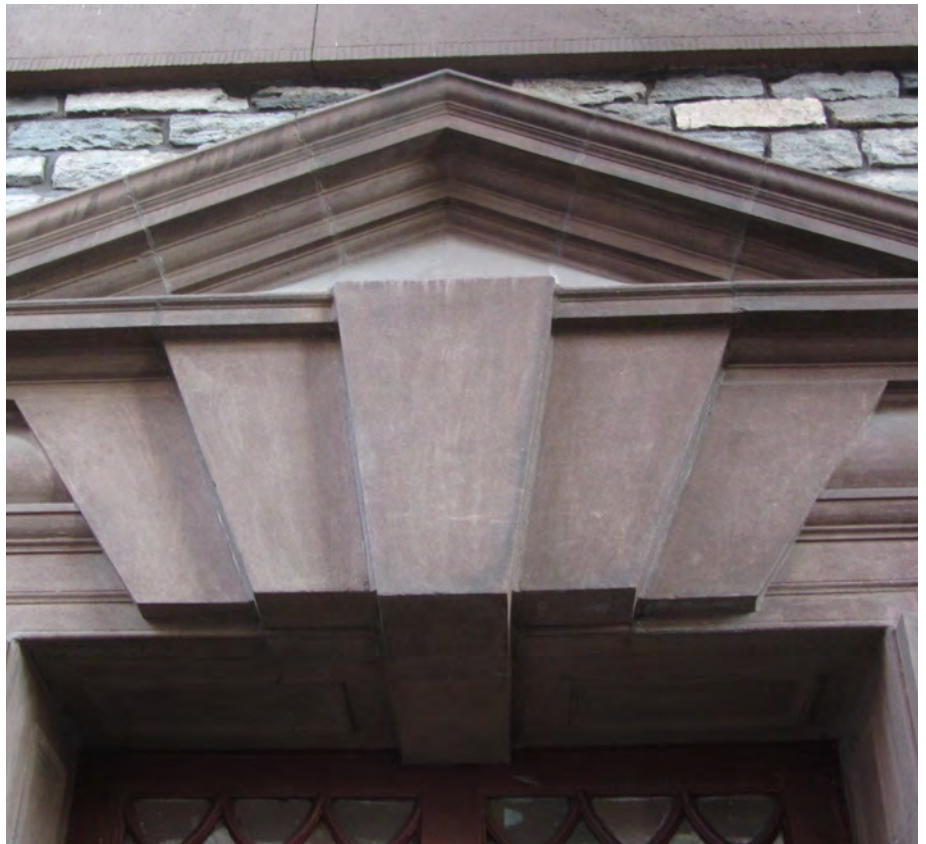
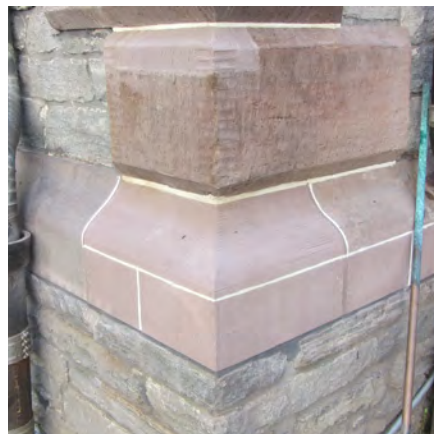
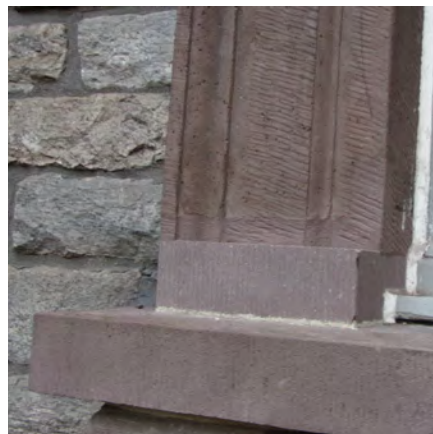
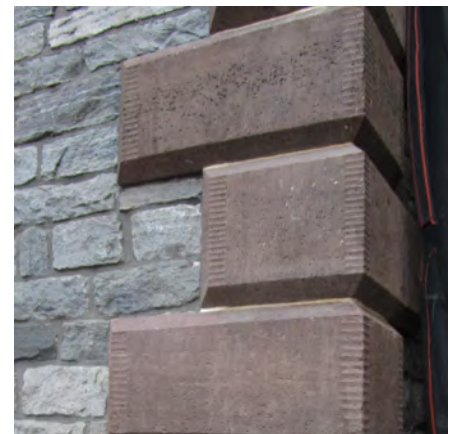
mortar, and sand as well as match the color and texture of the original mortar. Previously installed patches of improper materials were causing damage to the mother stone and were replaced with softer, more appropriate repair mortar and tooled to match the existing finish.

*Top left: Sandstone around window before restoration. Top right, bottom left, right and center: Restored sandstone.*

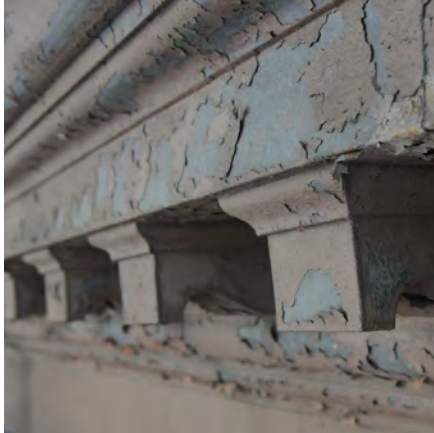
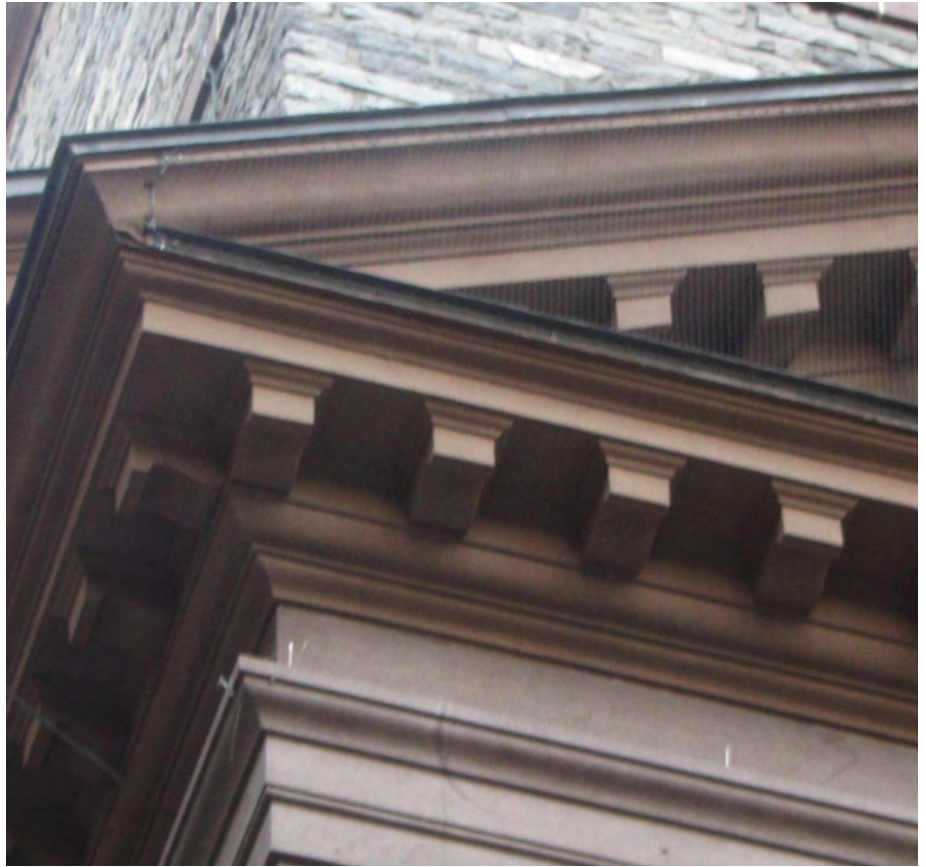
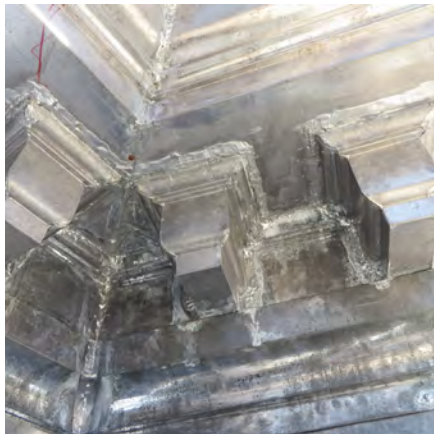
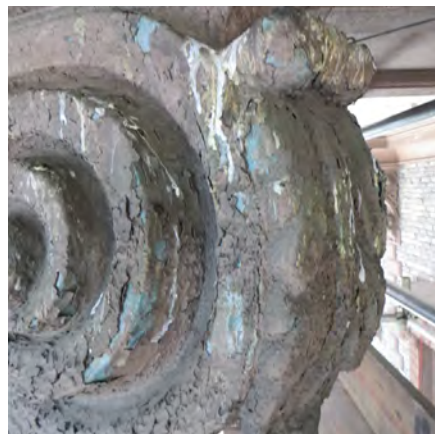
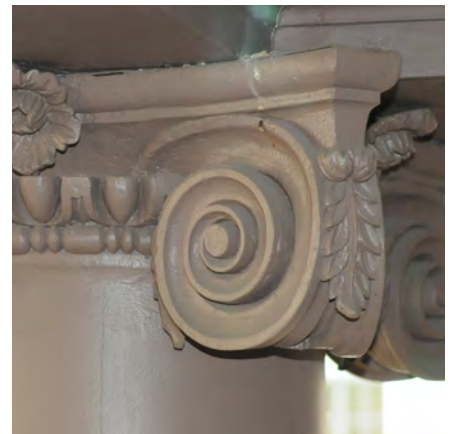
Sheet metal cornices were restored on the east and west elevations, including those framing the tympanum, and on the north and south sides of the porticos. The metal cornices had been installed over wooden cornices in 1929 and mimicked their shape. The dentils were removed from the wooden cornices to allow installation of the sheet metal. This was one of the factors leading to selection of the 1929 exterior as the model for the present restoration. The cornices were recoated with sand-infused paint to give the appearance of surrounding sandstone, as was the intent with the original coatings on the cornices.

*Upper left: Cornice before restoration. Lower left: Cornice during restoration. Upper right: Restored cornices. Lower center: Metal column capital before restoration. Lower right: Restored capital.*

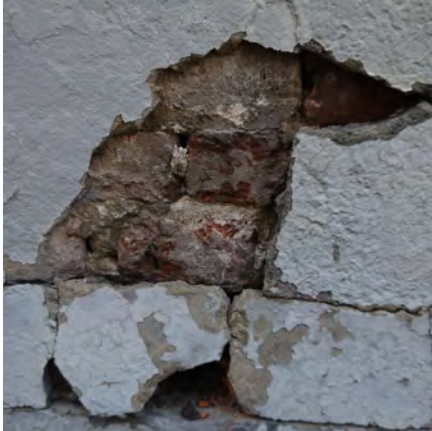
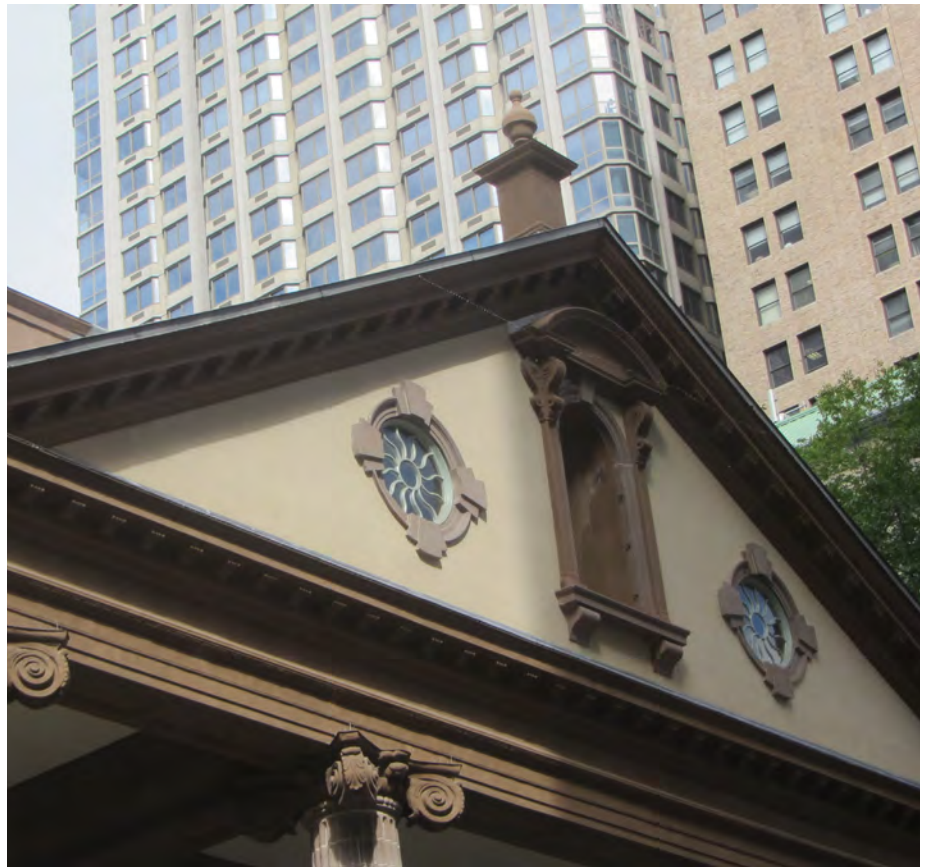
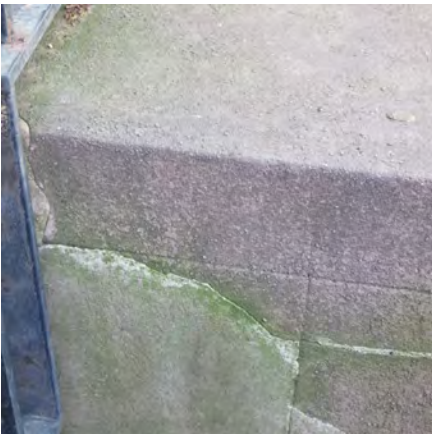
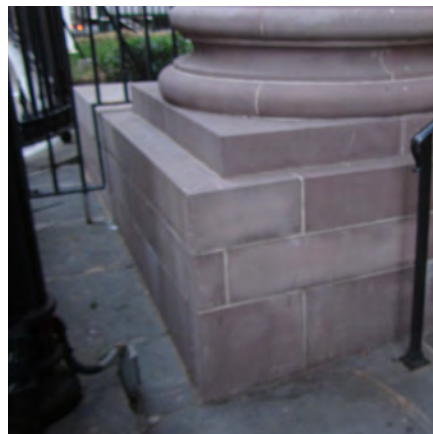
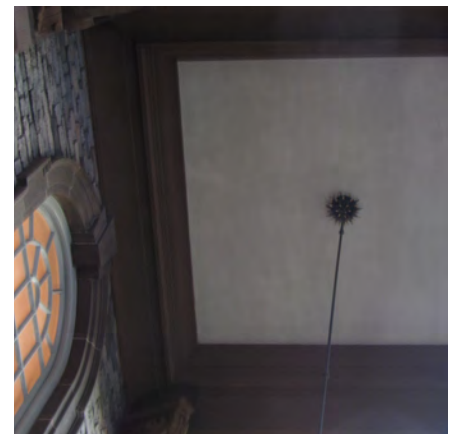
A significant portion of the plaster facade of the tympanum above the eastern portico was deteriorated. For repair of the plaster wall SUPERSTRUCTURES specified a stucco mix matching the appearance of the original plaster. The scoring marks used to give the impression of stone were freshened and the entire area was coated.

The base of the portico had been replaced with historically inappropriate concrete, which in turn was extremely deteriorated. The concrete was replaced with cast stone selected to match the original sandstone.

*Upper left: Deterioration in facade of tympanum before restoration. Upper right: Restored tympanum. Lower left: Portico base before restoration. Lower center: Portico base restored. Lower right: Portico ceiling restored.*

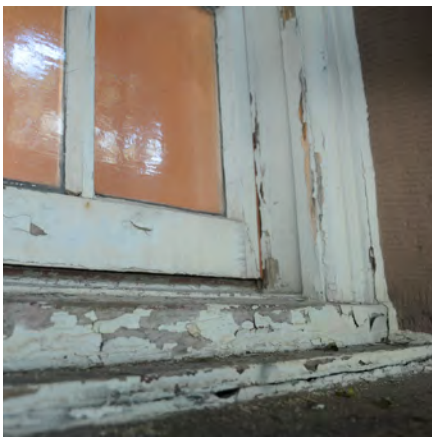
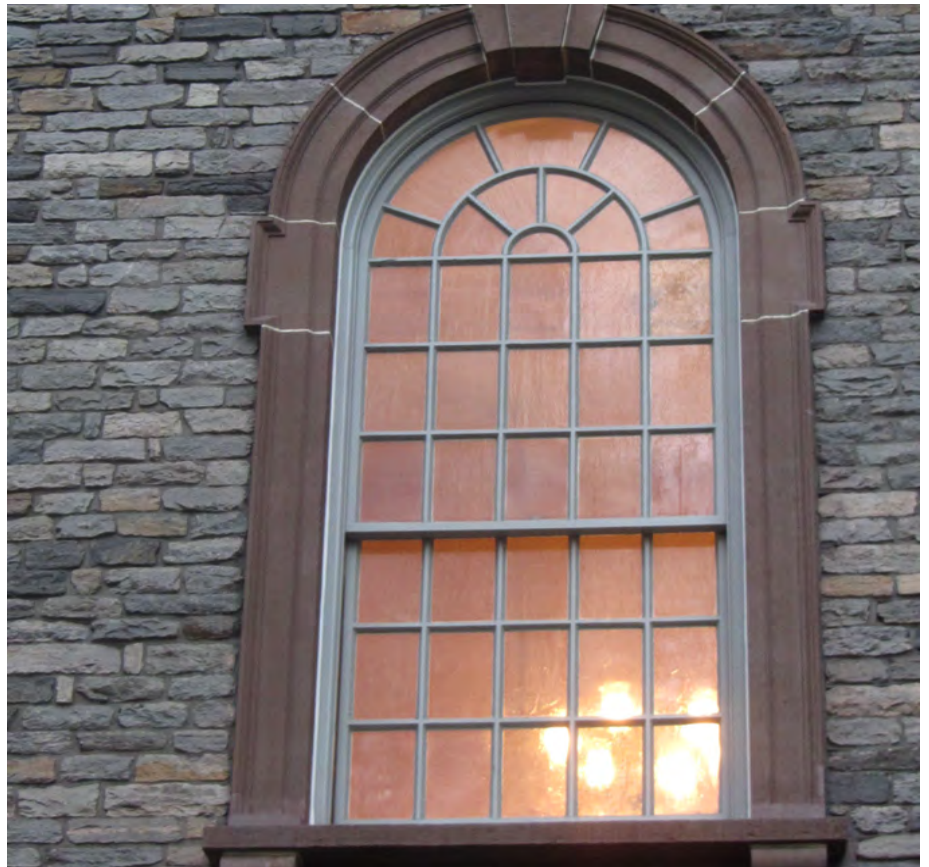
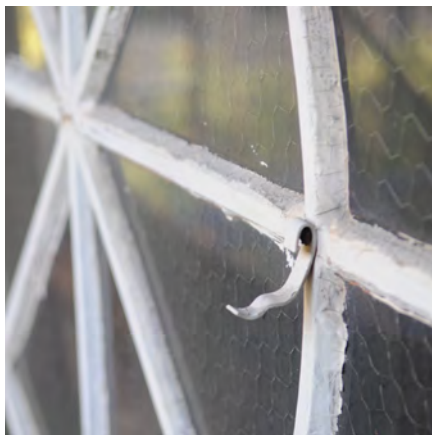
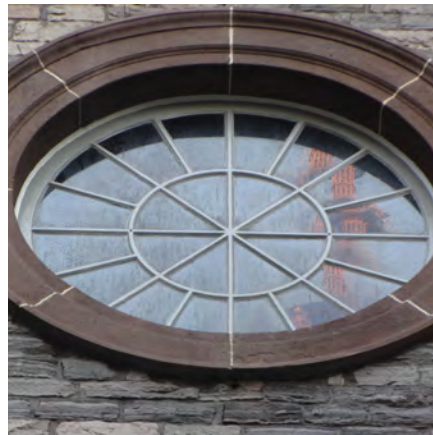
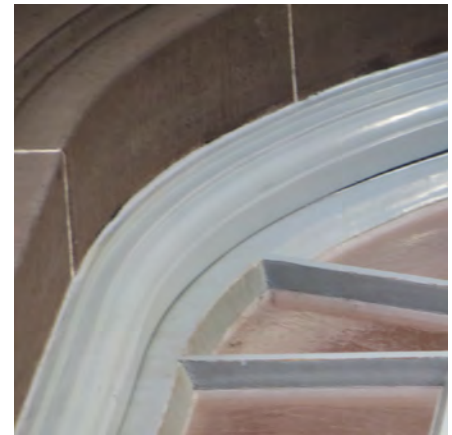
The window repair program was comprehensive. All wooden sashes were removed, stripped and repainted. Some wood consolidation was required. All the glazing was re-set. Broken panes were replaced with Restoration Glass® from Bendheim Architectural Glass for historical accuracy. Imported from Germany, the panes are mouth-blown glass and display characteristics of antique glass including mild waviness and occasional air bubbles. The window hardware was restored, including the mostly hidden operational hardware such as counterweights, chains and pulleys.

*Upper and lower left: Windows before restoration. Upper right, lower center and right: Windows after restoration.*
