# Consolidated Edison Headquarters

2022 ICRI Metro New York Project Awards

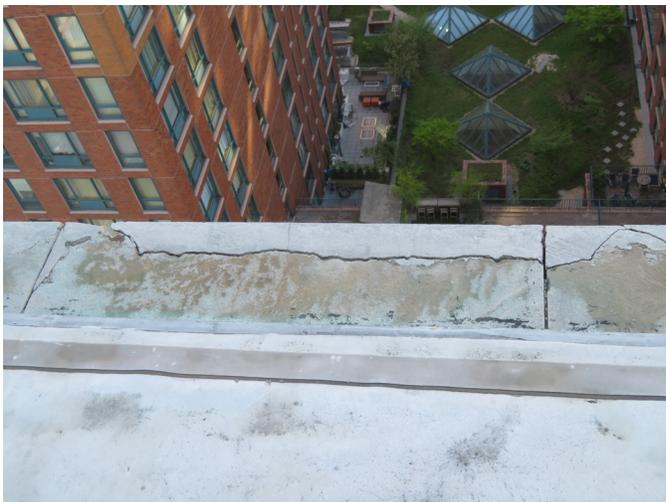
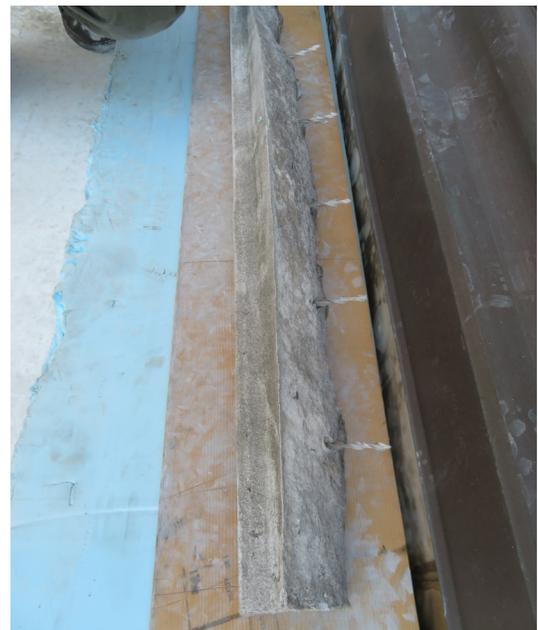
Early in the project, the project team identified sections of failed patches along the outer cornice, 19 stories above street level, while conducting a survey from the roof. Emergency rigs were installed to perform safe off repairs. During the removal, the crew discovered that the patches had been feathered and fastened to the parent stone with helical ties. Approximately 50 LF of the cornice edge was replaced with new limestone dutchmen fastened with a stainless steel rod set in epoxy. The EPDM roofing was extended to cover the new cornice edge stone to the outer edge.

*Figure 1: Discovered failing patch at cornice edge 19 stories high (left). Failed patches removed during the inspection identified helical ties had been used to fasten the new patches to the parent stone (right).*

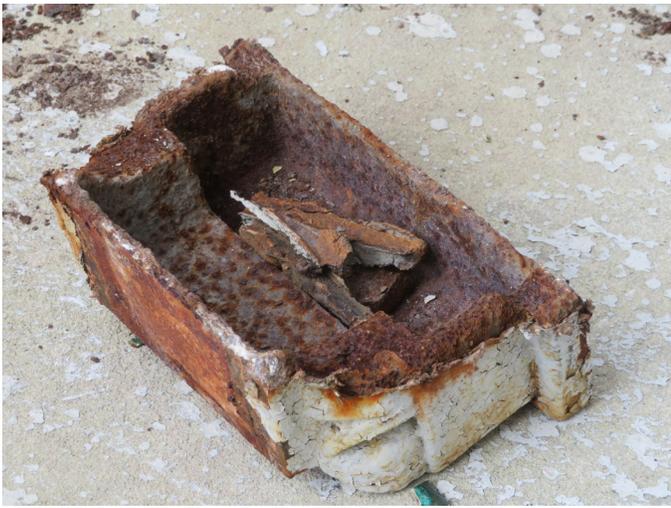
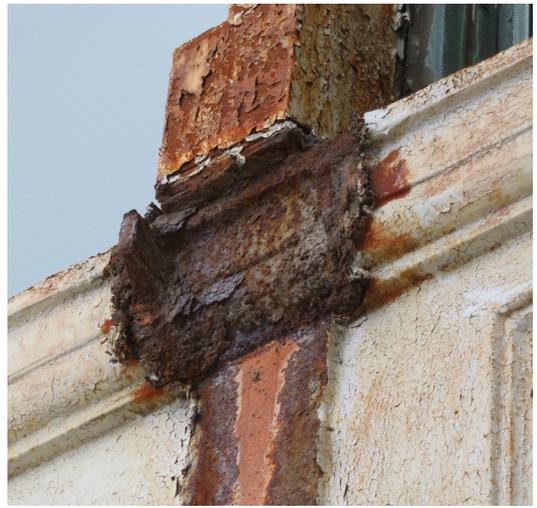
Figure 2: Cast iron window mullion piece discovered on a setback. This led to a full survey and repair campaign of the entire facade.

In November 2019, a cast iron mullion piece fell onto a setback roof within the construction zone, triggering a full inspection of the ornamental cast iron façade elements located on the north, west, and south elevations. The project team inspected, stabilized, and repaired the cast iron elements to prevent further damage. Furthermore, it was decided that the entire building needed to be surveyed and repaired to create a state of good repair for the building. This decision led to a growth in the original project scope over three and a half times the original project plan, which resulted in a schedule extension of approximately five months, including a three-week job shut down in 2020 for the Covid-19 pandemic.

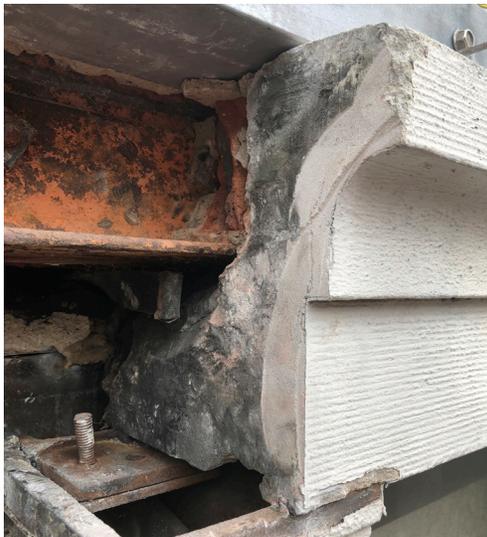
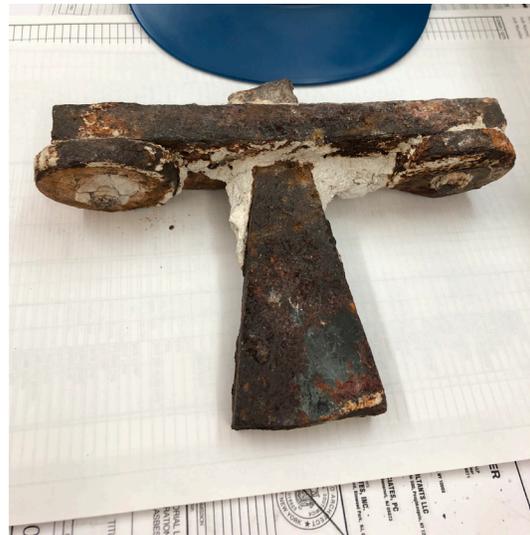
Figure 3: STN 500 stone lintel replacement in progress. Corrosion of the original dovetail anchor contributed to the formation of large cracks within the lintel.

Some limestone units were removed and reset after inspection, and all existing limestone units were stabilized and re-anchored. Cracked limestone lintels and sills were removed and replaced in kind. Exposed steel was cleaned, in some areas repaired with welded additional steel to reinforce the existing and treated with rust inhibitive coatings, before rebuilding with new materials to match existing.

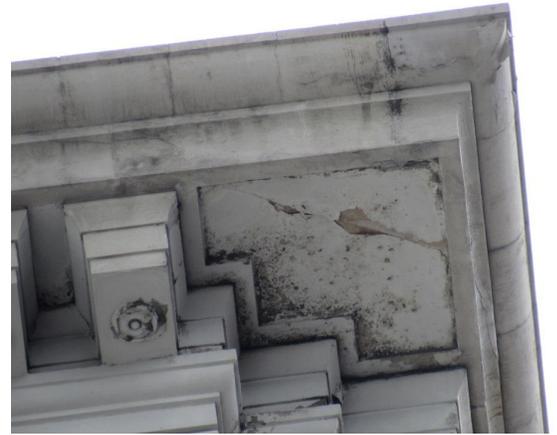
*Figure 4: 6 ft fracture along corner cornice stone.*

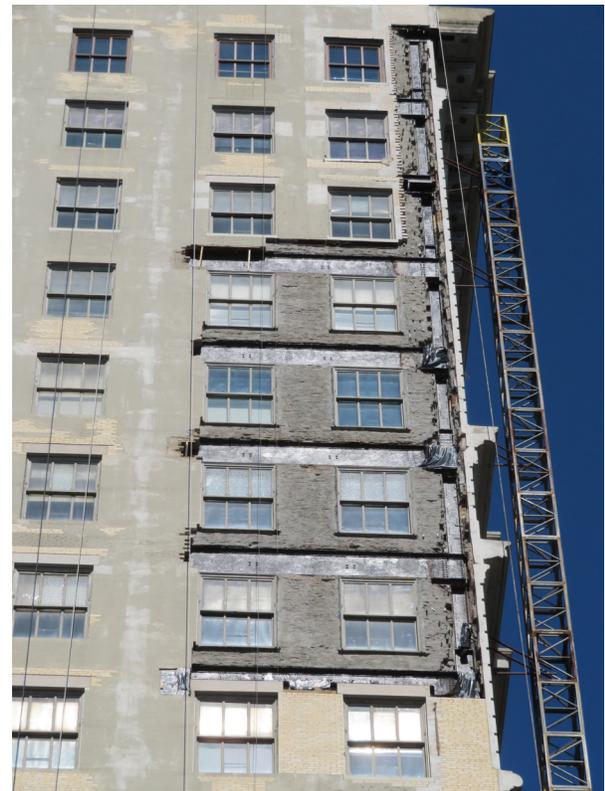
The east elevation scope was originally generated by the Local Law 11 inspection, which found areas of cracked brick, cracked limestone lintels, and vertical cracks at column lines – most severely at the two east building corners. Once work began on the identified scope, the team discovered that the problems were more severe. The vertical corner cracks in the brick sides of each corner were due to the column rust jacking. This condition was caused primarily by prolonged water entry at the cornice, parapet walls, and roof.

Each corner is comprised of one side as backup with face brick, and the alternate side as backup brick with 4"-8" deep limestone face. The pressure caused by the rusting and expanding steel followed the path of least resistance, in this case the brick side. Cracking at the brick sides of the corners was made worse due to the orientation of the "W" column section, placing the rusting flange ends right at the back of the face brick.

*Figure 5: Corner and wall field repairs conducted on both the northeast and southeast corners. Steel repairs, brick replacement, waterproofing, new lintels, new sills were installed.*

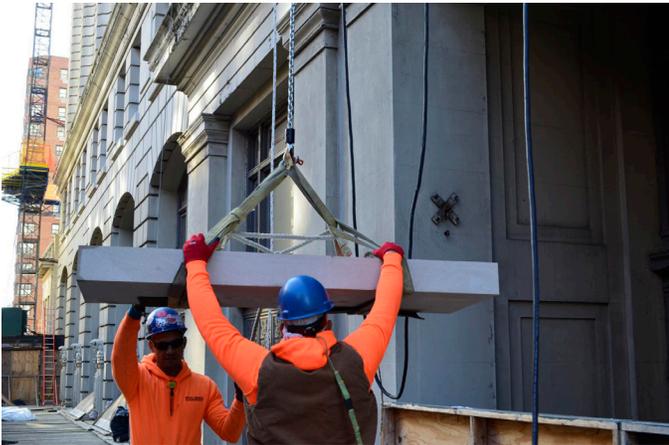
Figure 8: Installation of a stone lintel in progress

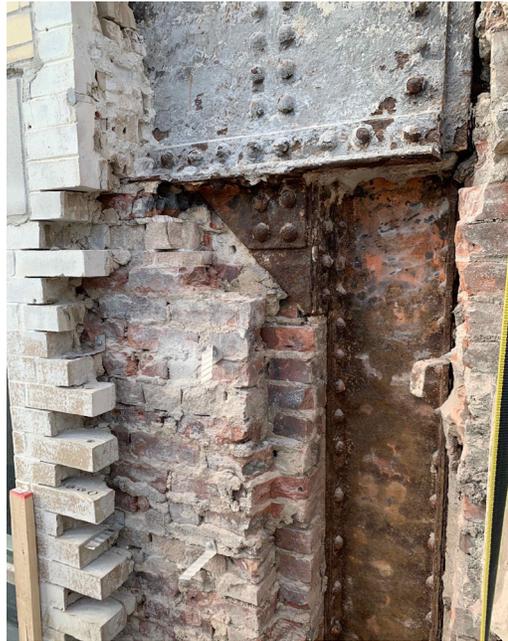
Figure 9: Column repair in progress

A stair tower, built on needle beams, was constructed nearly 400ft high at the top stages of the clock tower to rebuild the inner corners of the structure. Limestone panels and brick backup were removed to assess the embedded steel columns. Only one section of a column was exhibited significant corrosion and required a welded reinforcement plate. All steel was scraped and painted, anchor ties were welded to the steel, brick backup infilled, and new limestone panels installed.
