The New York Landmarks Conservancy
Lucy G. Moses Preservation Awards
Submittal

Clemente Soto Vélez Cultural & Educational Center
107 Suffolk Street
New York, New York

Exterior Renovation

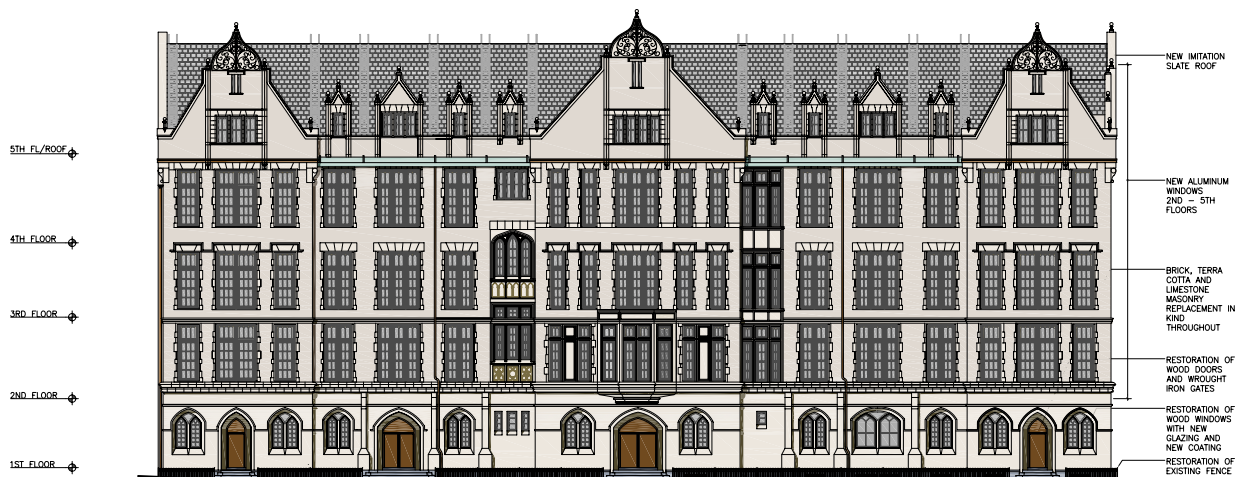
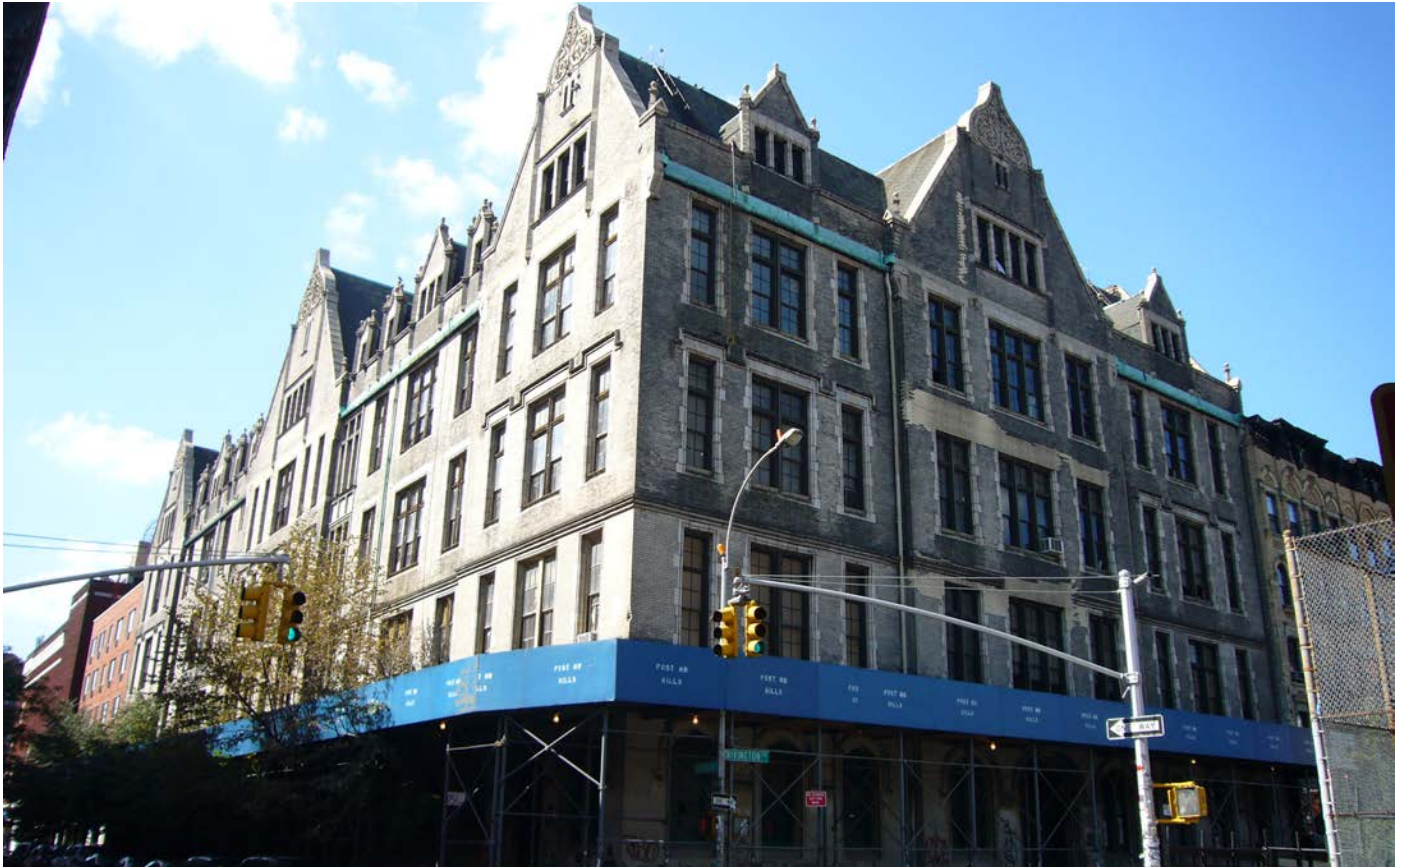
107 Suffolk Street prior to restoration

After over a century of service without substantial rehabilitation, the building was in very poor condition when SUPERSTRUCTURES began an investigation of the exterior in 2006. By that point there had been a sidewalk shed in place for eight years due to the deteriorated condition of the façade. Interviews done as part of a master planning study conducted by CSV during this period confirmed a deep respect and admiration for the architecture of the building's exterior. However, there was a vital interest in improving the safety of the building and in providing a more welcoming entrance.

The complete exterior restoration completed in 2012 included roof replacement and repair, replacement of bulkheads and copper gutters, replacement and/or repair of brick masonry, restoration or replacement of terra cotta, replacement and/or restoration of windows, cleaning of limestone and terrazzo. The Department of NYC Cultural Affairs and NYC Department of Citywide Administrative Services funded the project, which was managed by the NYC Department of Design and Construction. Text accompanying the photos on subsequent pages details some of the highlights of the renovation project.

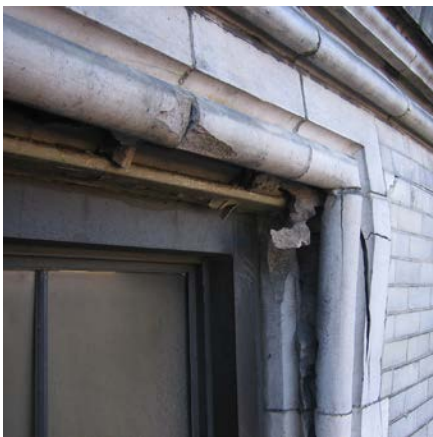
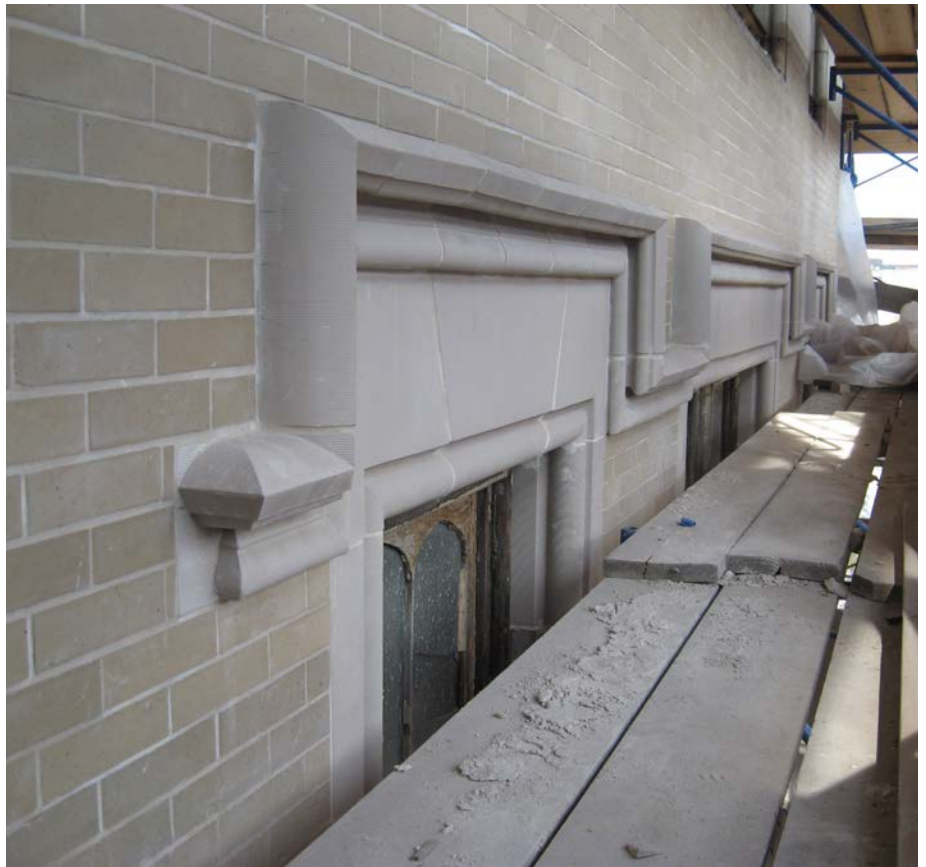
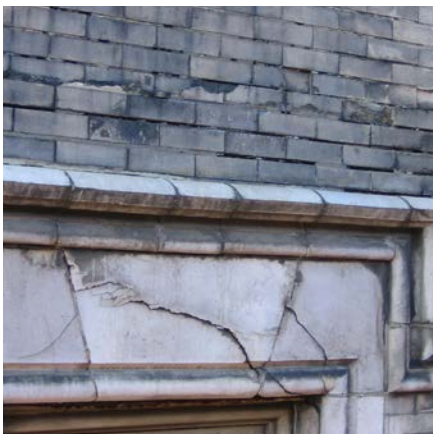
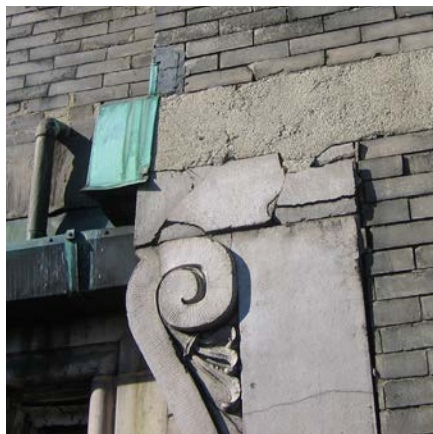
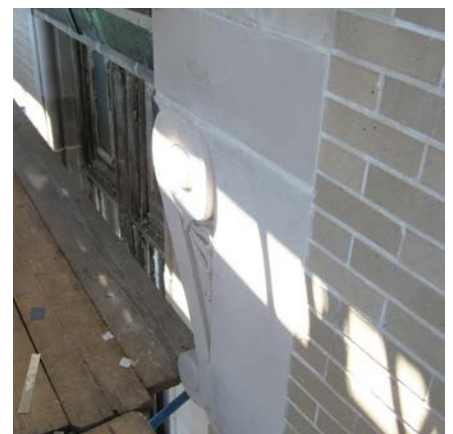
The terra cotta at the window heads and spandrels was severely deteriorated with cracks and spalls observed due to water penetration and expansion of corroding steel and could not be saved. On occasion terra cotta was found to be bulging from the wall. Replacement terra cotta was provided to match the original.

*Top, left; bottom, left: Terra cotta before.
Bottom, center: Spalling and displaced terra
cotta bracket. Bottom, left: Terra cotta
bracket after. Top, right: Terra cotta after.*

Original terra cotta gables, window surrounds, and copings that were in fair condition were carefully cleaned and repaired. Mortar joints were repointed throughout.

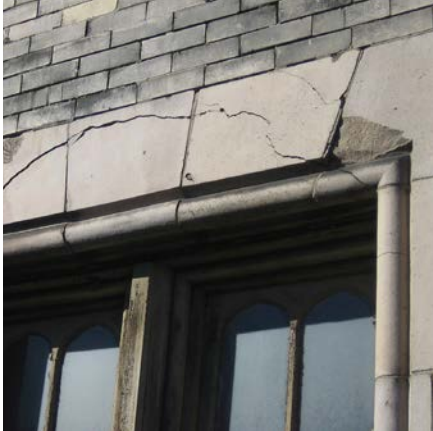
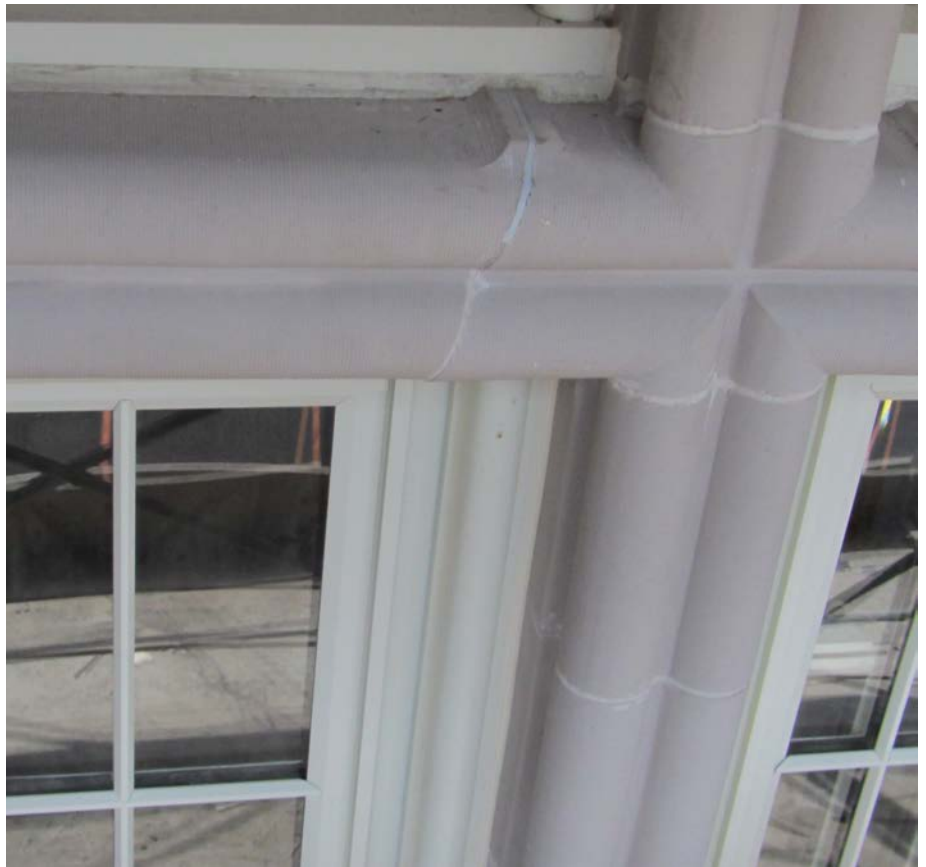
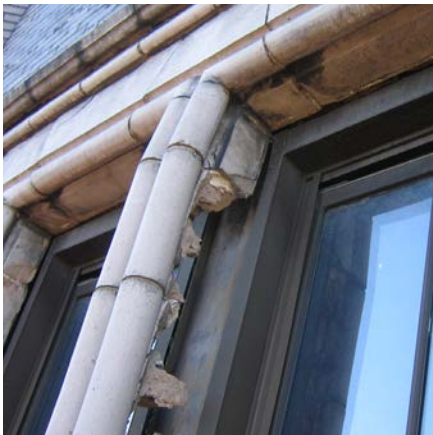
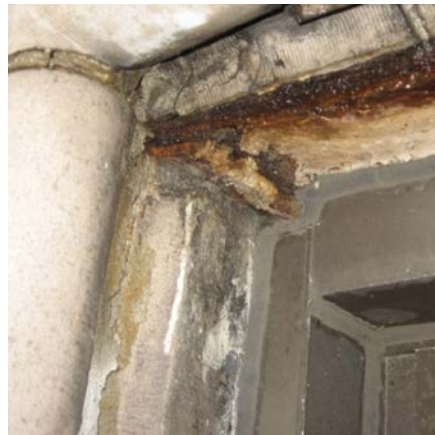
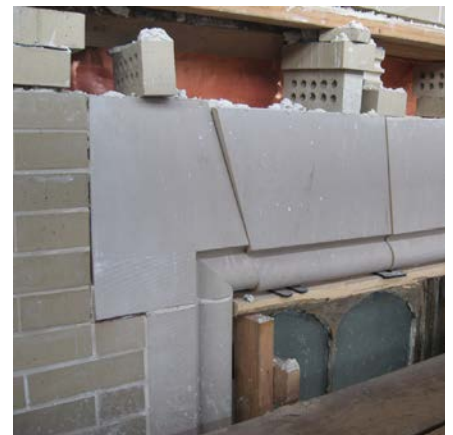
Top, left; bottom, left; bottom, center: Deteriorated terra cotta. Bottom, left: New terra cotta installed. Top, right: New terra cotta after.

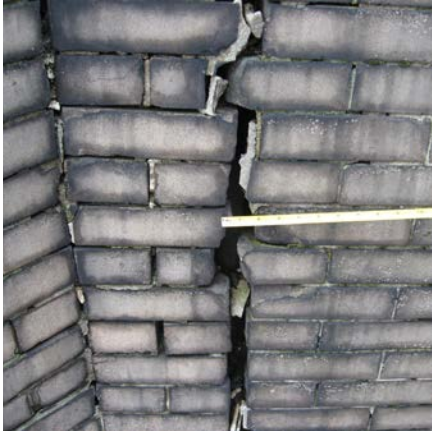
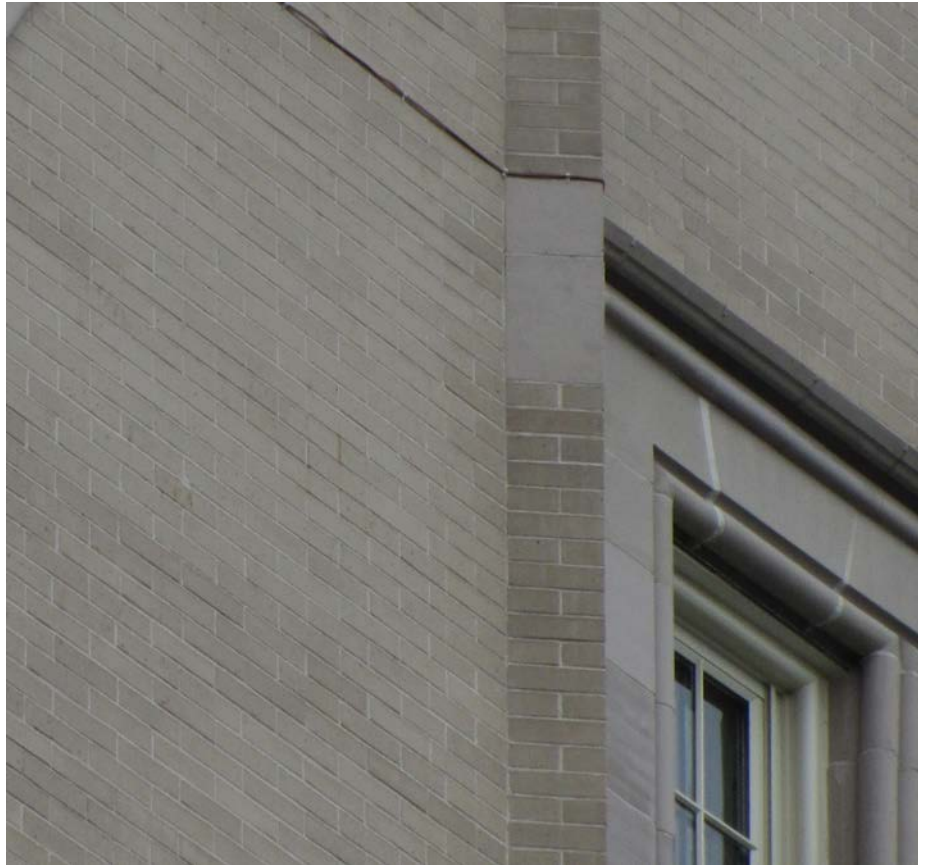
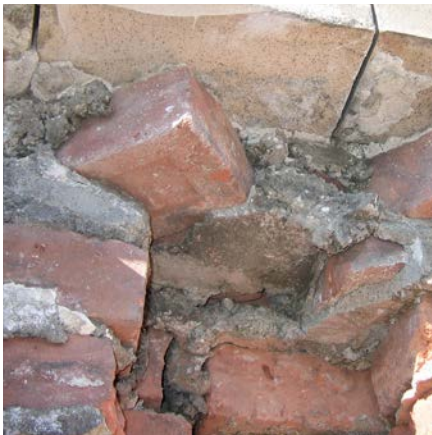
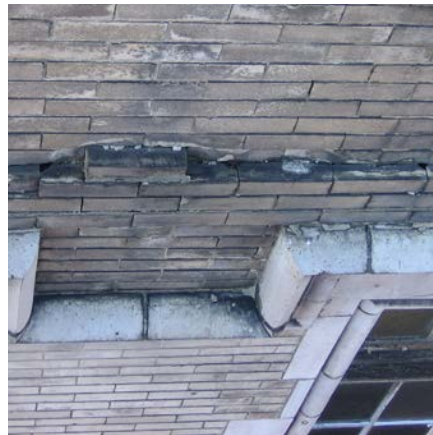
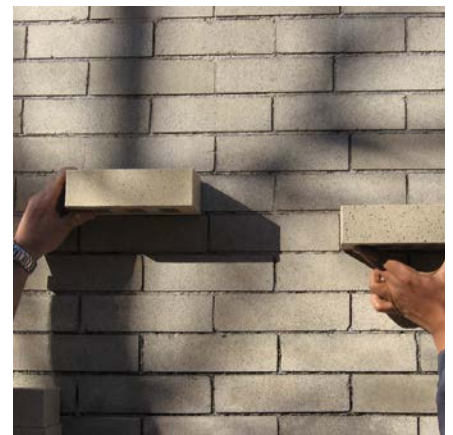
The outer wythe of brick was laid on a running course, i.e. there was no brick perpendicular to tie the courses together and back-up masonry was placed at an angle to tie the courses together. With the deterioration of the steel frame, particularly at the spandrels, exterior brick was pushed away from the plane of the wall. To stabilize the masonry, the angled bricks were replaced with stainless steel veneer anchors at every five courses.

Top, left: Brick deterioration before restoration. Top, right: Brick after restoration. Bottom, left: angled brick used before to tie courses together. Bottom center: Brick displacement at spandrel level. Bottom right: matching new brick to original.

Brick masonry was replaced on all five floors of the street facades. The replacement of iron-spot brick involved an extensive match process – approximately 20 samples were reviewed.

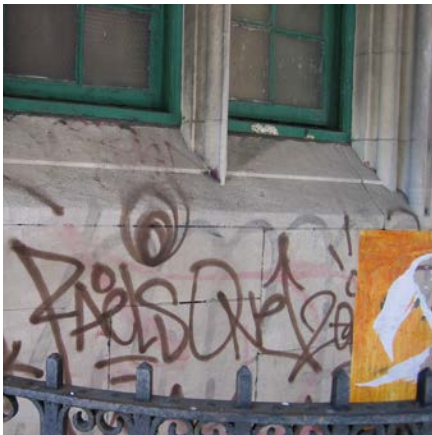
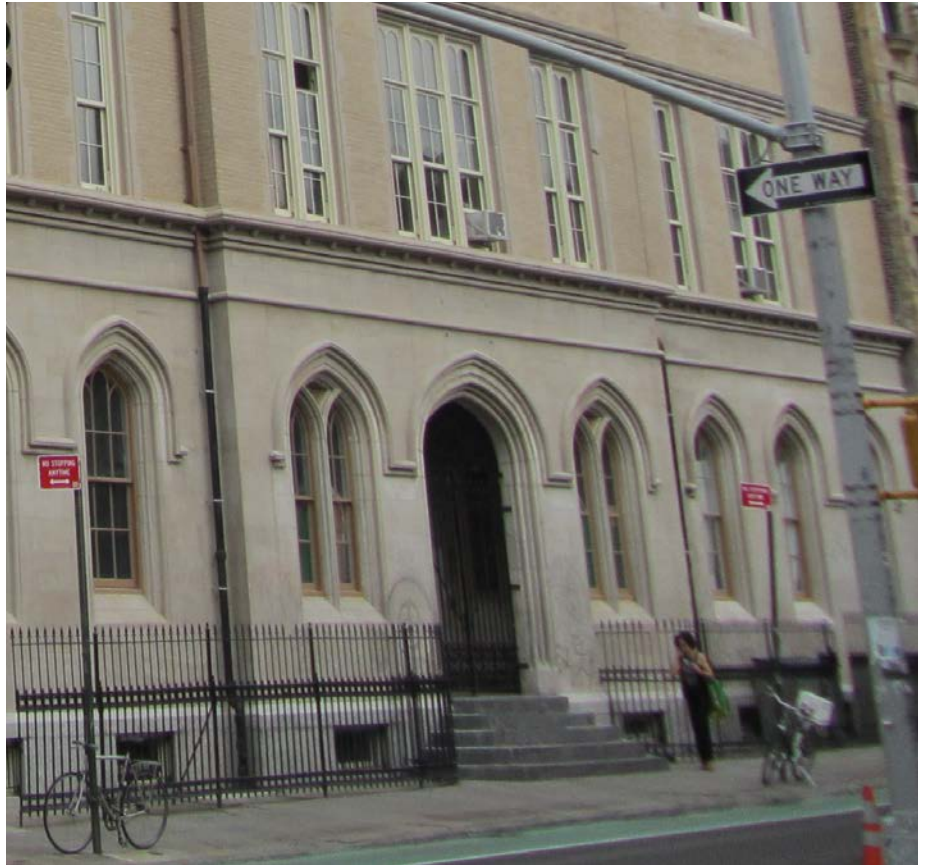
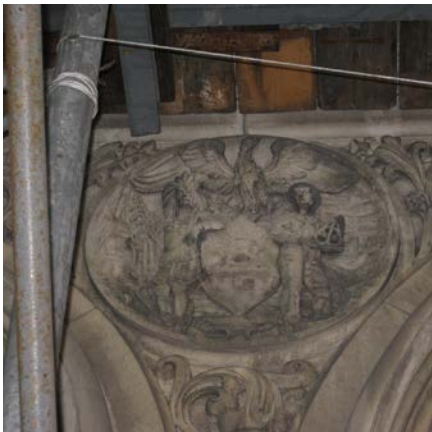
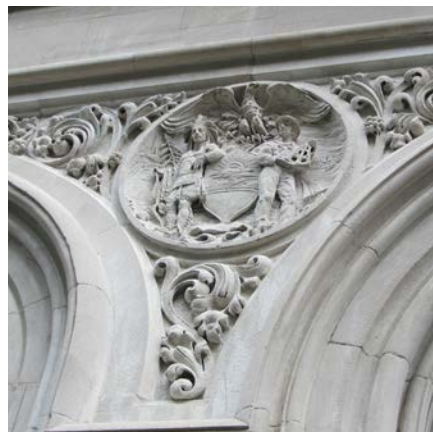
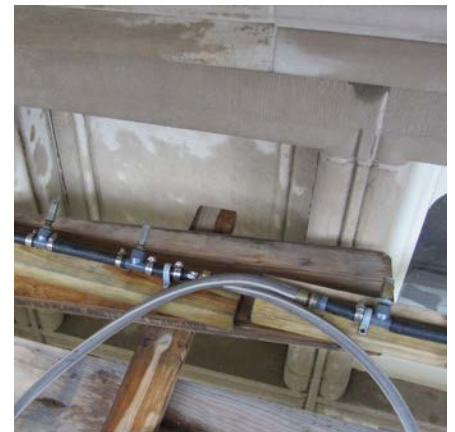
The sidewalk shed having been in place for many years encouraged vandalism of the limestone, bluestone steps, and windows. Limestone at the base of the building and extending up to the second floor at the center bay was cleaned, which due to the level of grime, graffiti, and biological growth was an arduous process requiring several different cleaning methods. Once cleaned, the limestone and granite base of the building was in fair condition.

Top, left: Graffiti covered limestone. Top, right: Limestone cleaned. Bottom, left: Ornamental limestone before. Bottom, center: Ornamental limestone after. Bottom, right: Limestone cleaning in progress.

Some areas required restoration or replacement of limestone in kind. One bluestone tread of the entrance steps was replaced. The limestone and granite base, as well as the bluestone entrance steps were repointed.

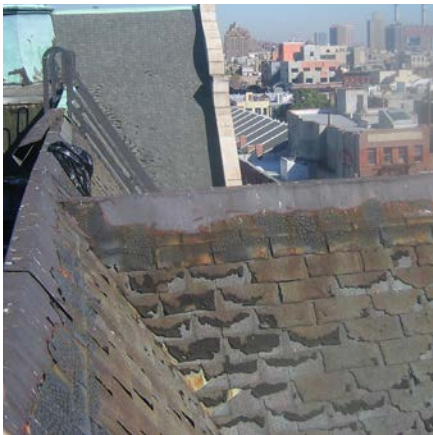
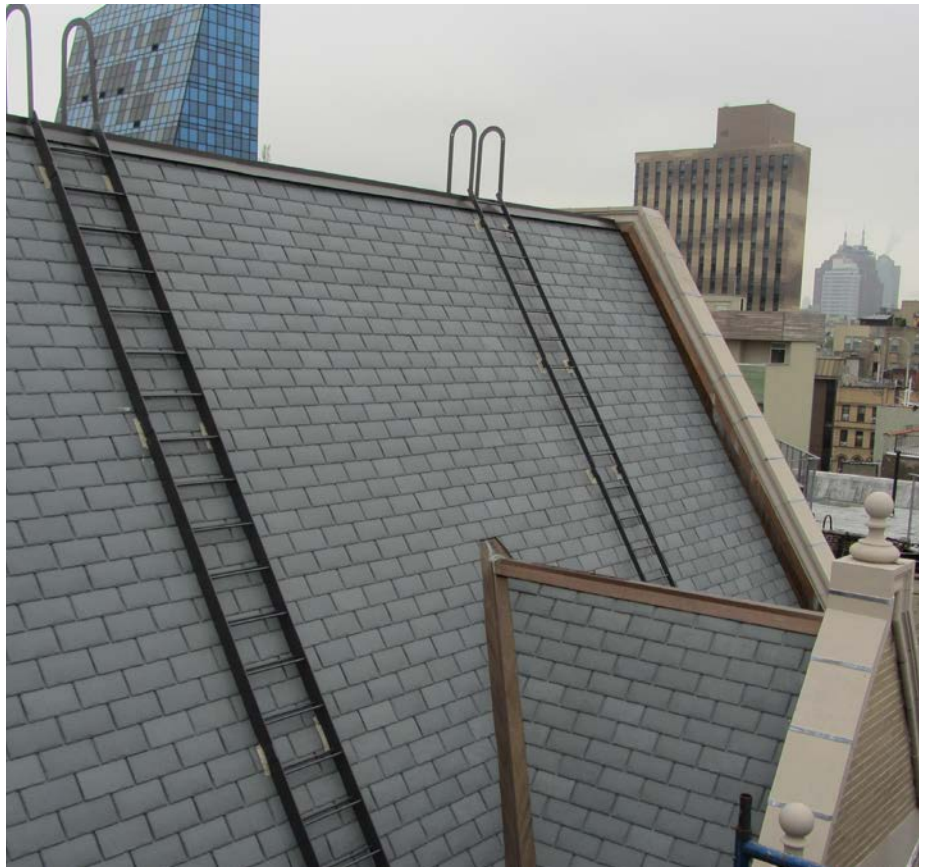
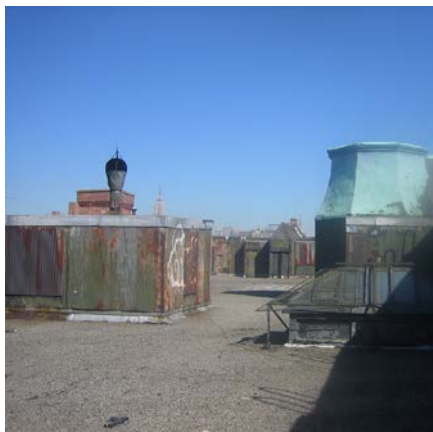
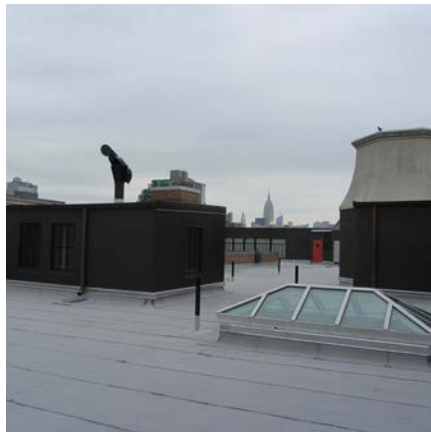
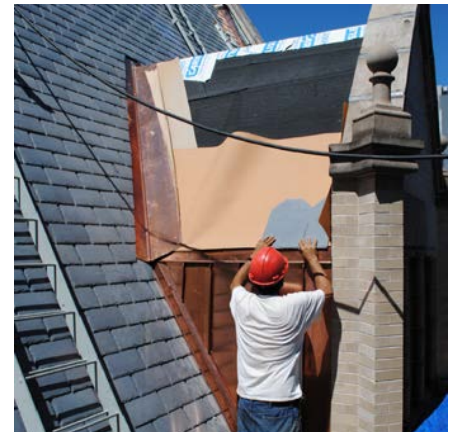
The existing pitched roofs were in very poor condition. The existing asphalt shingles were disintegrating, clogging the drains of the built-in copper gutters below. In many locations water was able to penetrate the interior causing damage to interior finishes and artist's studios.

Top, left: Slate roof before. Top, right: Slate roof after. Bottom, left: Flat roof before. Bottom, center: Flat roof after. Bottom right: Roofing installation in progress.

The asphalt shingles were replaced with imitation slate tiles made from recycled rubber and plastic. Copper flashings, ridge caps, and built-in gutters were replaced with new copper including the standing seam cladding at the dormer walls. The flat roof behind the sloped roofs was also replaced as were the bulkhead roofs and cladding and a skylight.

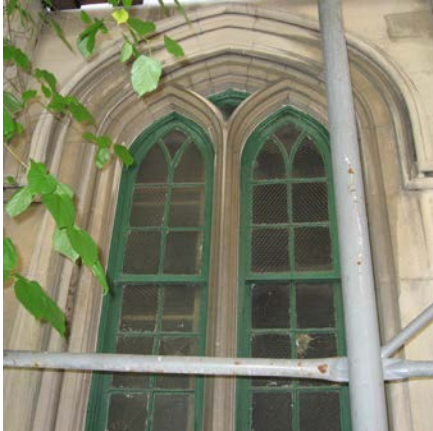
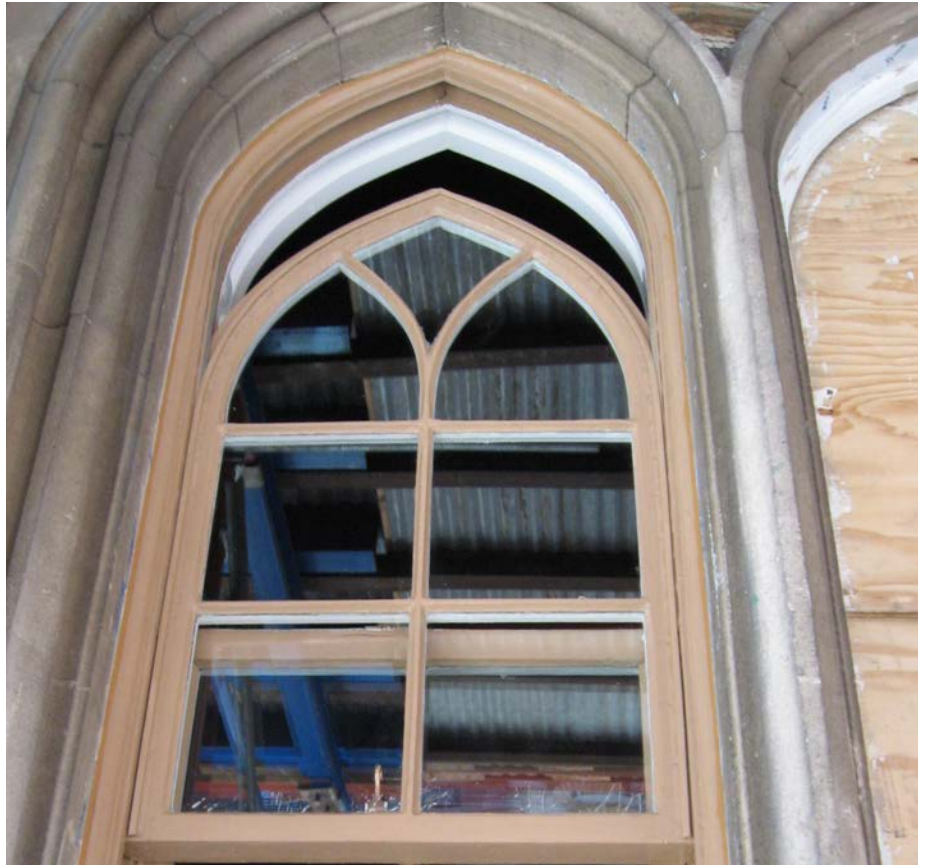
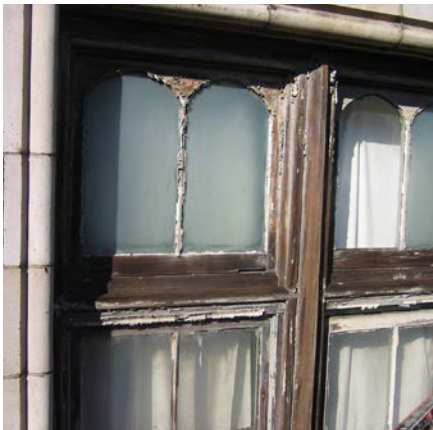
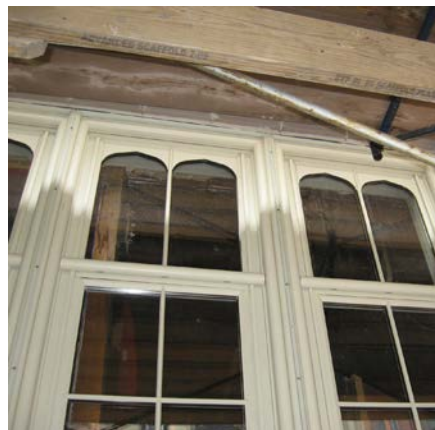
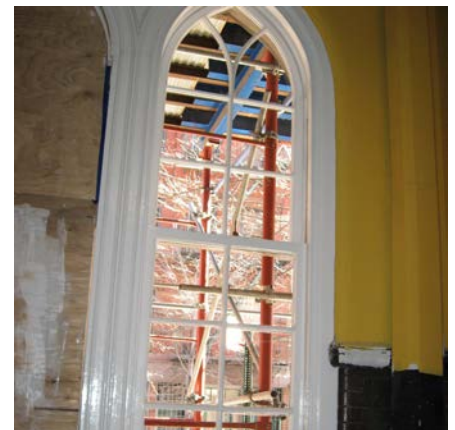
The first-floor wood windows were restored and fitted with new hardware to match the originals. Many of the windows had been vandalized and had to be fitted with new glazing. The windows were painted with color determined to be original based on paint analysis. The wood windows on the upper floors were found to be in advanced state of deterioration and were replaced with aluminum windows. The original wood windows had very detailed profiles which were replicated as closely as possible in aluminum. This was achieved by using custom extrusions of profile and width that closely replicate the original detailing, including the pointed arches of the fixed transoms above the double-hung windows.

Top, left: Wood windows before . Top, right: Wood window after. Bottom, left: Window before. Bottom, center: Window after. Bottom, right: New wood window from interior.

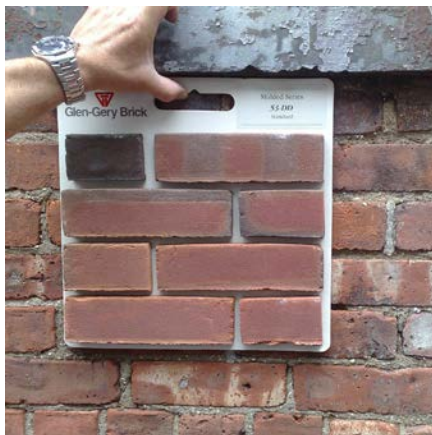
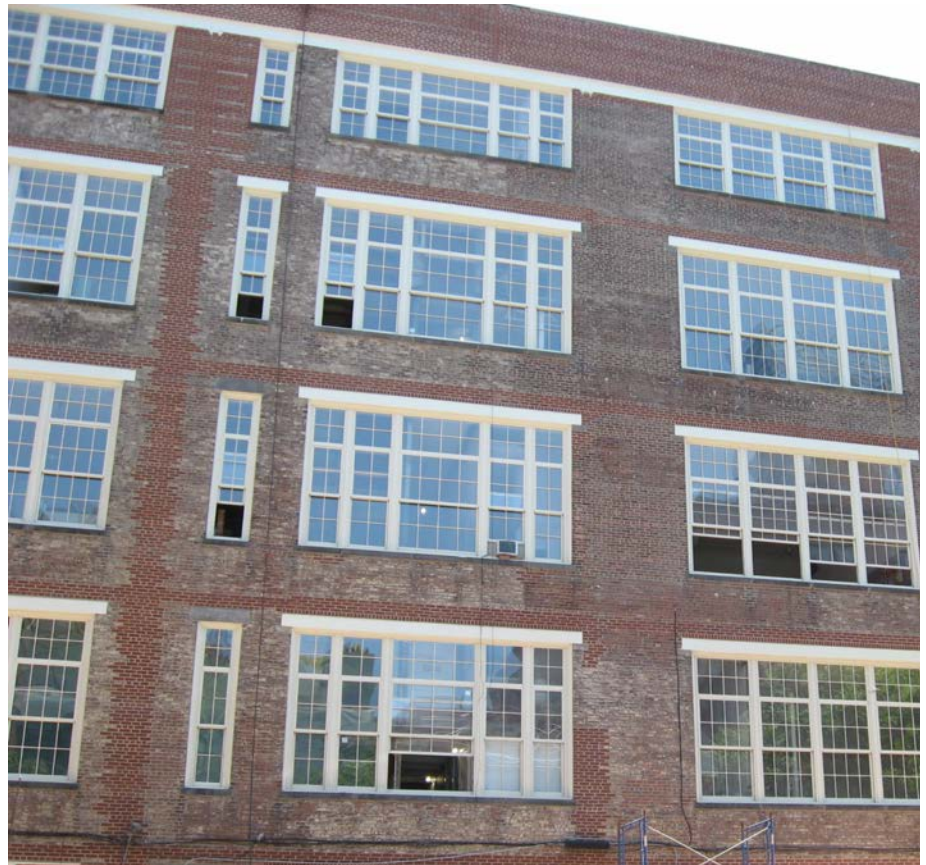
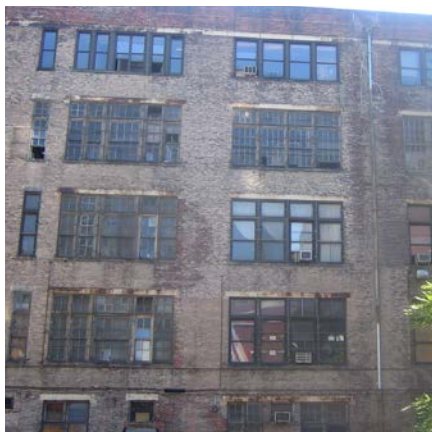
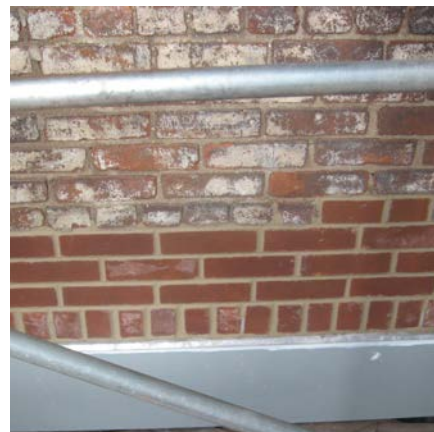
Top, left: Brick matching. Top, right: Rear facade after. Bottom, left: Rear facade before. Bottom, right: Brick replacement.

At the back of the building the brick masonry was restored including replacement of deteriorated brick, lintel repair and flashing, rebuilding of the parapets, and repointing. The windows were replaced with aluminum to replicate the original configuration of the wood windows.
