The New York Landmarks Conservancy
Lucy G. Moses Preservation Awards
Submittal

The MacIntyre Building
874 Broadway
New York, New York

Facade Restoration and Roof Replacement

The MacIntyre Building is Readied for Its Next 100 Years

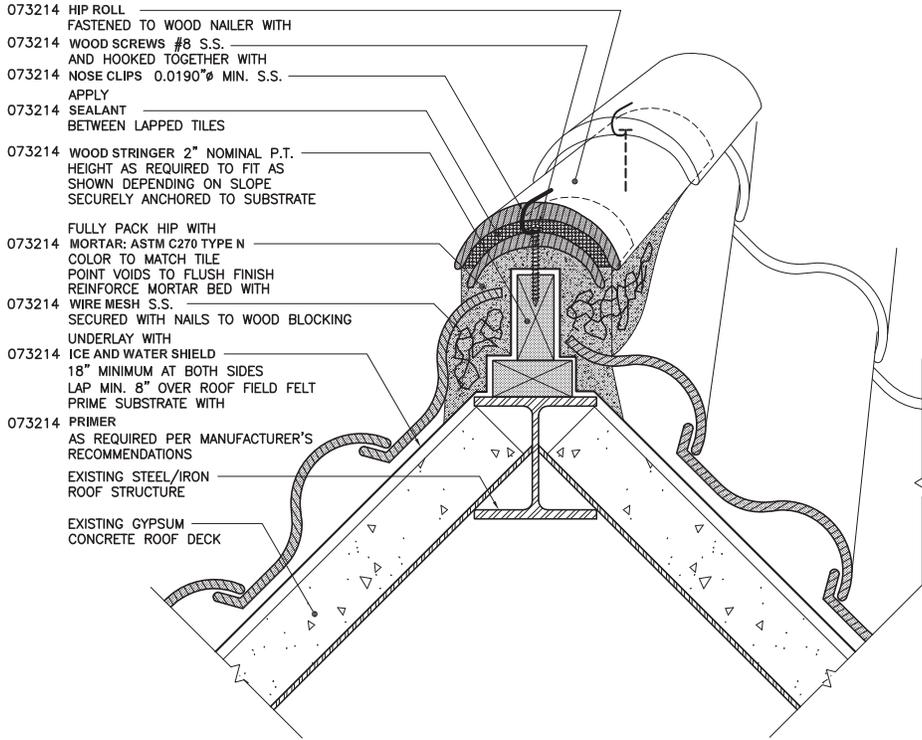
SECTION B-B: HIP

The tower is one of the most distinctive elements of the building's architecture. The Spanish-style clay tile roof was severely deteriorated and had clearly reached the end of its life span. In keeping with the Owner's budget, a facsimile tile of formed metal was originally considered. The Landmark's Preservation Commission staff took an interest in the roof and suggested the roof design might be approved, and the delay and expense of a full Commission hearing avoided, if the clay terra cotta roof was replaced in kind.

Custom-manufactured tile was deemed impractical for the project given the small size of the roof and the short construction schedule. Therefore all 15 domestic manufacturers of this type of tile were contacted in order to find the closest matching tile. The tile manufacturer Ludowici supplied a tile with the closest profile, only millimeters larger than the original, with the size difference not perceptible from the street. The new tiles' glaze closely replicated the mottled, almost smoky, finish of the aged tiles being replaced.

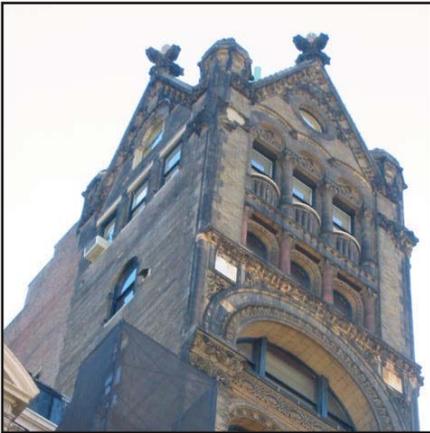
Below, top: The MacIntyre Building before exterior renovation. Below, bottom and at right: After restoration.
