The New York Landmarks Conservancy
Lucy G. Moses Preservation Awards
Submittal

Jefferson Market Library
425 Avenue of the Americas
New York New York

Exterior Renovation

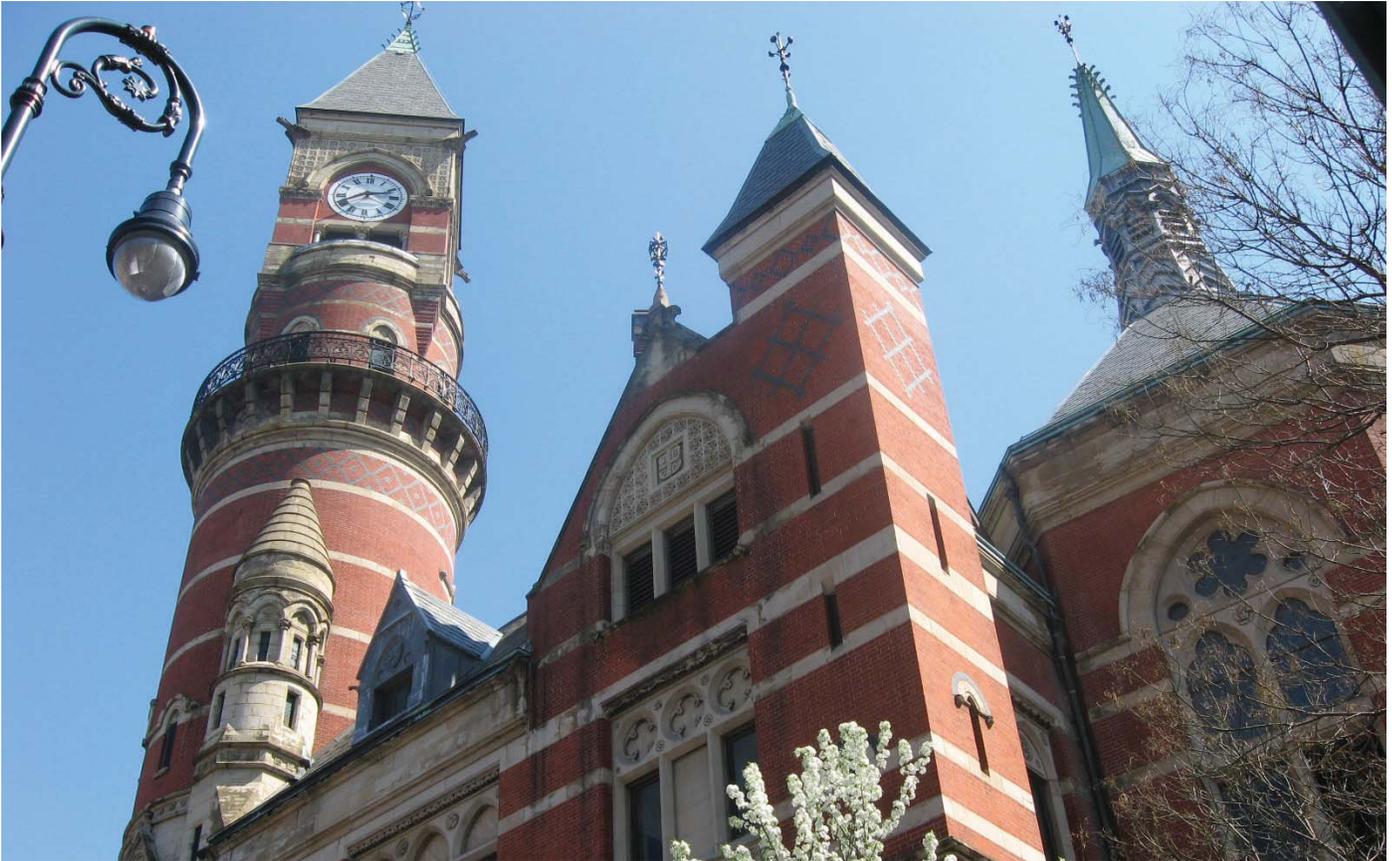
425 Avenue of the Americas prior to restoration

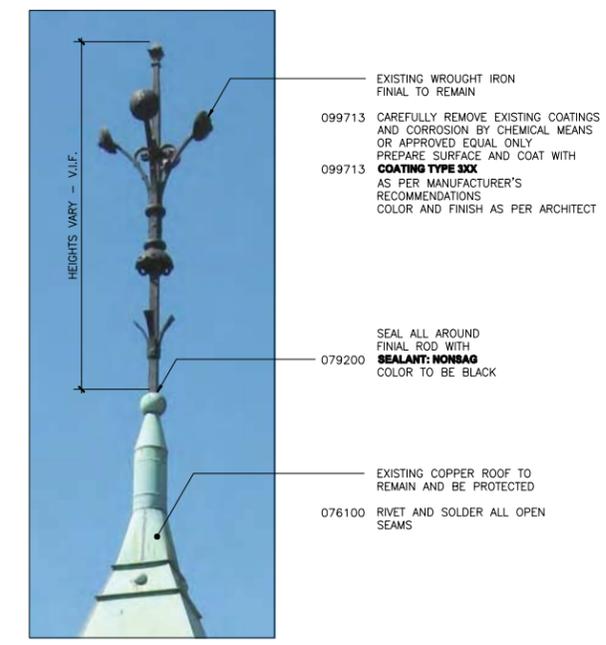
PHOTO: IRON FINIAL AT COPPER ROOF CAPS

The finial bases were spalling and breaking up because of the corrosion of the finial ironwork. New stone blocks were installed and the finials were re-set. Finials were restored as necessary off site. The drawing on the following page details additional repairs to sandstone and iron elements of various of the many finials on the building.

FIN 04
IRON FINIAL RESTORATION: AT COPPER ROOF CAPS
NOT TO SCALE

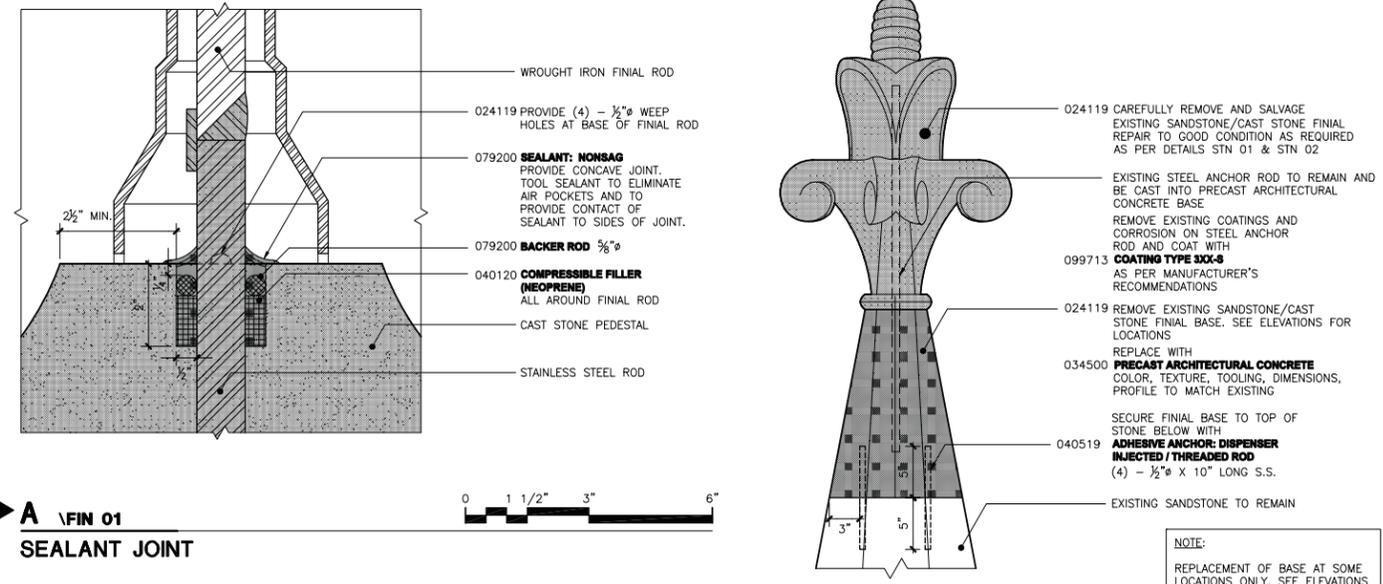
FIN 05
SANDSTONE FINIAL RESTORATION: ENTRANCE PORTAL

NOTE:
REPLACEMENT OF BASE AT SOME LOCATIONS ONLY. SEE ELEVATIONS FOR LOCATIONS.

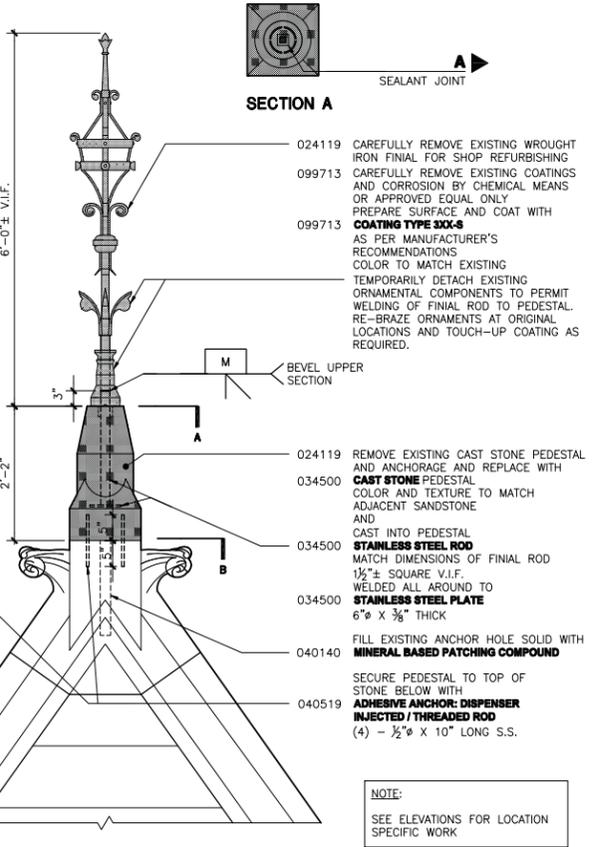
FIN 03
IRON FINIAL RESTORATION: TYPICAL

NOTE:
SEE ELEVATIONS FOR LOCATION SPECIFIC WORK

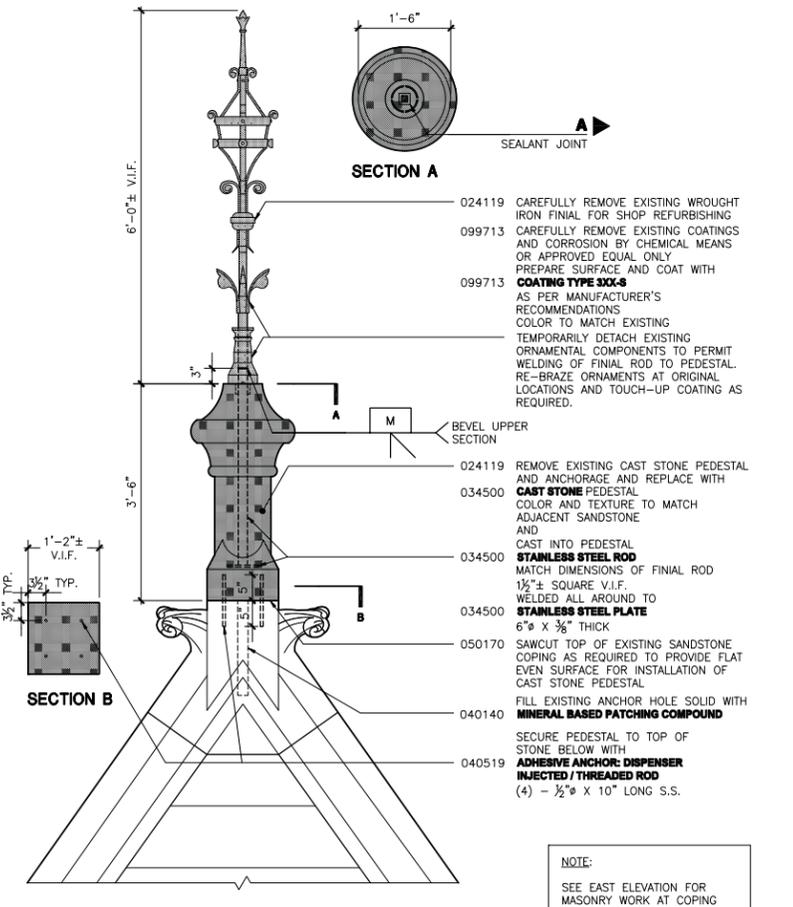
FIN 02
IRON FINIAL RESTORATION: LOWER GABLE

NOTE:
SEE EAST ELEVATION FOR MASONRY WORK AT COPING

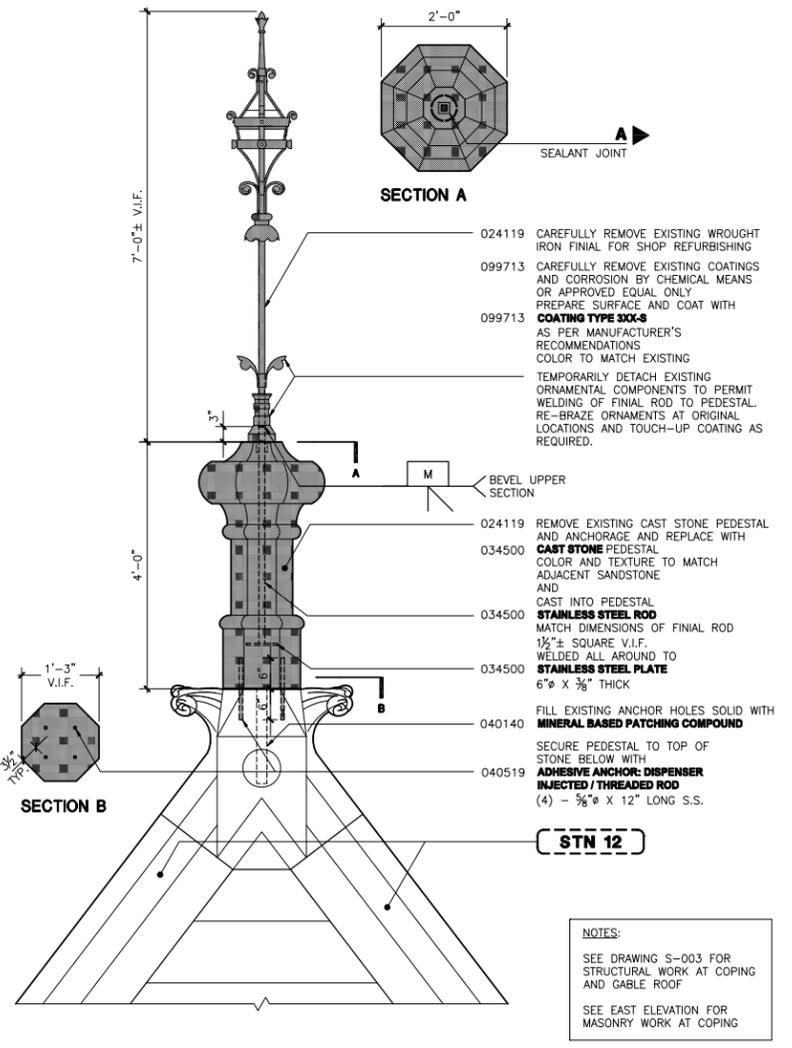
FIN 01
IRON FINIAL RESTORATION: MAIN GABLE

NOTES:
SEE DRAWING S-003 FOR STRUCTURAL WORK AT COPING AND GABLE ROOF
SEE EAST ELEVATION FOR MASONRY WORK AT COPING
