The New York Landmarks Conservancy  
Lucy G. Moses Preservation Awards  
Nomination

708 Broadway  
New York, New York

Exterior Restoration

### On Broadway—Revived Facades Take the Stage at 708.

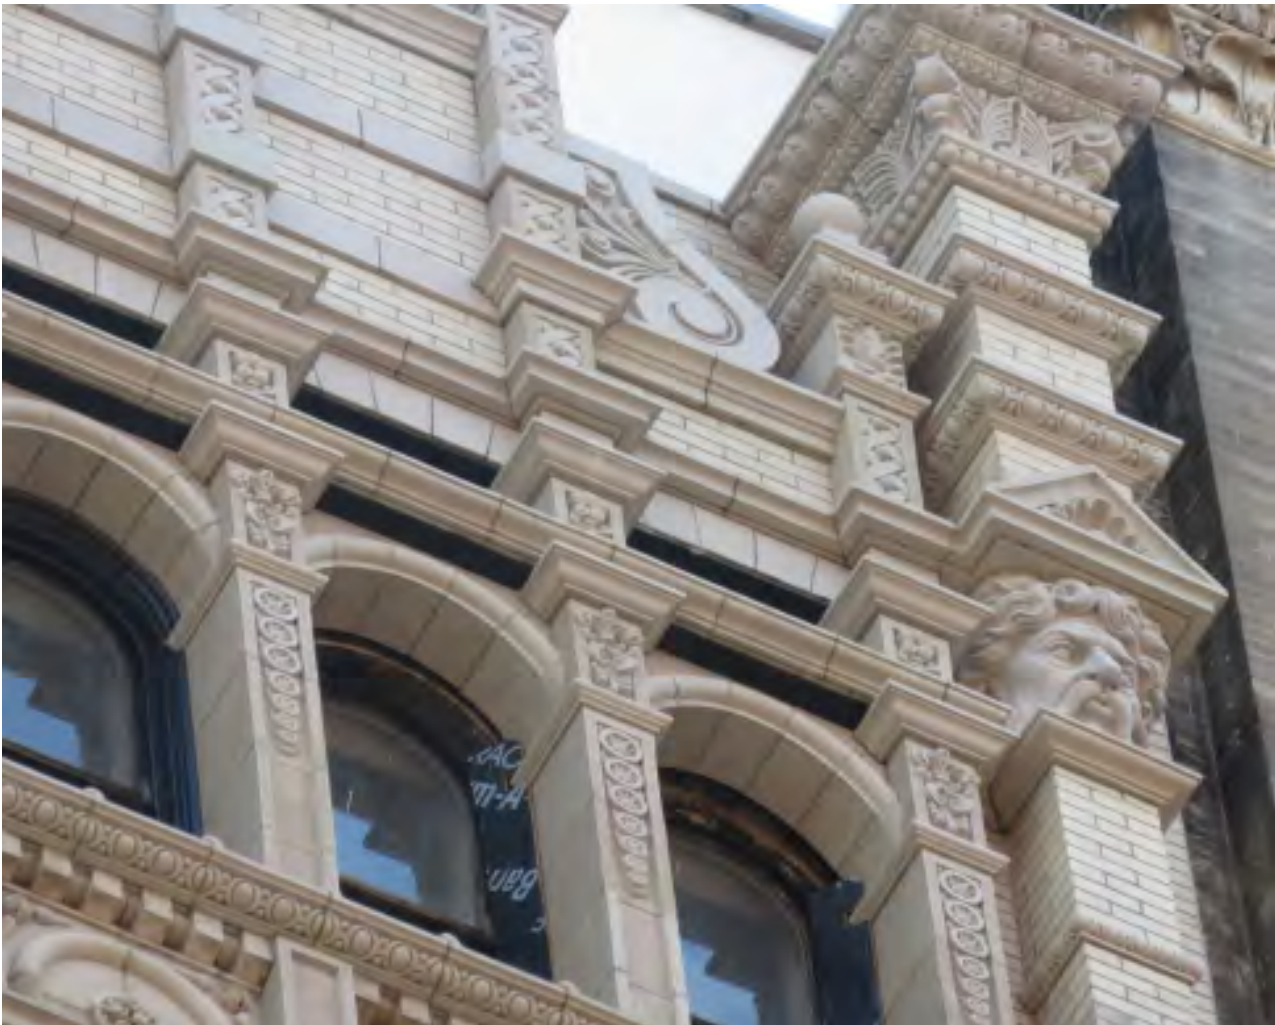
West Facade - Terra Cotta

The repair scope on the western (Broadway-facing) facade included extensive terra cotta replacement and repairs. Most of the existing terracotta units at the upper section of the facade were replaced with new terra cotta manufactured by Gladding McBean. The replacement units included highly decorative elements and sculptures.

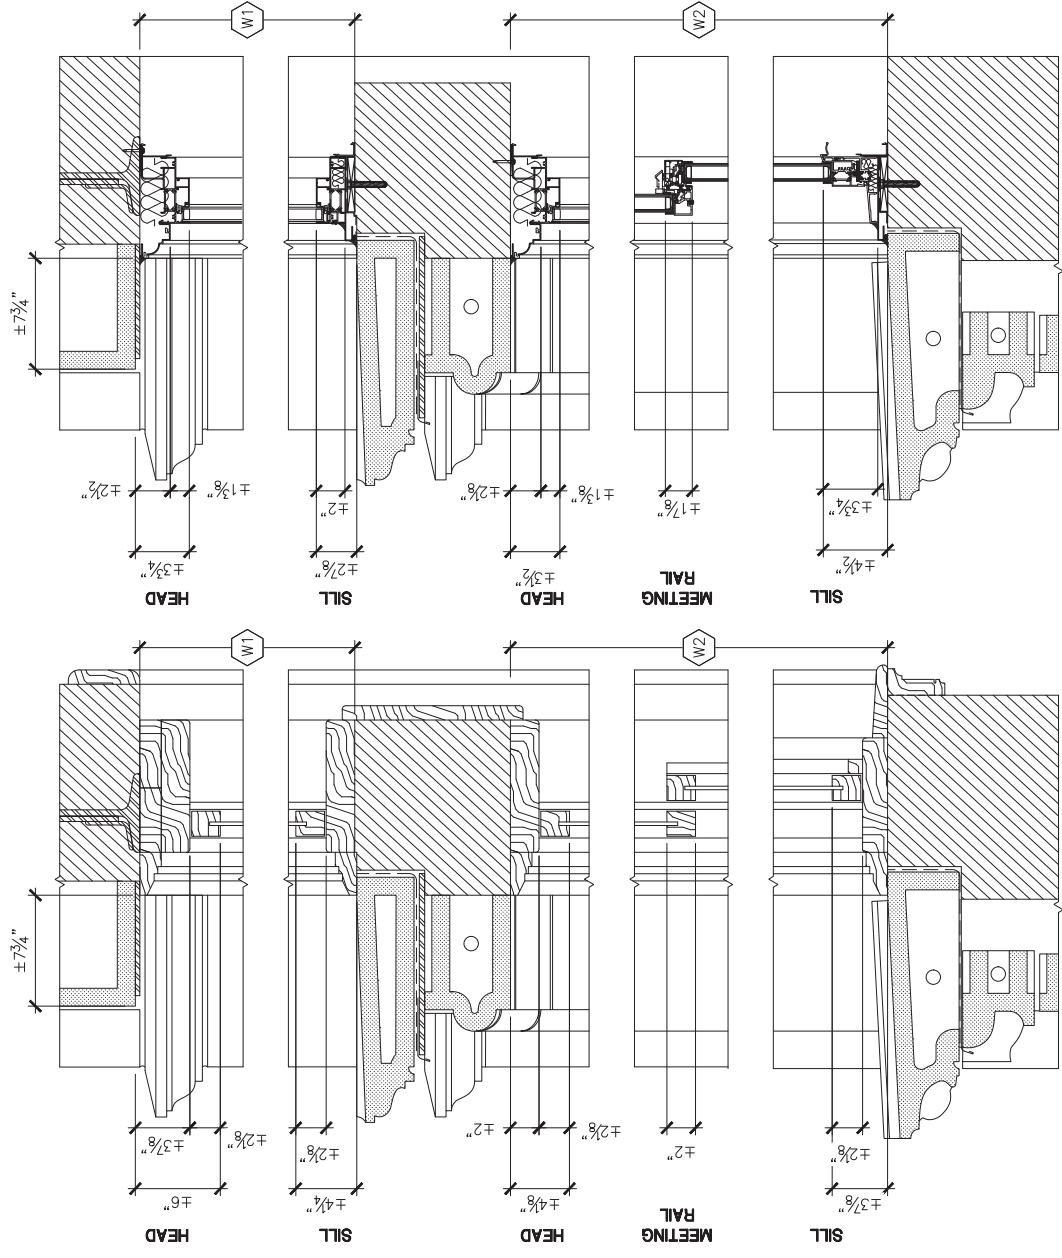
WINDOW TYPE: W1 & W2  
WEST FACADE (PRIMARY)

Eighteen window types were replaced for a total of 119 window units in 83 openings along the west, east, and north facades. Replacement was required due to the following conditions:

- Deterioration of aluminum panning and underlying wood frames
- Cracked or missing glazing
- Inoperable sashes
- Louvers remaining from abandoned HVAC equipment through openings
- Damage to interior finishes due to excessive water infiltration

After work was completed on the facades, the next phase of the restoration involved replacement of the existing window sashes and wood frames with new aluminum windows, matching the original historic window profiles and shapes. The original wood windows had later been retrofitted with aluminum cladding. The windows were replaced with aluminum windows to match the historic wood profiles. The Landmarks Commission eventually ruled that arched windows, which were originally stipulated to be replaced with in-kind material, could be replaced with aluminum as well.
