Low Memorial Library
Columbia University in the City of New York
535 West 116th Street
New York, New York

Interior Restoration -
Main Entrance and South Ambulatory (Foyer)

Low Memorial Library – A Treasured Interior Landmark Shines Anew

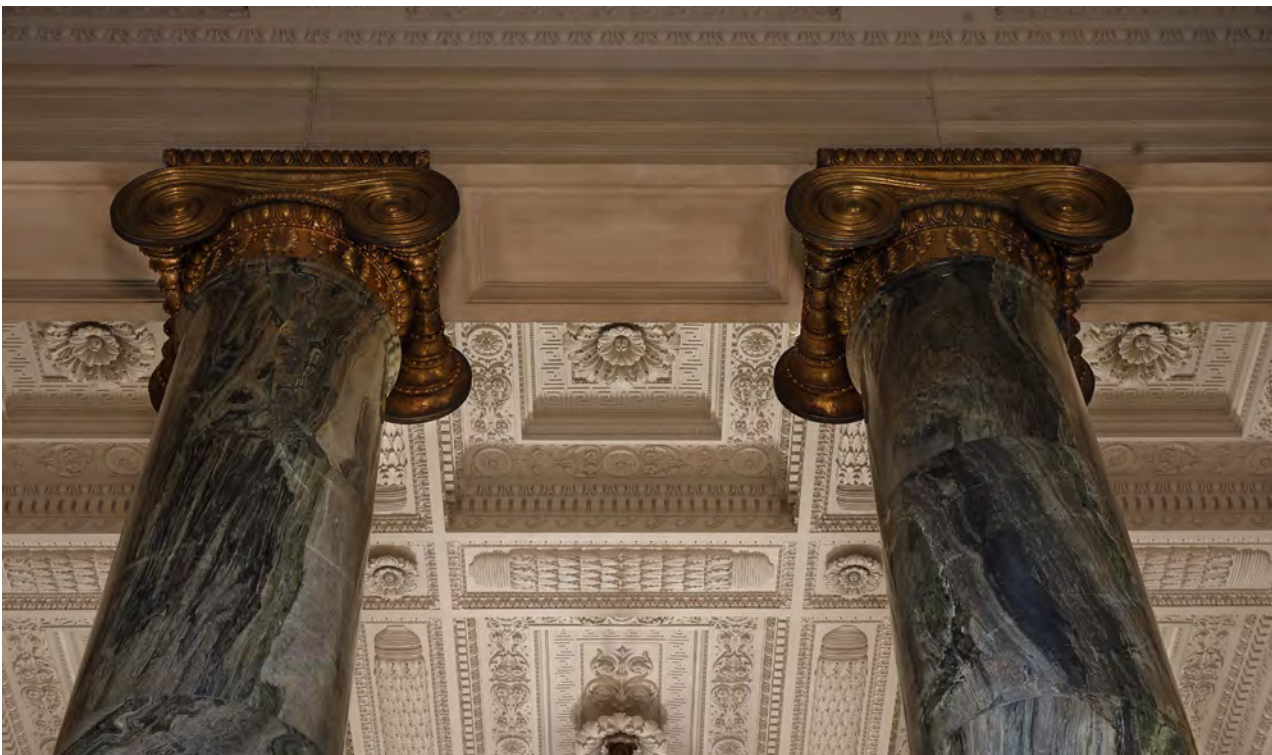
Plaster ceiling, marble columns with bronze capitals, after restoration. Photo: Whitney Cox

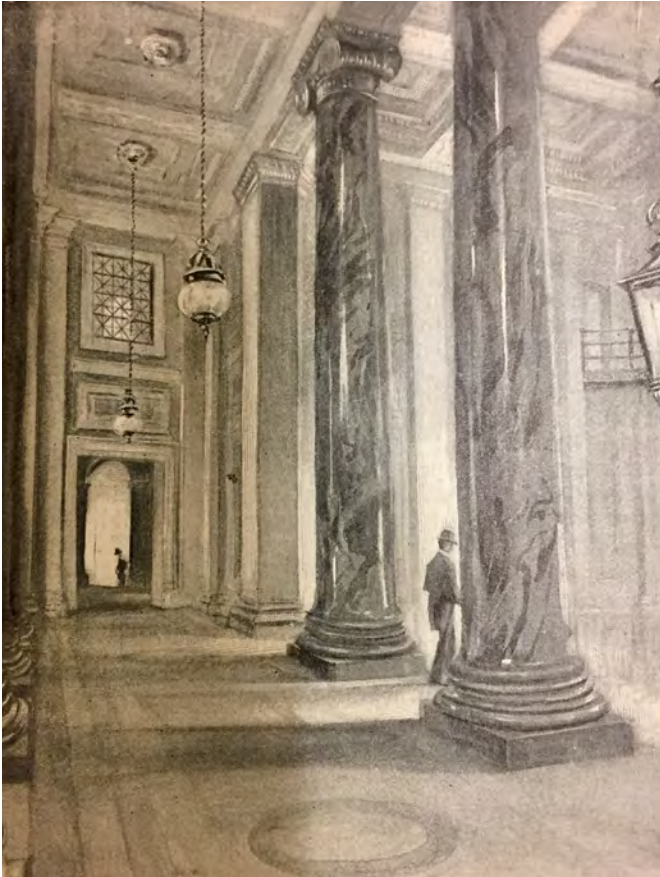
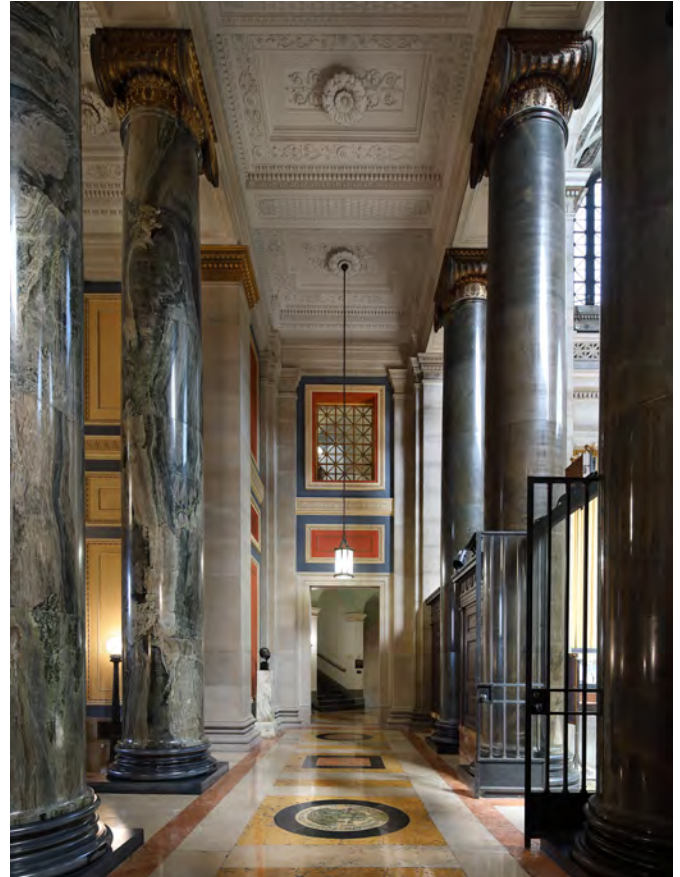
Right: South Ambulatory: historic drawing from the Historical Photograph Collection, Rare Book and Manuscript Library, Columbia University. Left: Ambulatory pictured after current restoration (photo: Whitney Cox).

The Main Entrance decorative plaster ceiling had been subjected to water penetration in several locations and was in poor condition in these areas--exhibiting wide cracks, displacement, disaggregation, loss, and widespread staining. The ceiling had been largely untouched prior to the subject restoration, so exhibited 100 years of deterioration, dirt, and grime.

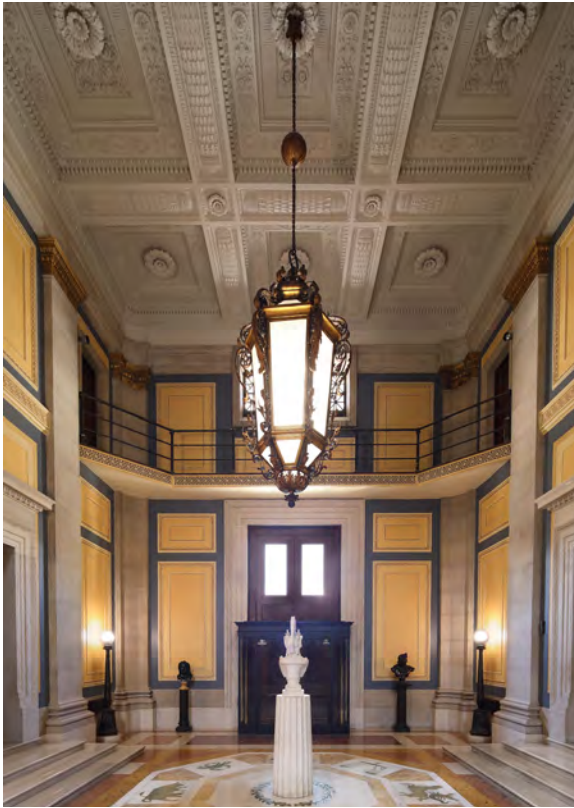
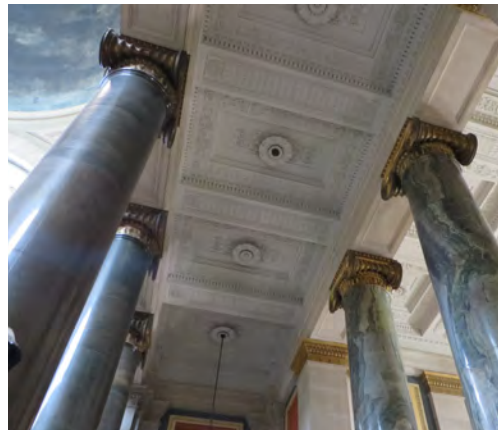
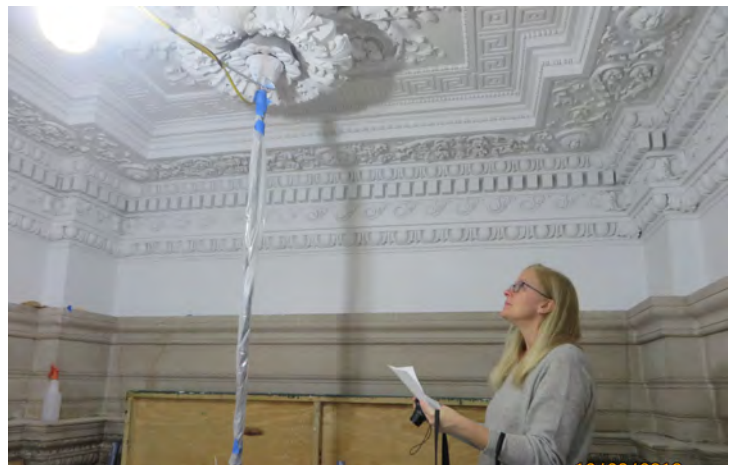
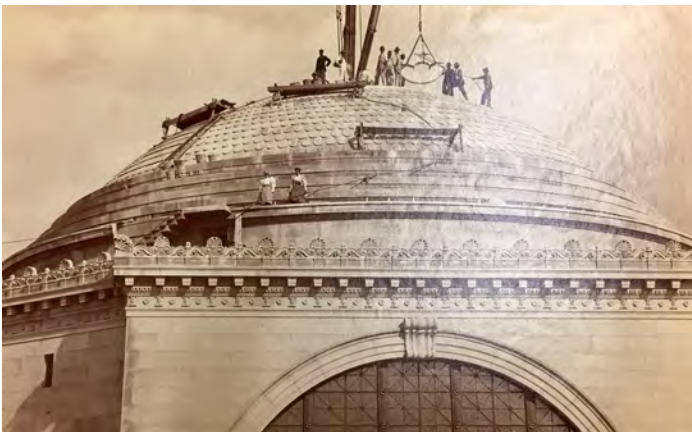
*Top left: Cleaning mock-up at plated bronze;
Bottom left: Plated bronze capital before
cleaning; Bottom middle: limestone before
repair; Top left; base of limestone pilaster af-
ter restoration; Bottom right: Gilded limestone
column capital after cleaning*

Cracks in all surrounding limestone below the ceiling were repaired. Deteriorated and loose material was removed. Infill mortar was carefully matched to the existing stone in color and texture. All limestone was cleaned, as were gold-plated bronze column capitals, gilded limestone column capitals, chandeliers in the Main Entrance and South Ambulatory, and the bronze window frame and glass over the entrance.
