The New York Landmarks Conservancy Lucy G. Moses Preservation Awards Submittal

Rod Rodgers and Duo Multicultural Arts Center 62 East 4th Street New York, New York

Exterior Restoration

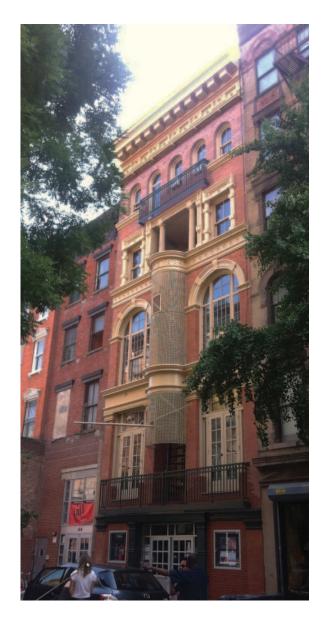
Front Spiral Staircase and Rear Fire Escape

It was discovered that the steel supporting the circular iron fire escape stairway on the front facade of the building was extremely deteriored. The entire stairway was shored up to allow for replacement of the steel. Restoration of the staircase also involved cast iron and steel repairs to cracked and missing sections, though nearly all of the original fabrication was retained. The deteriorated rear fire escape was replaced with a new steel stair. Paint analysis guided the final coating of the staircase and lattice cage, which were meticulously scraped of all existing rust.
