The New York Landmarks Conservancy
Lucy G. Moses Preservation Awards
Submittal

Jefferson Market Library
425 Avenue of the Americas
New York New York

Exterior Renovation

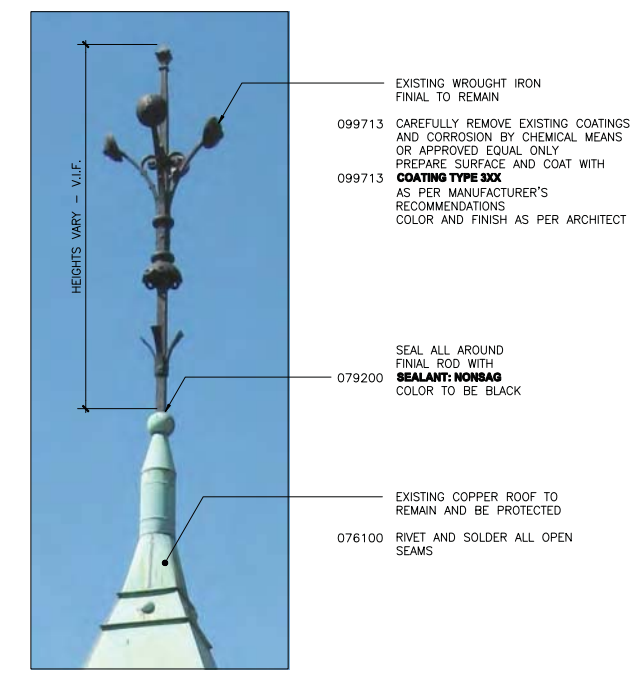
PHOTO: IRON FINIAL AT COPPER ROOF CAPS

FIN 04
IRON FINIAL RESTORATION: AT COPPER ROOF CAPS
NOT TO SCALE

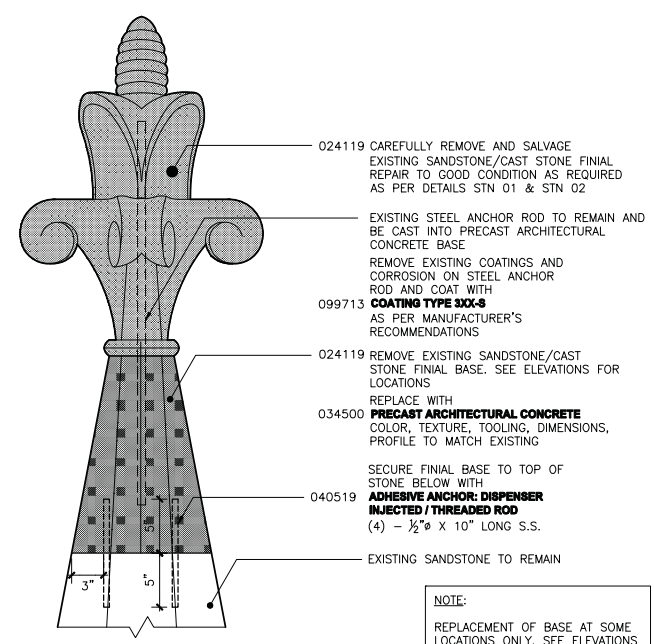
FIN 05
SANDSTONE FINIAL RESTORATION: ENTRANCE PORTAL

NOTE:
REPLACEMENT OF BASE AT SOME LOCATIONS ONLY. SEE ELEVATIONS FOR LOCATIONS.

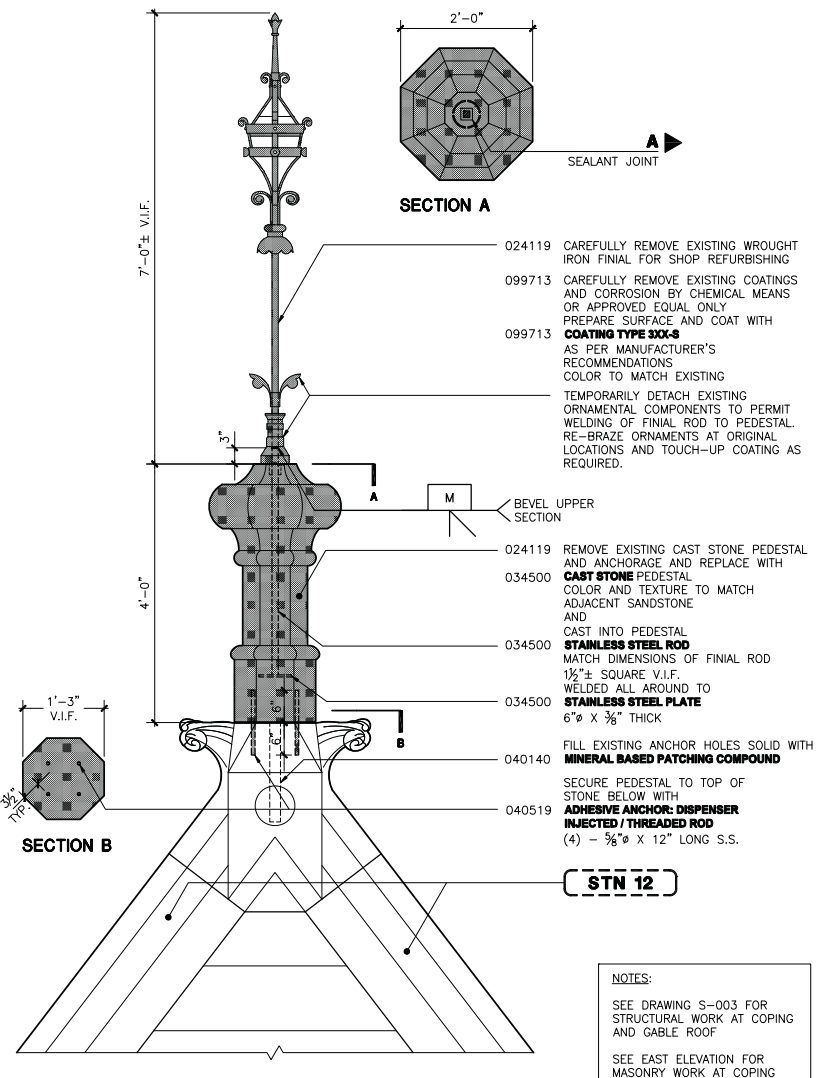
FIN 01
IRON FINIAL RESTORATION: MAIN GABLE

The finial bases were spalling and breaking up because of the corrosion of the finial ironwork. New stone blocks were installed and the finials were re-set. Finials were restored as necessary off site. The drawing on the following page details additional repairs to sandstone and iron elements of various of the many finials on the building.
