The New York Landmarks Conservancy  
Lucy G. Moses Preservation Awards  
Nomination

St. Paul's Chapel  
209 Broadway  
New York, New York

Exterior Restoration

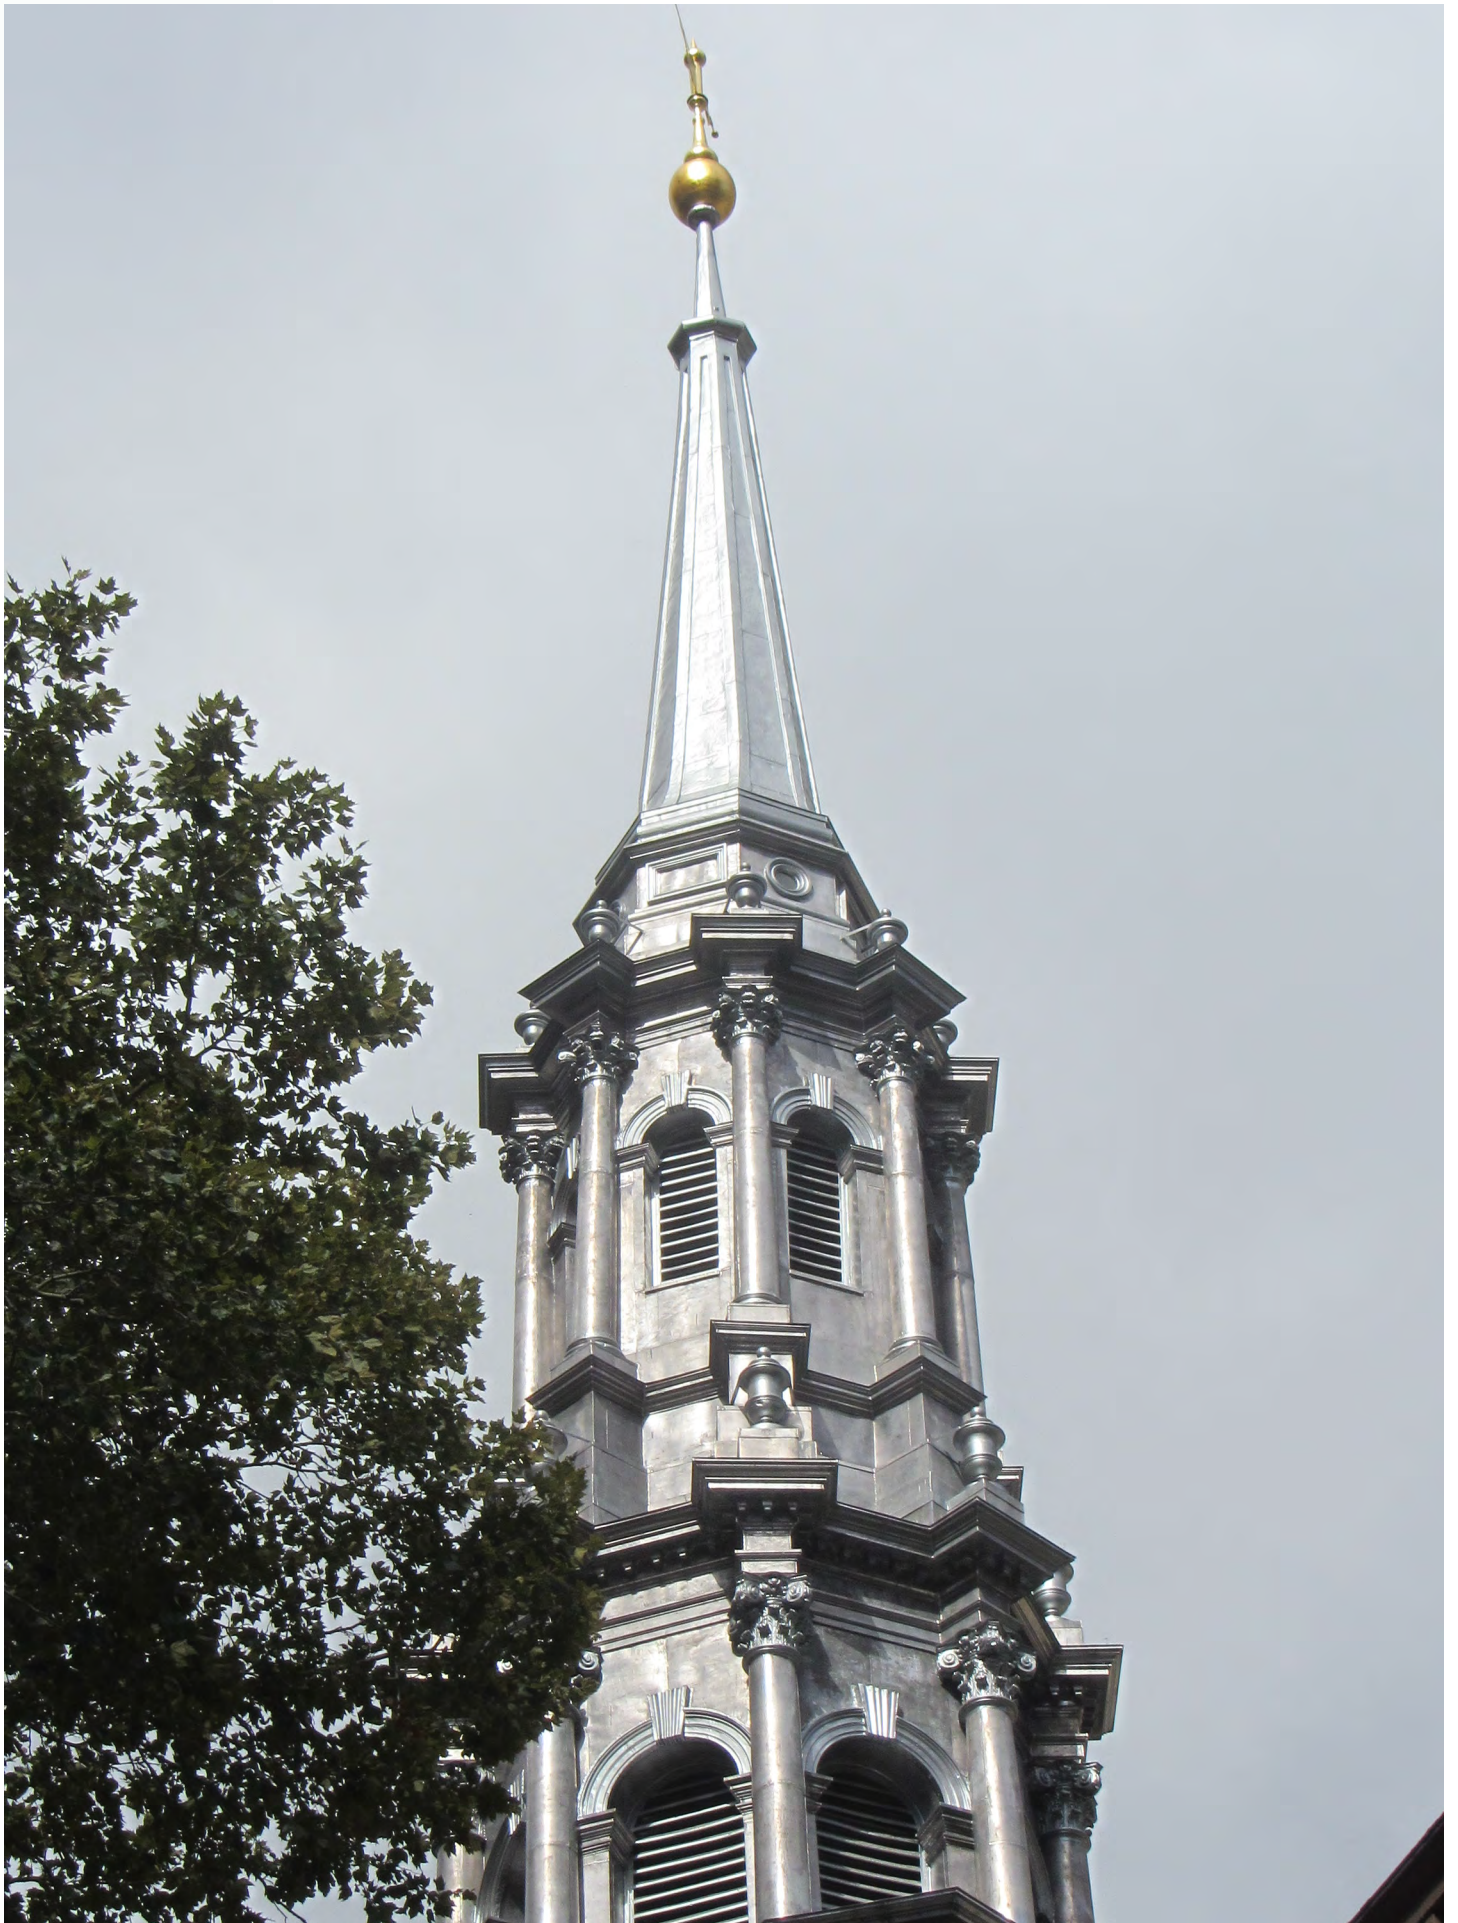
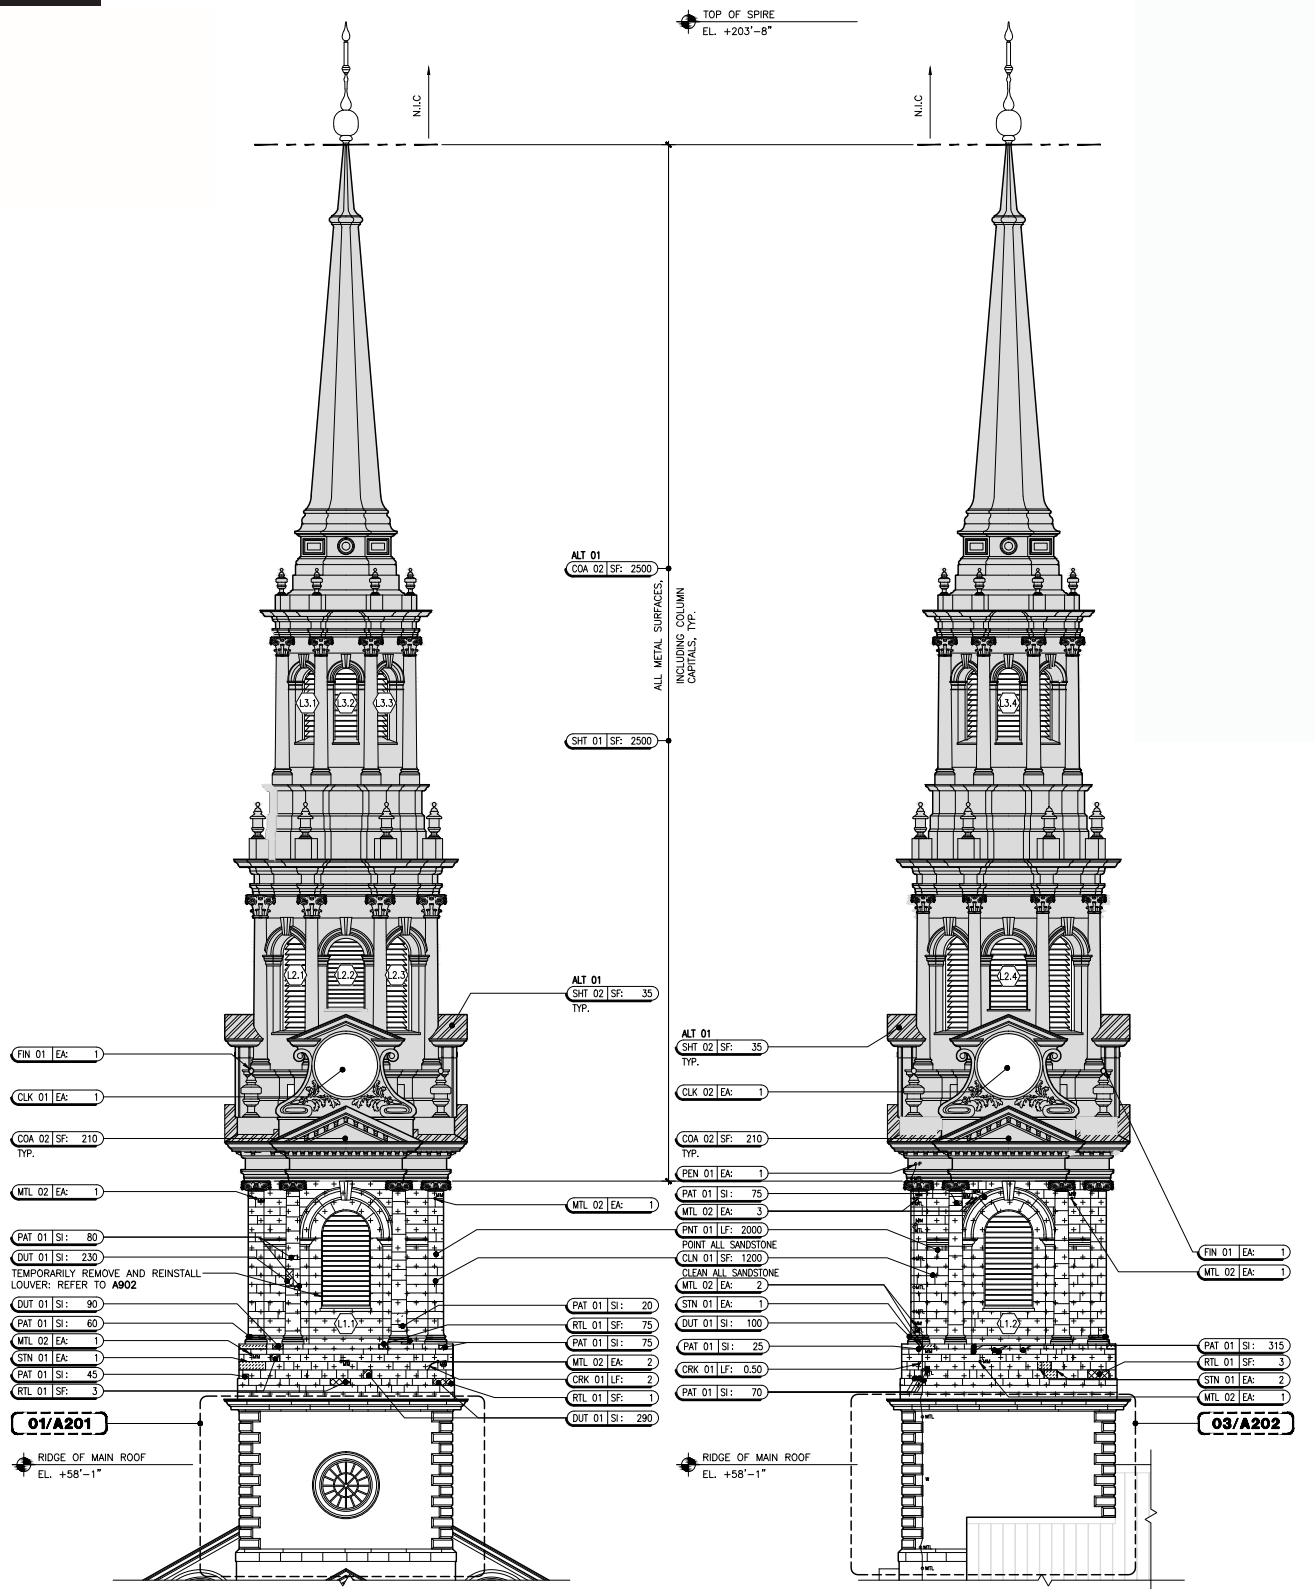
TOWER WEST ELEVATION

TOWER SOUTH ELEVATION

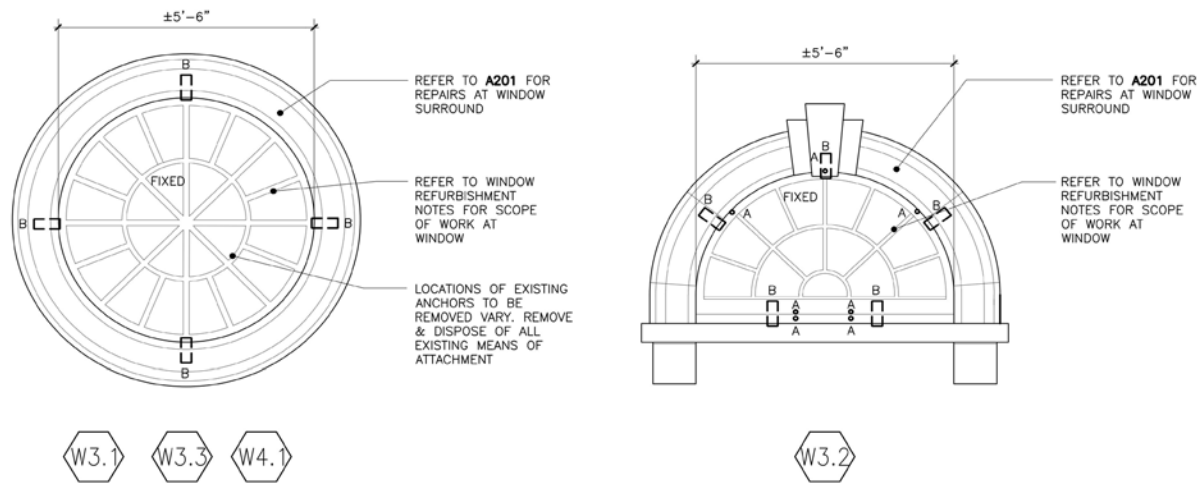
## 02

### WINDOW REFURBISHMENT: TYPE 02

1. REMOVE SASHES FROM MASONRY OPENINGS.
2. CAREFULLY REMOVE & STORE EXISTING SOUND GLAZING, REMOVE & DISPOSE OF PUTTY.
3. REMOVE & DISPOSE OF EXISTING ANCHORS AND MEANS OF ATTACHMENT. STRIP PAINT FROM ALL EXPOSED COPPER-CLAD SURFACES, EXTERIOR & INTERIOR FACES.
4. REPAIR EXISTING OPEN SEAMS IN COPPER CLADDING WITH COPPER RIVETS AND SILICONE SEALANT.
5. REINSTALL EXISTING GLAZING WITH NEW WINDOW PUTTY.
6. PAINT ALL EXPOSED COPPER-CLAD SURFACES.
7. INSTALL NEW HEAVY DUTY SOLID BRASS BRACKETS WITH BRASS ANCHORS TO MATCH EXISTING.
8. INSTALL NEW PERIMETER WEATHER-STRIPPING, TO BE 1-1/4" BRONZE ATTACHED TO SASH WITH #16x7/8" WEATHERSTRIP NAILS, ZERO INTERNATIONAL #19WB, OR EQUAL.
9. REINSTALL SASHES IN EXISTING MASONRY OPENINGS AFTER WORK TO SANDSTONE SURROUND IS COMPLETED.
