TERRA COTTA CRACK REPAIR

Drawing Title:
TERRA COTTA REPAIR DETAILS —

MASONRY REPLACEMENT AND STONE REPAIR DETAILS

CONCRETE REPAIR DETAILS

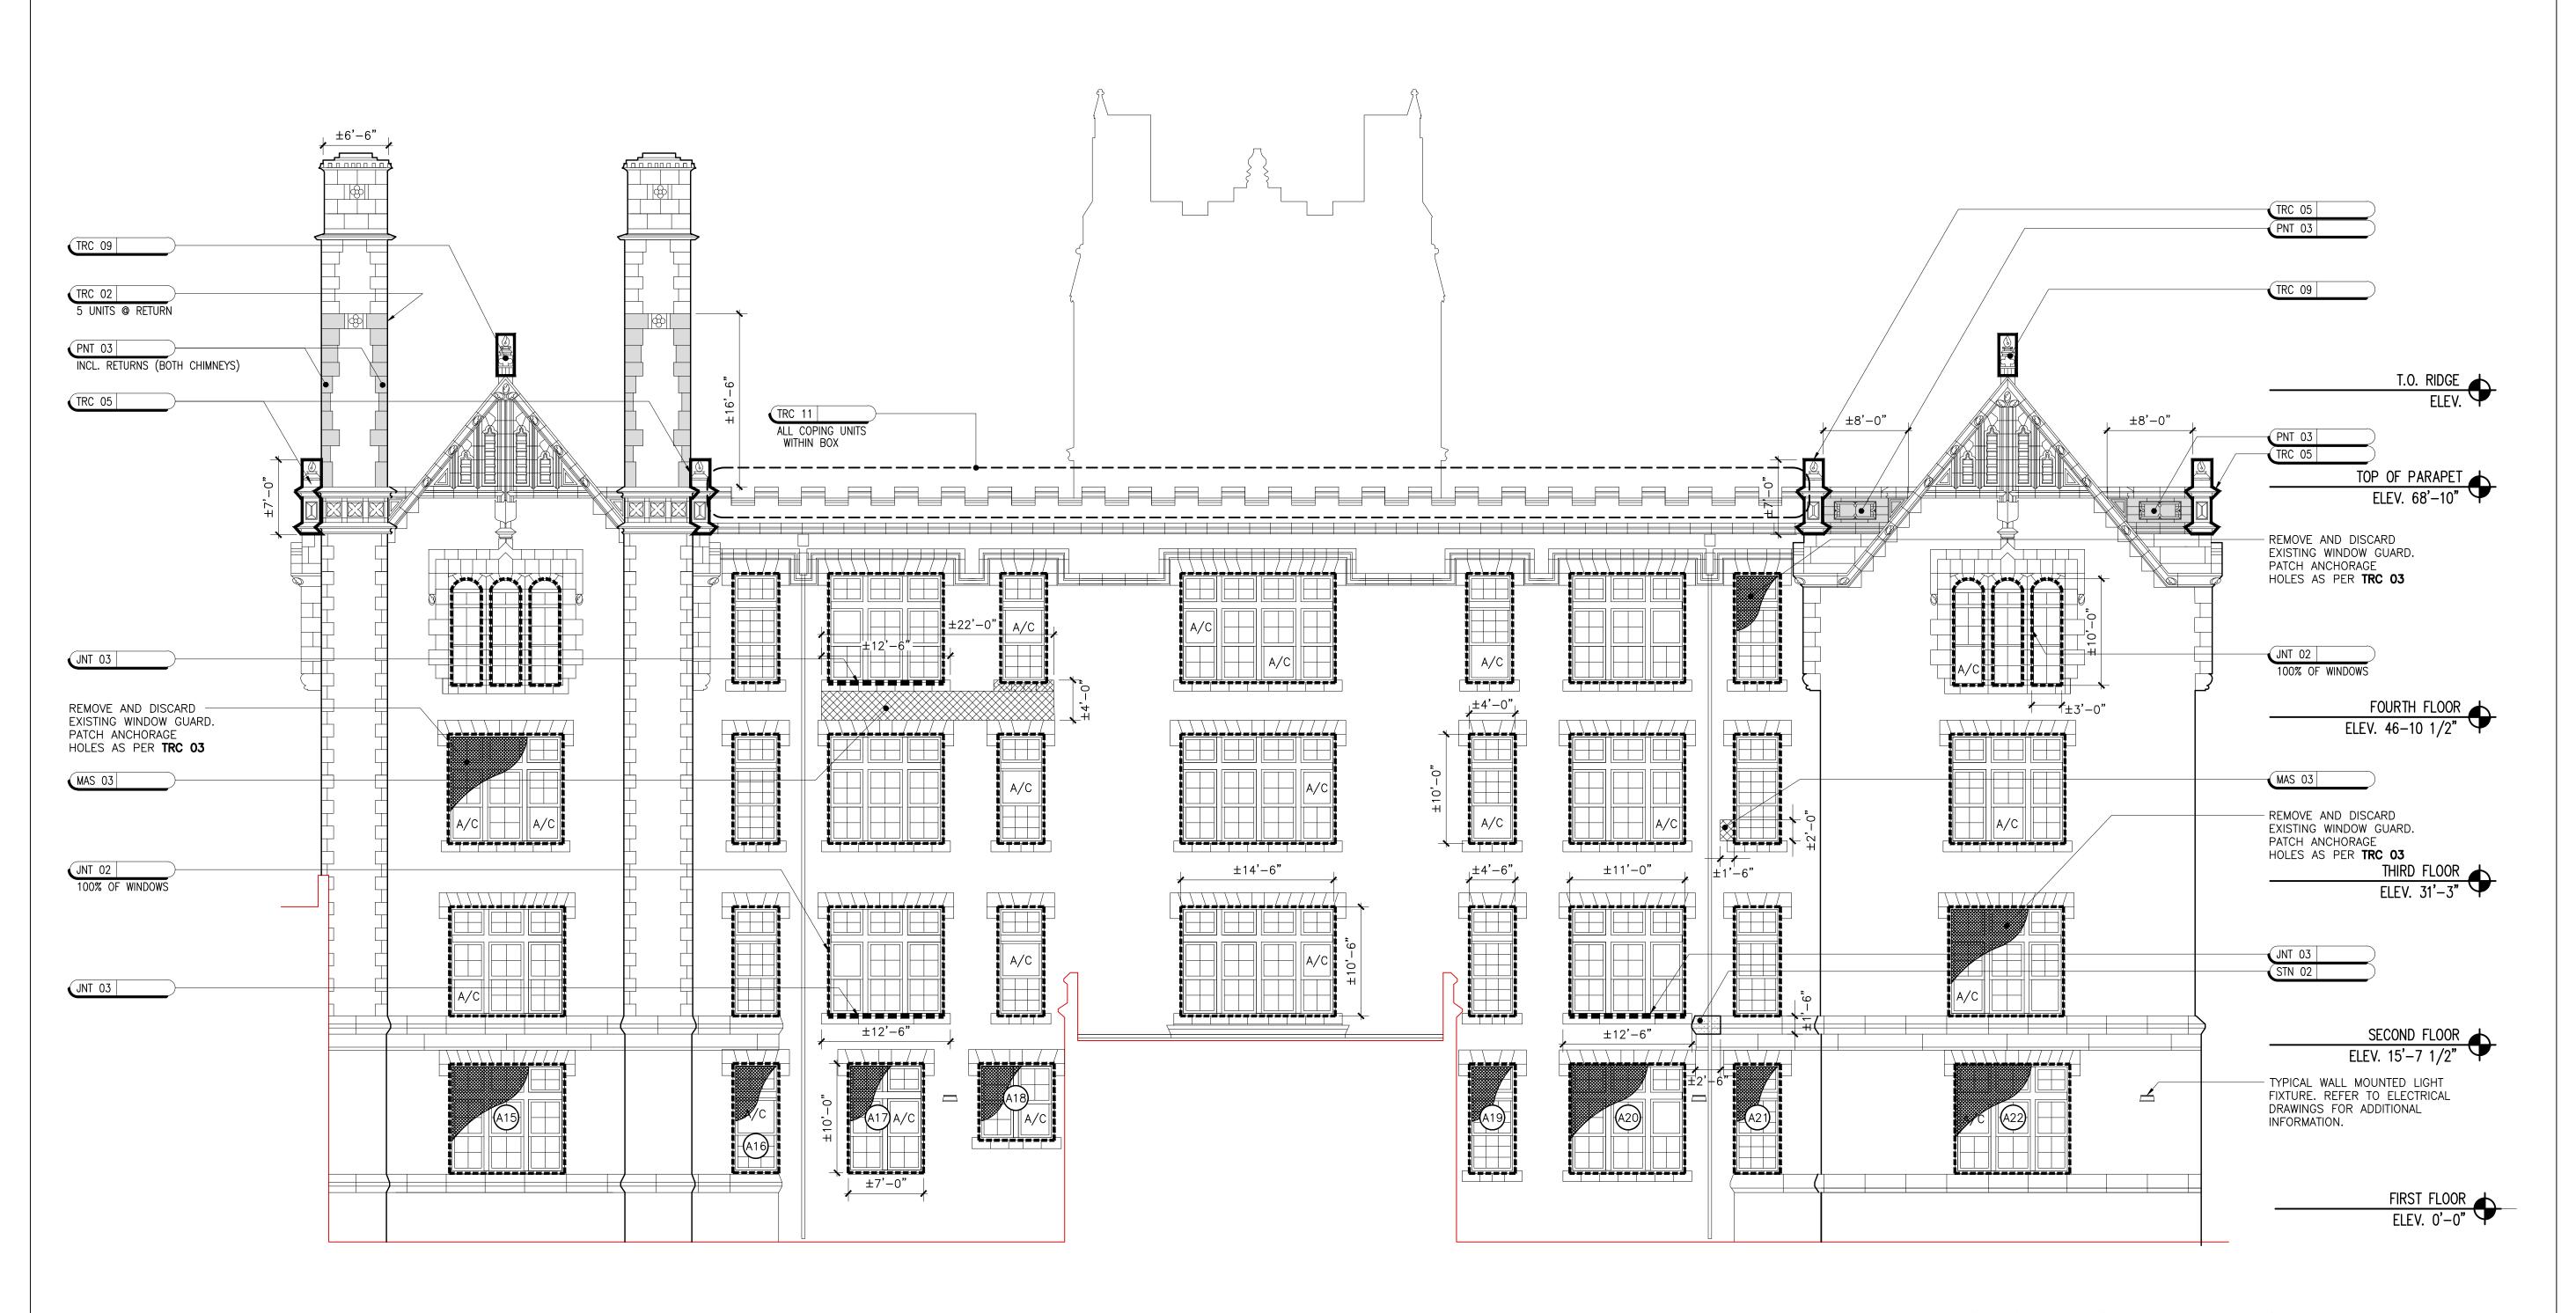
MAIN BUILDING

WEST ELEVATION - B

MAIN BUILDING WEST ELEVATION

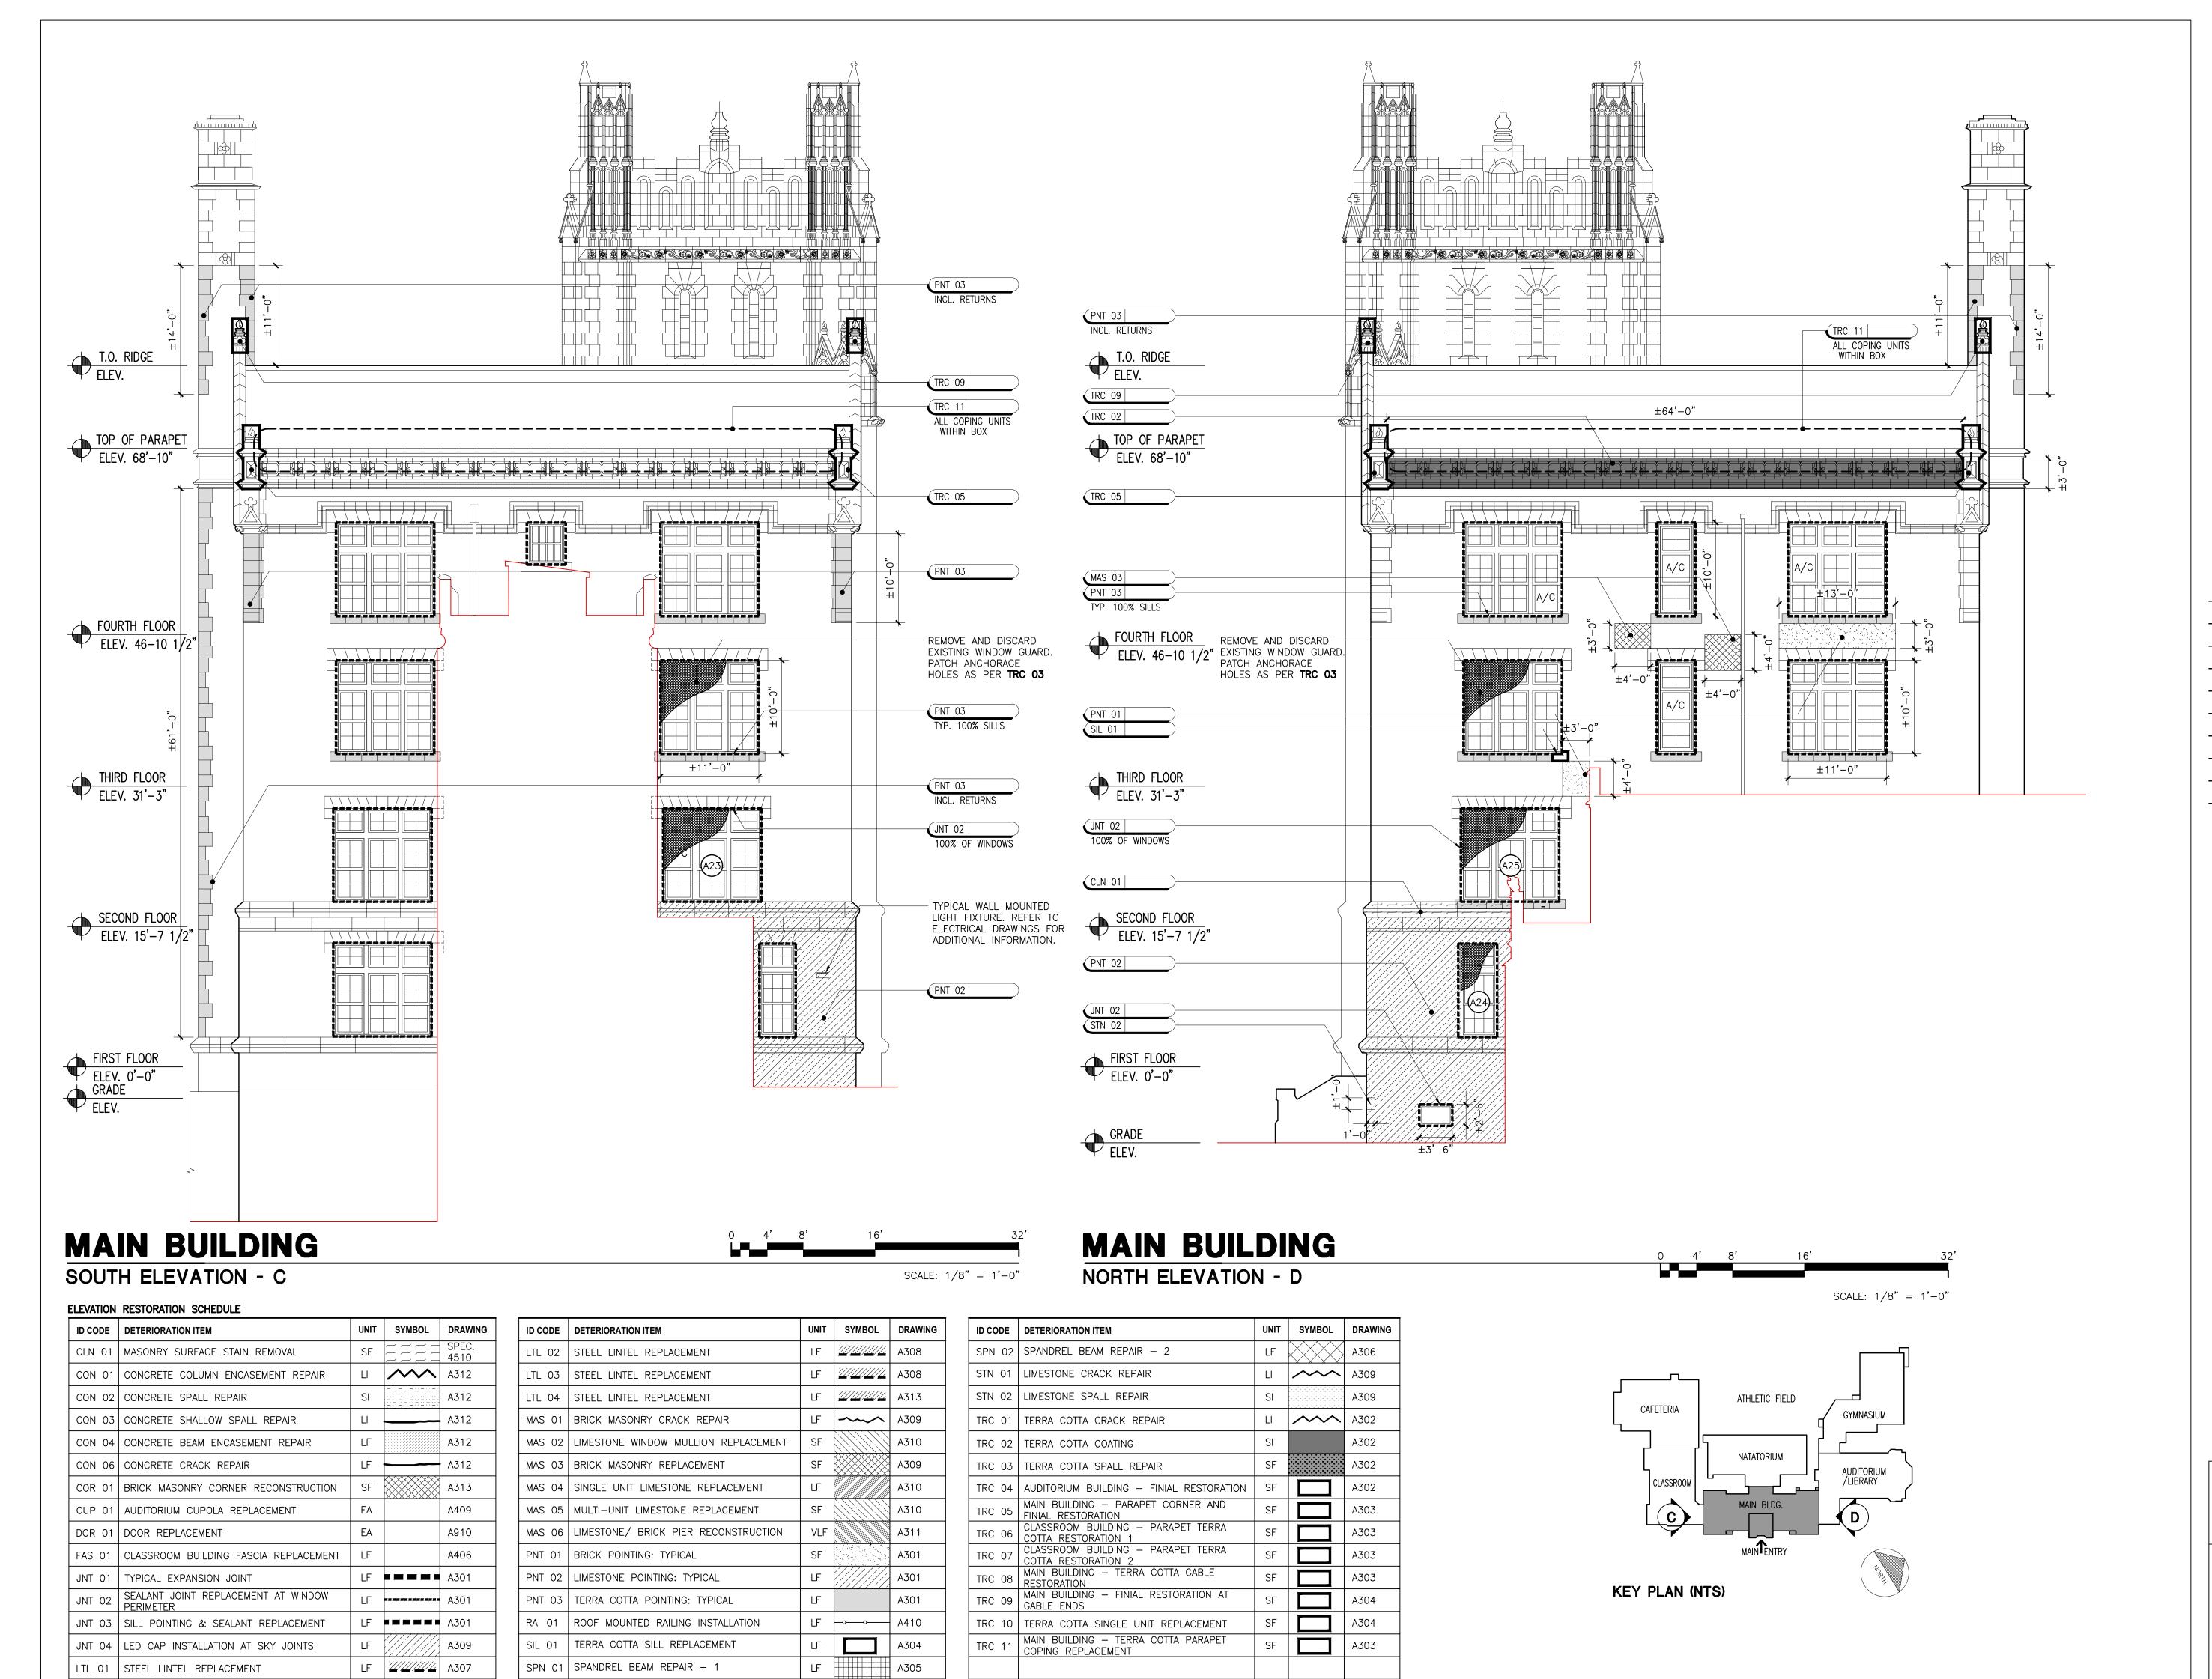
MAIN BUILDING

SOUTH & NORTH ELEVATIONS

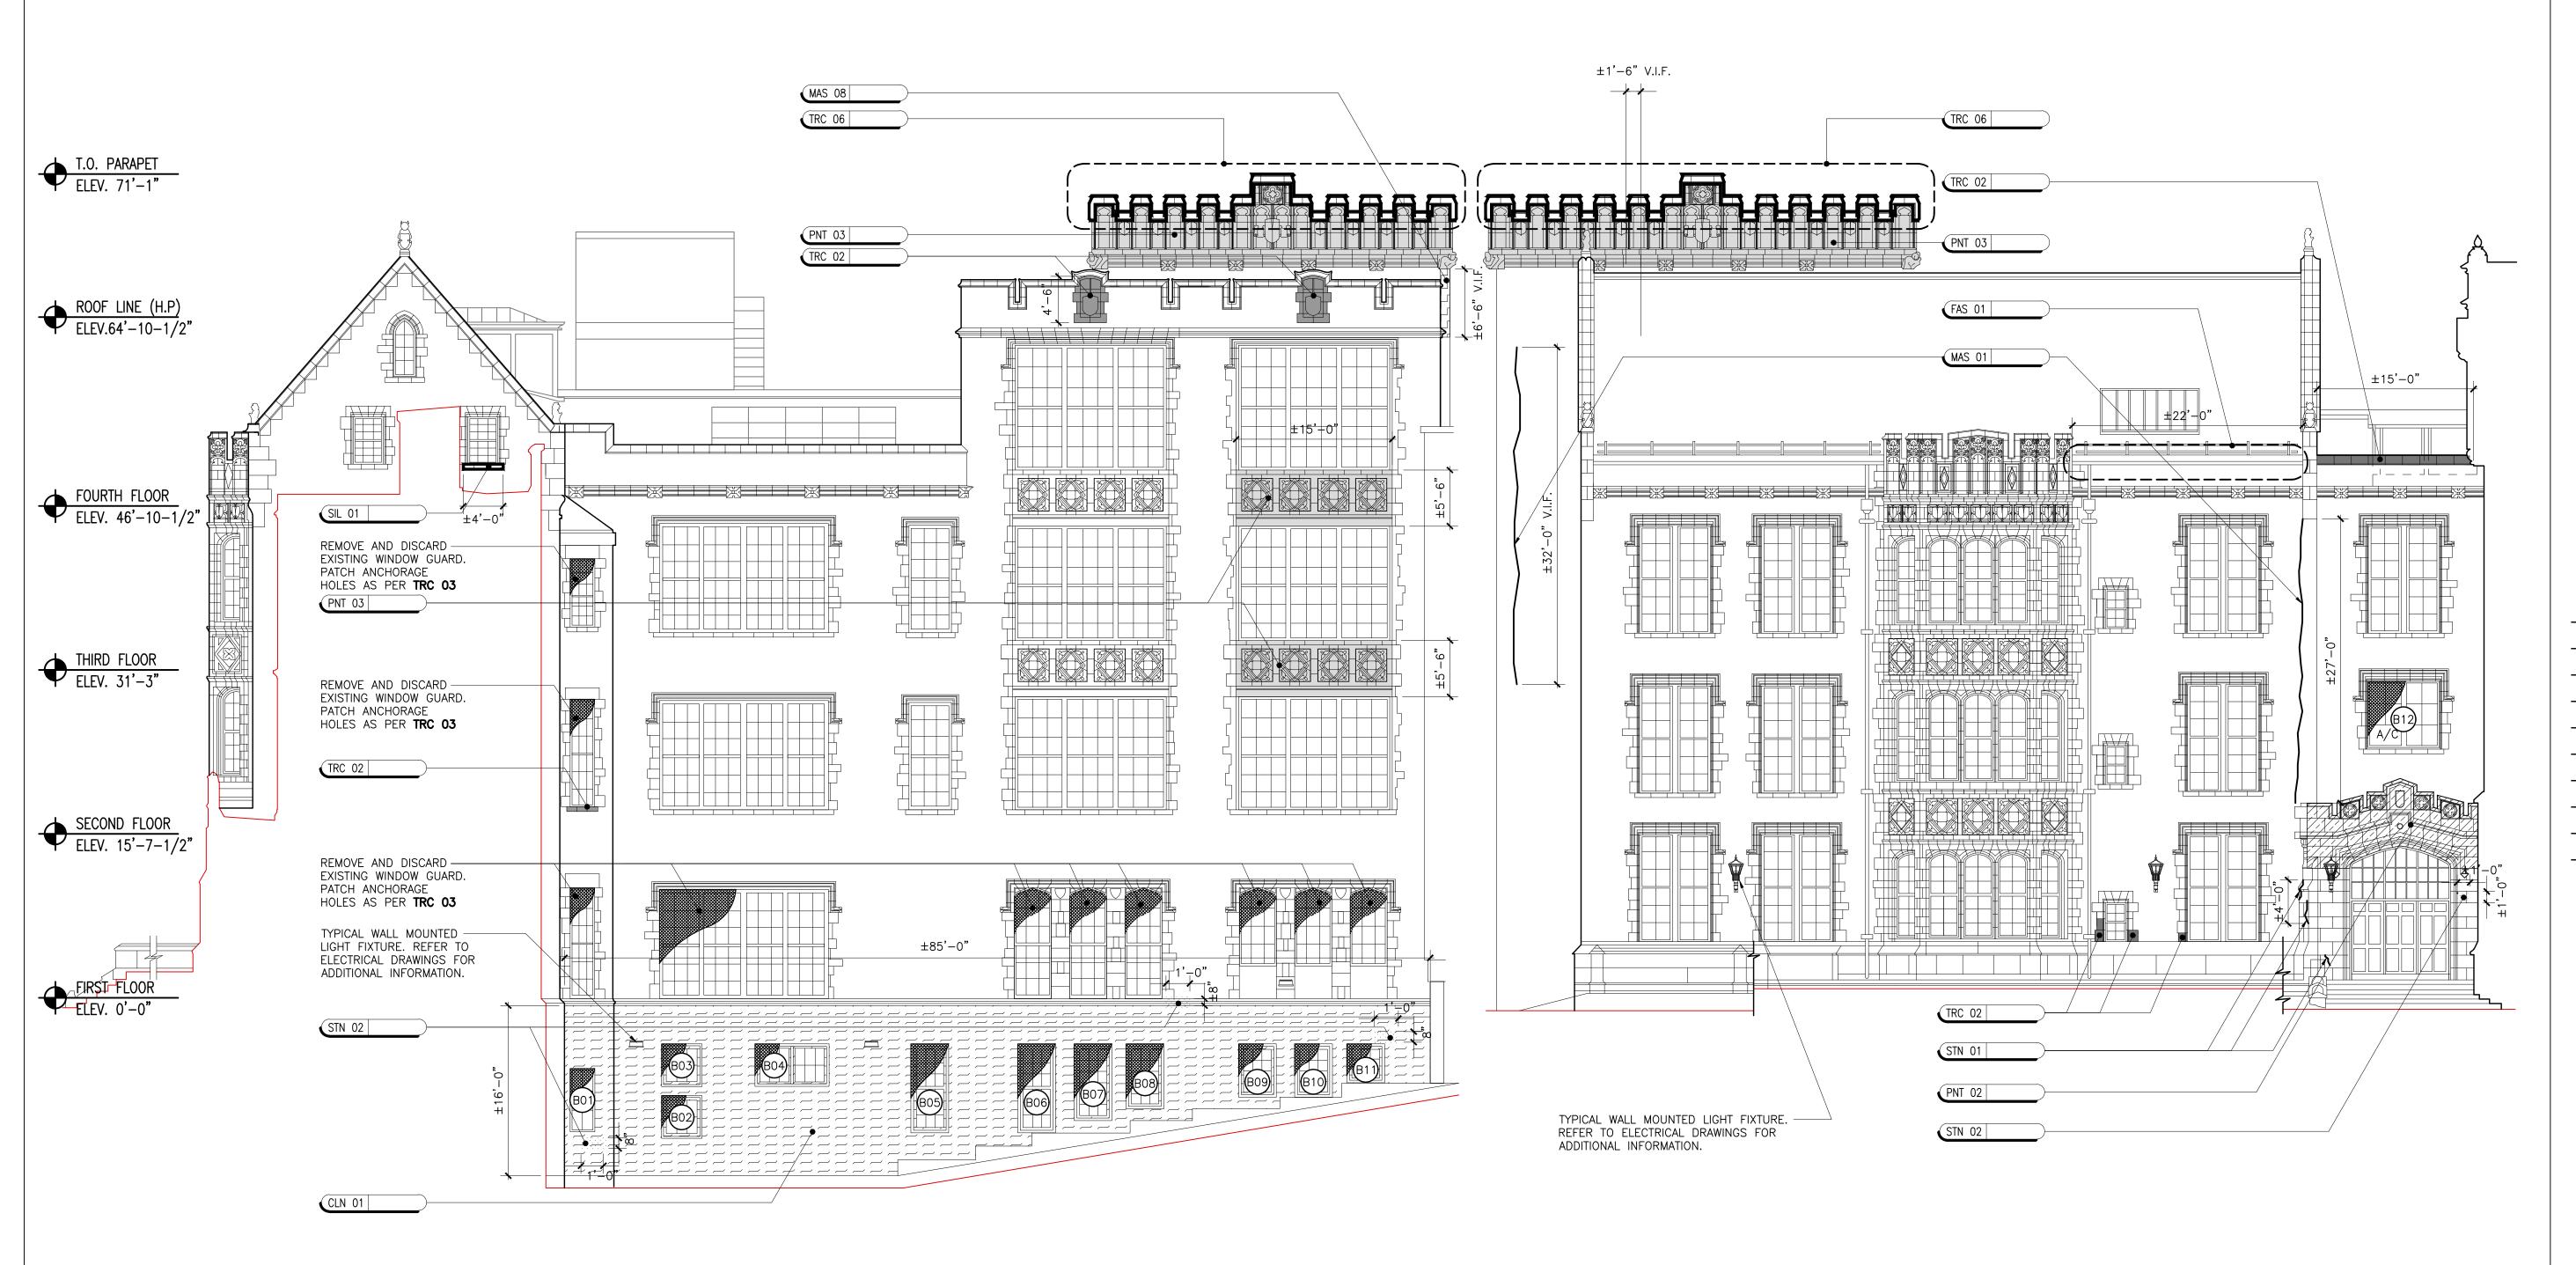
CLASSROOM BUILDING

NORTH ELEVATION - E

Drawing Title:
CLASSROOM BUILDING
NORTH & EAST ELEVATIONS

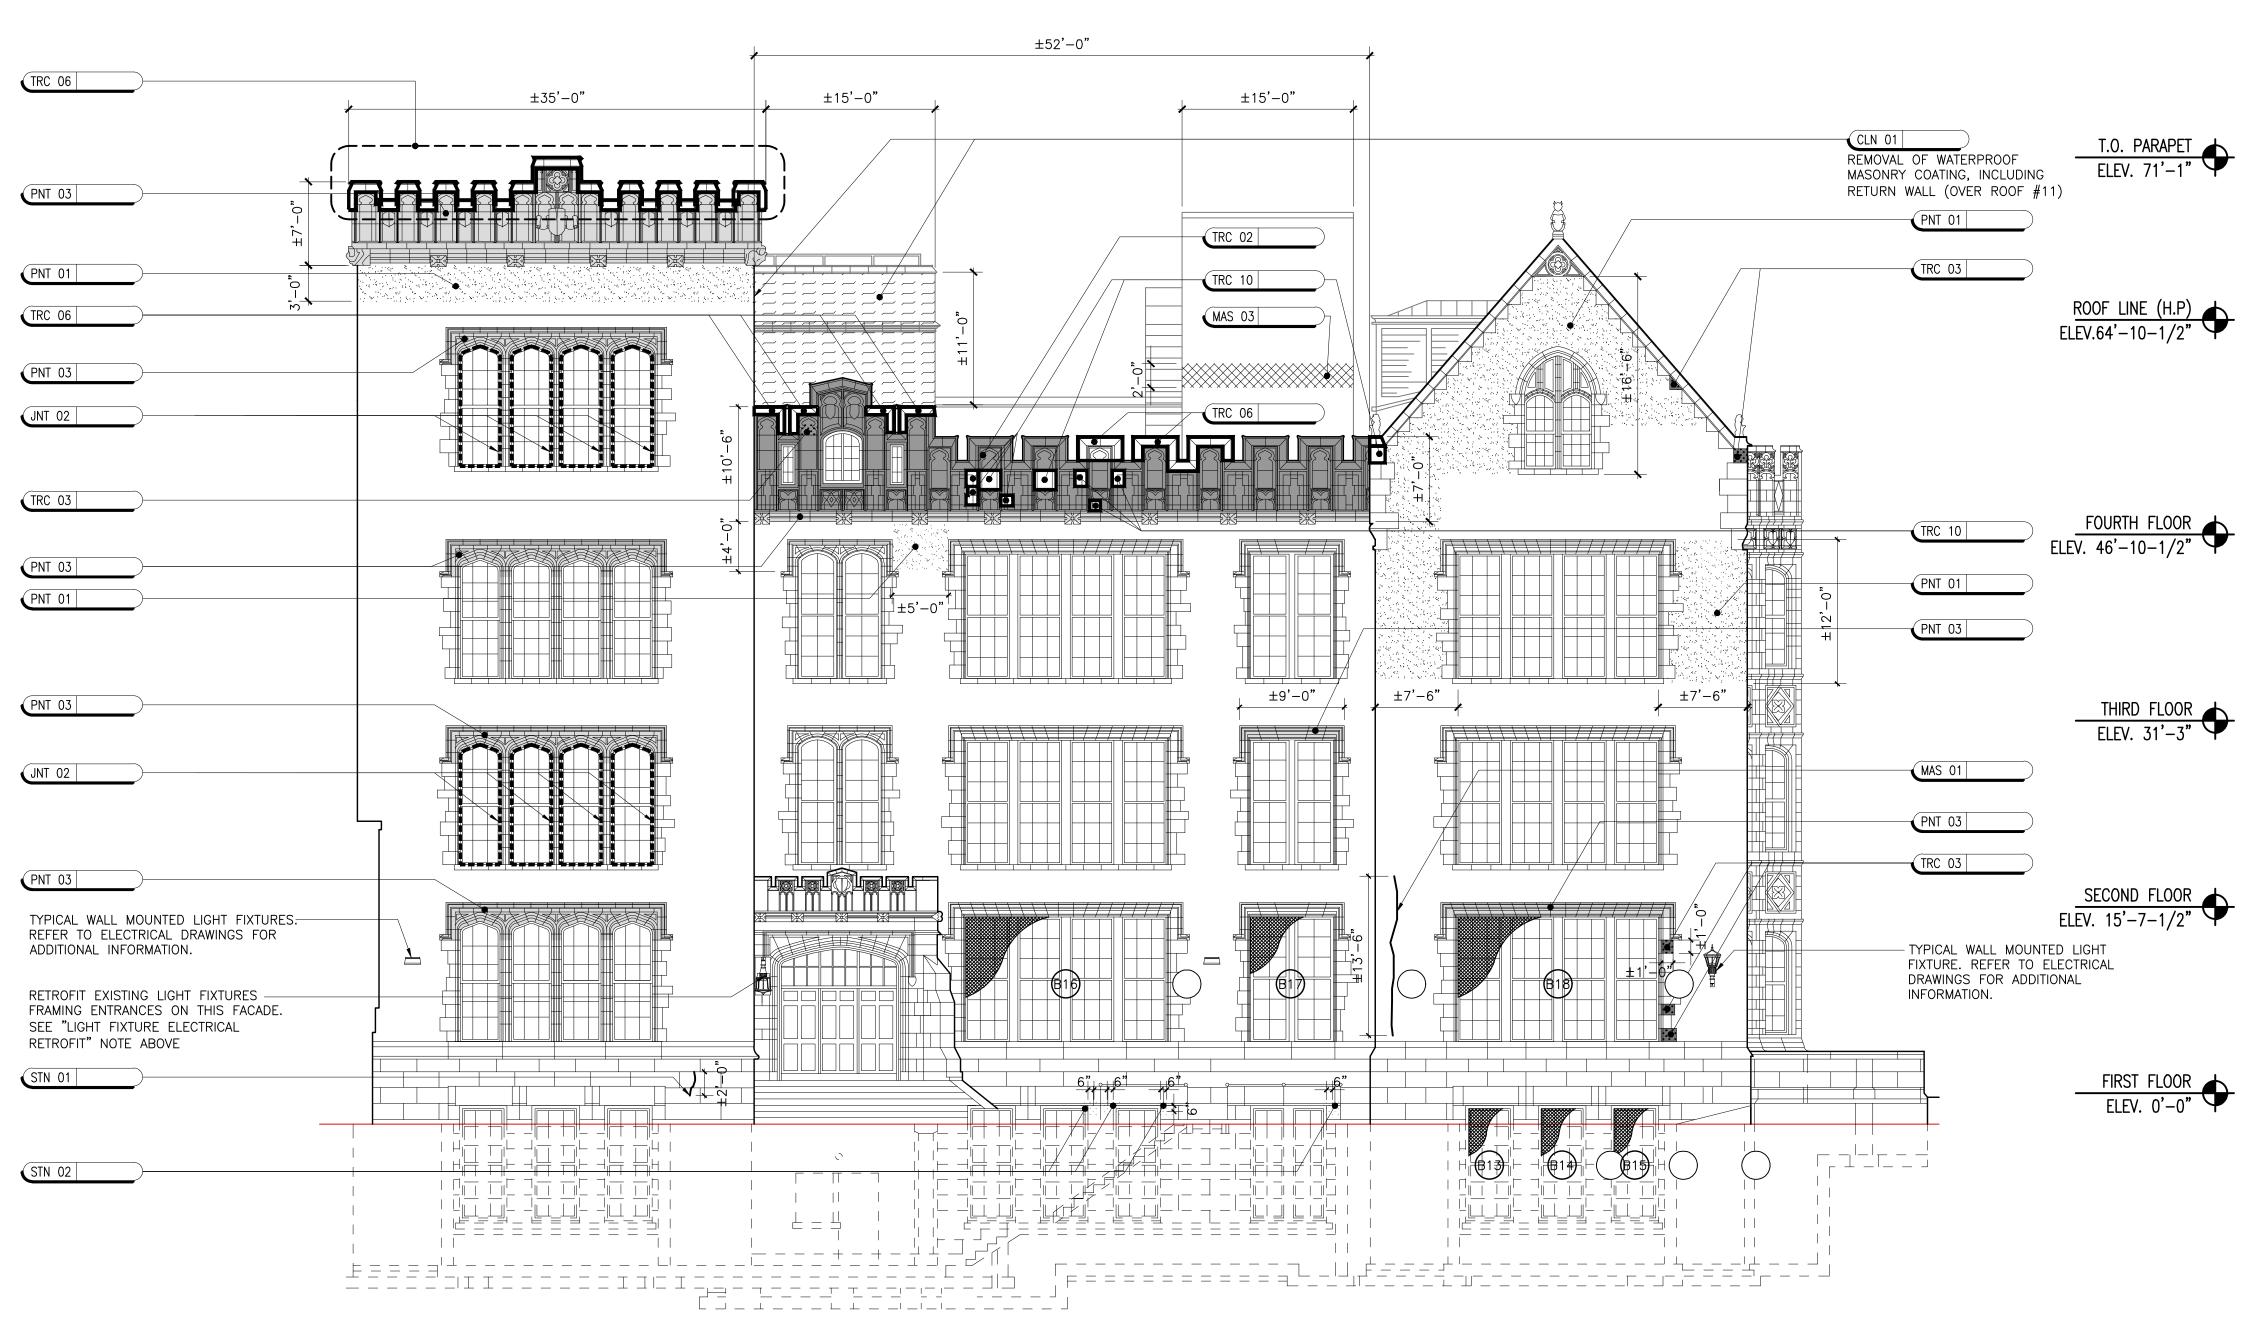
CLASSROOM BUILDING

SOUTH ELEVATION - G

Drawing Title:
CLASSROOM BUILDING
SOUTH ELEVATION

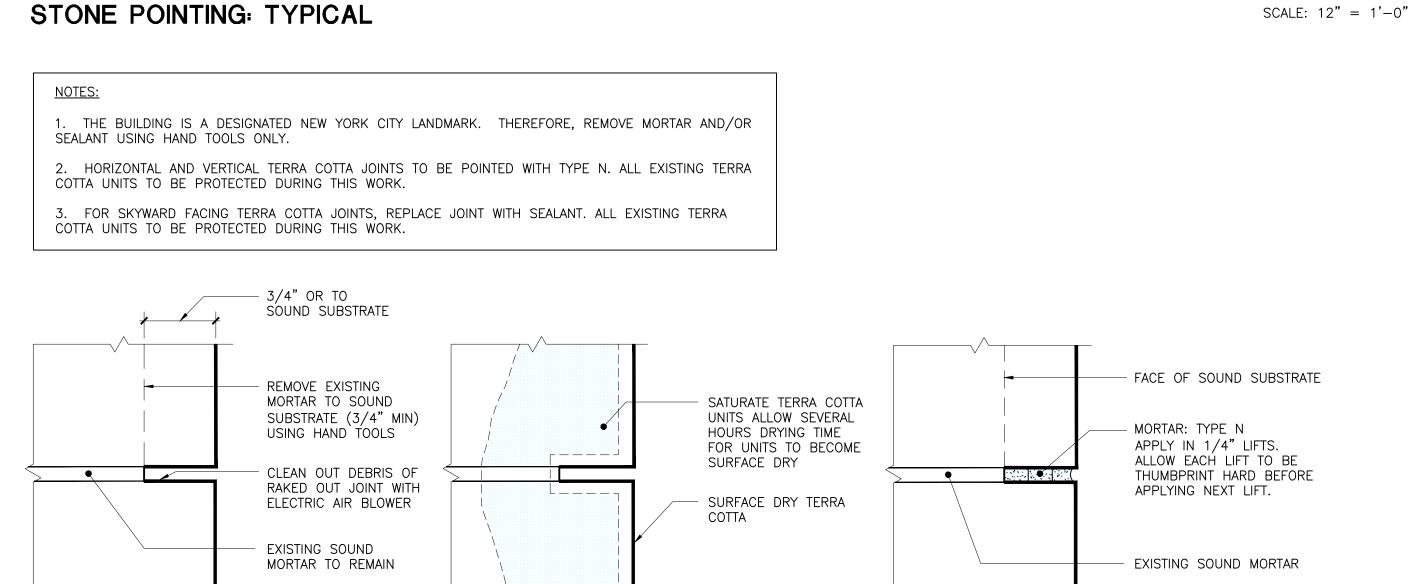
PNT 03

STEP 2: PRE-WETTING OF

TERRA COTTA UNITS

STEP 3: APPLICATION

OF MORTAR

— EXISTING TERRA COTTA

UNITS TO REMAIN

STEP 1: MORTAR REMOVAL

TERRA COTTA POINTING

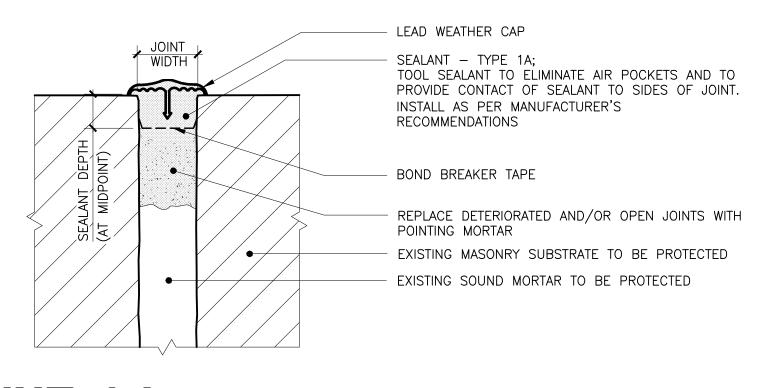
SEALANT JOINT REPLACEMENT AT WINDOW PERIMETER

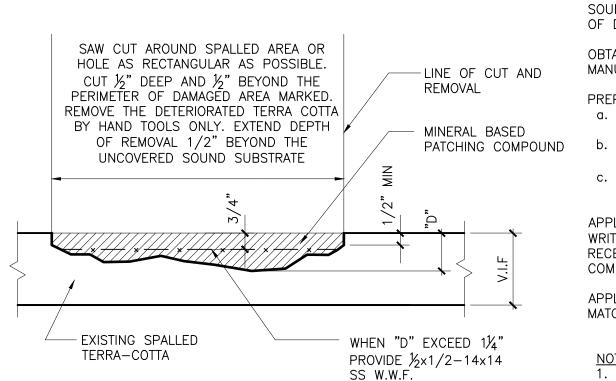
TRC 03

TERRA COTTA SPALL REPAIR

VISUALLY SURVEY TERRA COTTA AREA.

SOUND AREA AROUND EXISTING TERRA COTTA SPALLING AND MARK EXTENT OF DAMAGE. ONLY USE WOODEN MALLET FOR SOUNDING.

OBTAIN SAMPLE OF THE EXISTING TERRA COTTA AND SEND TO PRODUCT MANUFACTURER TO OBTAIN MATCHING AND COMPATIBLE PATCHING MORTAR.

- PREPARE AREA TO RECEIVE PATCH IN THE FOLLOWING WAY:
- a. REMOVE ALL LOOSE AND DETERIORATED MATERIAL FROM THE REPAIR AREA USING MANUAL TOOLS.
- b. AREAS TO BE REPAIRED SHOULD BE CUT TO PROVIDE A MINIMUM OF ½" DEPTH. DO NOT INSTALL REPAIRS ON FEATHERED EDGE.
 c. WASH THE PREPARED SURFACE WITH CLEAN WATER AND BRISTLE
- APPLY PATCHING COMPOUND (MINERAL BASED) AS PER MANUFACTURER'S WRITTEN INSTRUCTIONS. MOISTEN THE SURFACE TO RECEIVE PATCH WITH CLEAN WATER PRIOR TO APPLYING PATCHING

- 1. REPAIRS TO MATCH EXISTING TERRA—COTTA IN COLOR, SHAPE AND TEXTURE.
- 2. APPLY THE MORTAR MIX USING A TROWELL TO A MAXIMUM THICKNESS OF 3".
- 3. BUILD UP PATCHING MATERIAL SLIGHTLY ABOVE ADJACENT MASONRY
- 4. FOLLOW MANUFACTURER'S INSTRUCTIONS AND RECOMMENDATIONS.

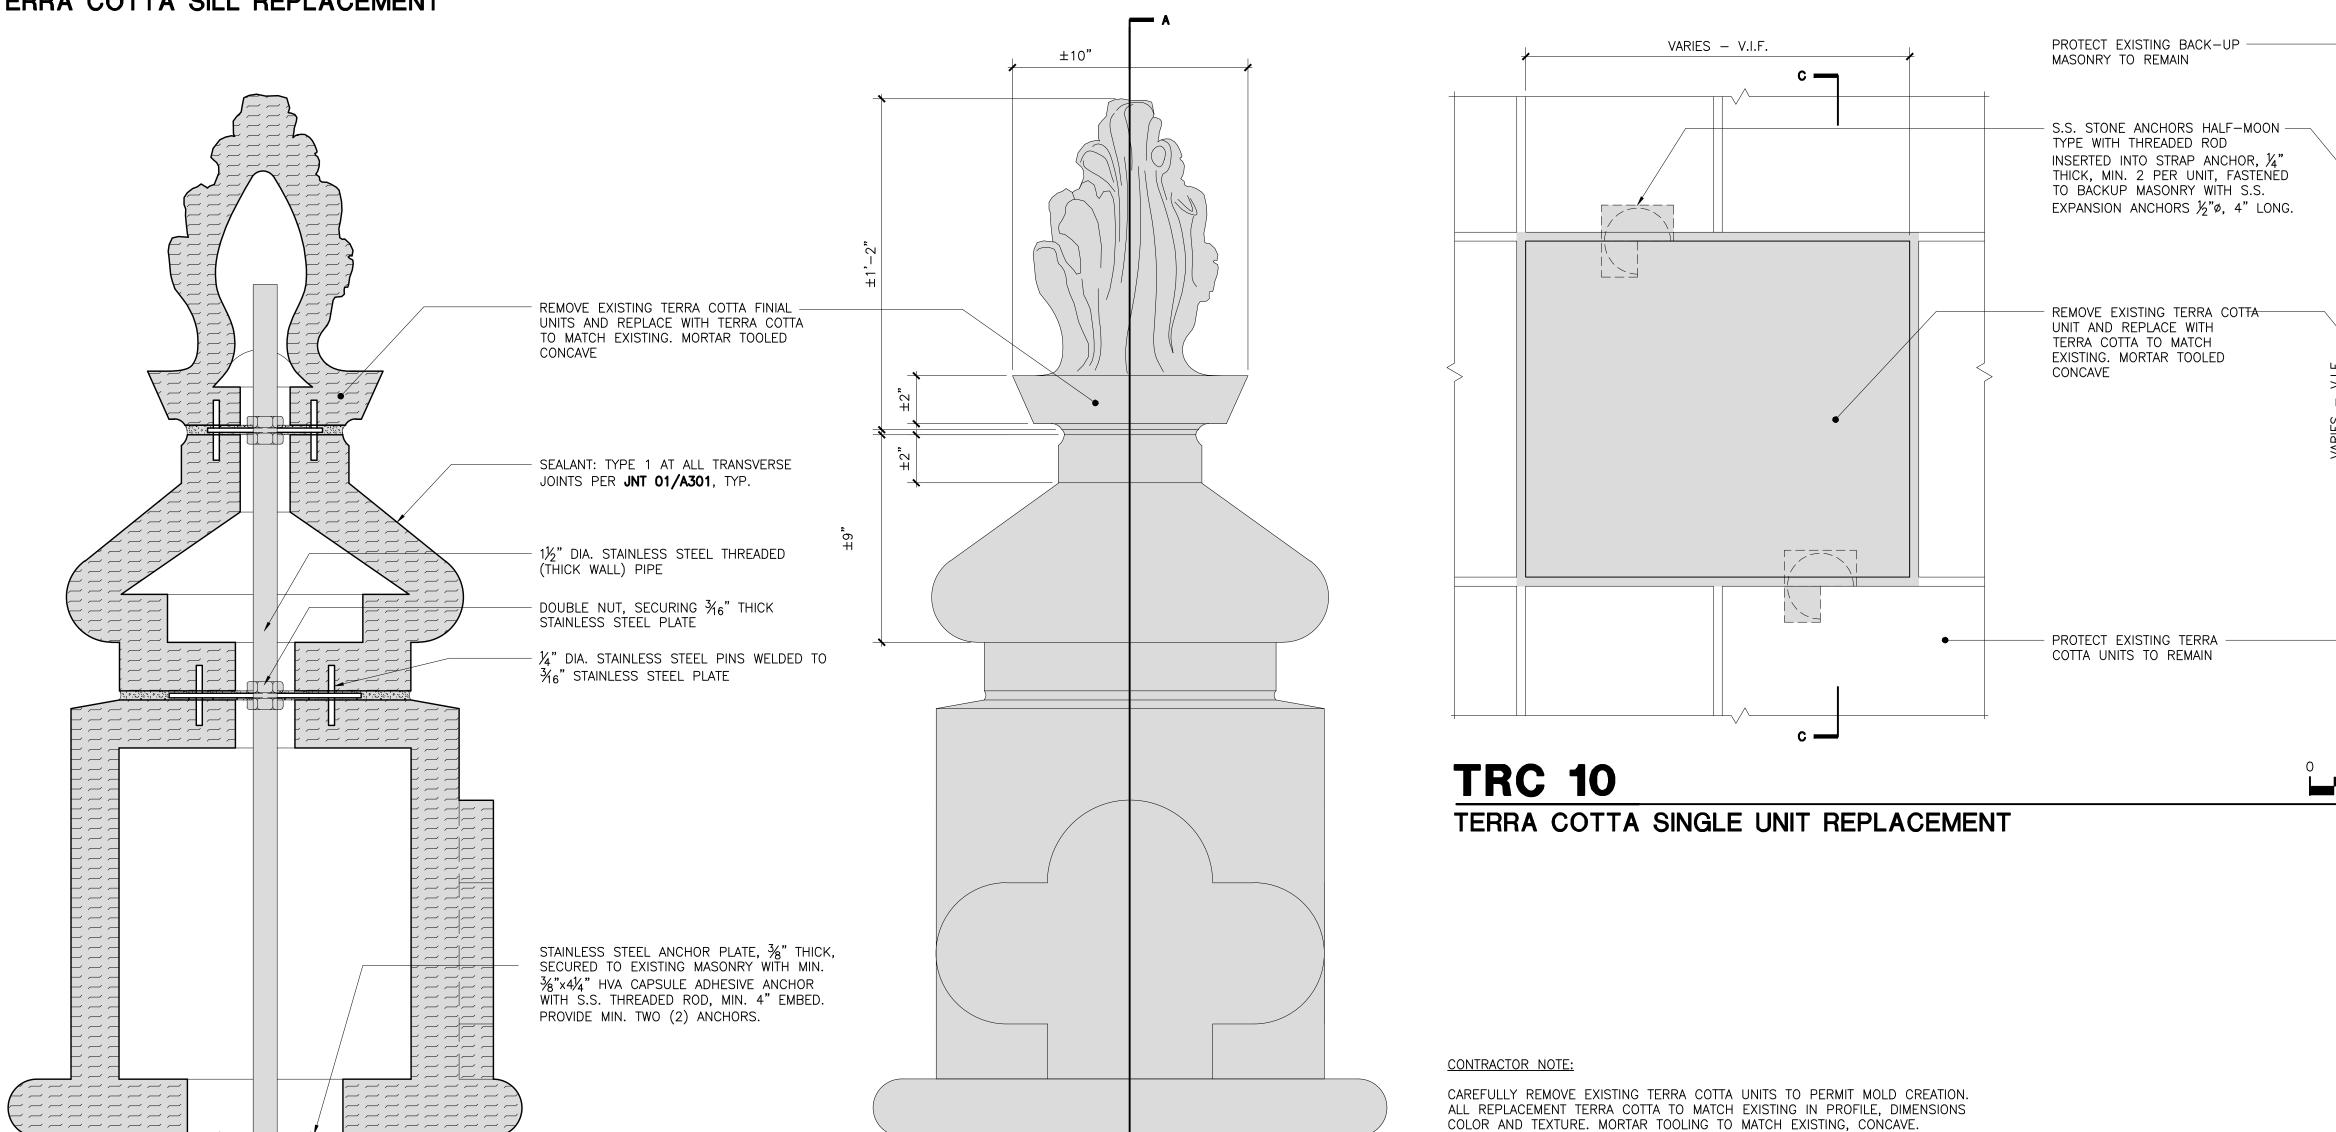
TRC 09

STAINLESS STEEL THROUGH WALL FLASHING.

FABRIC REINFORCEMENT AND UTILITY MASTIC

SEAL ALL PENETRATIONS AND SEAMS WITH

SECTION A-A

MAIN BUILDING - FINIAL RESTORATION AT GABLE ENDS

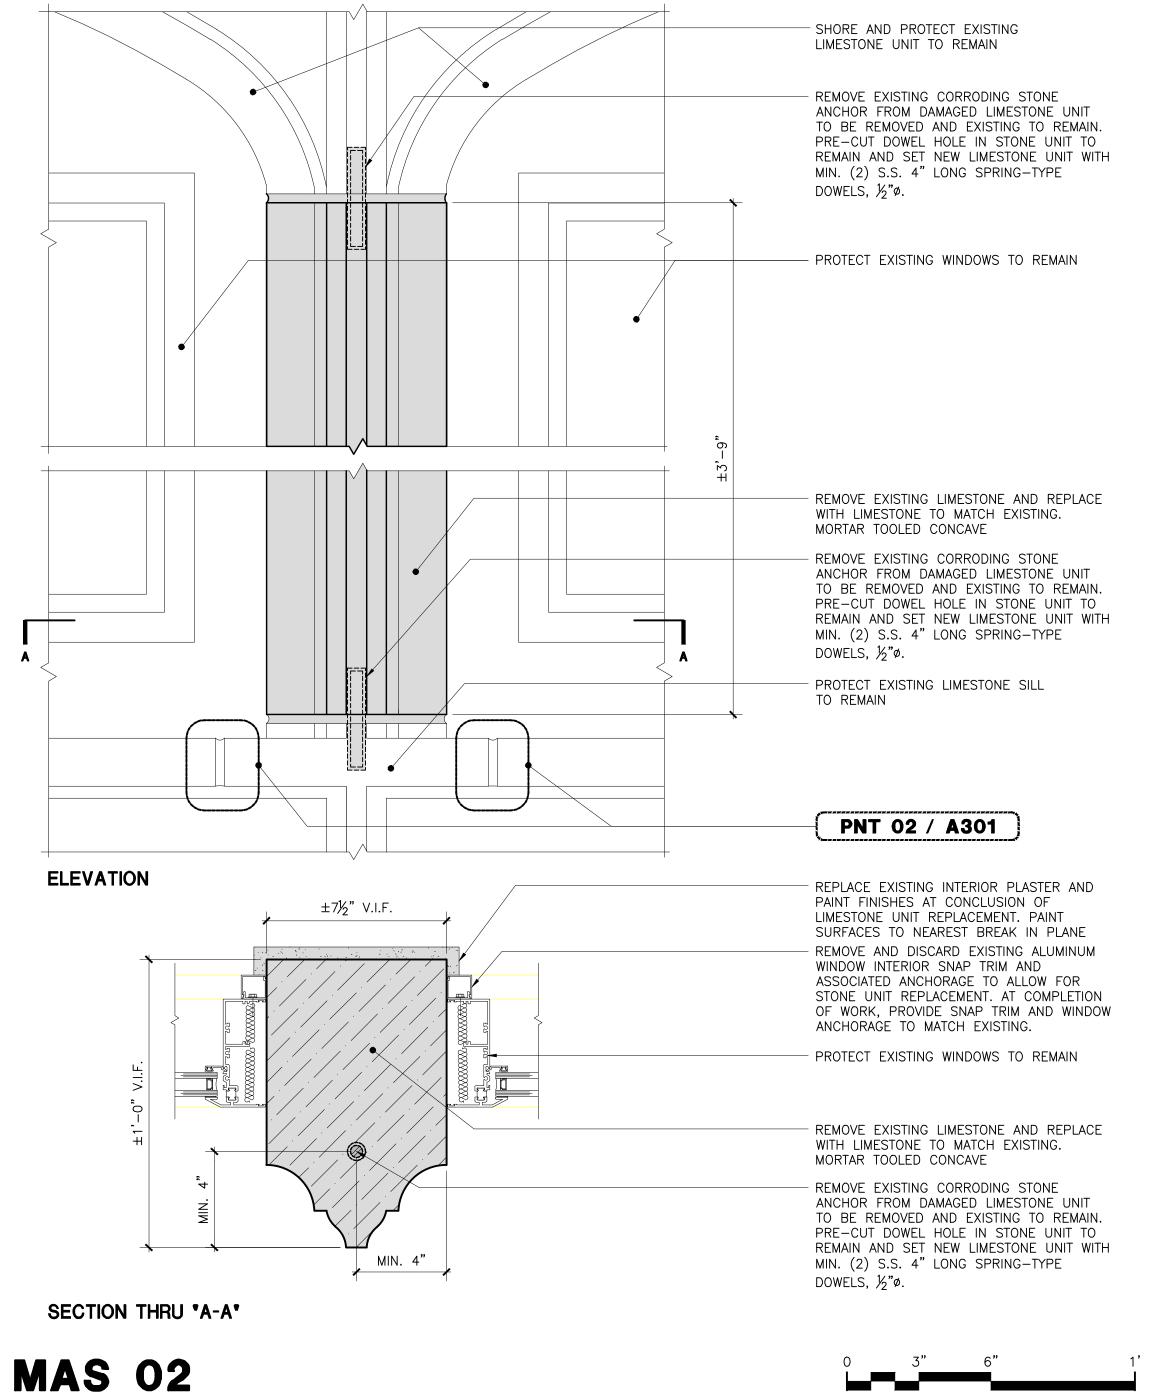
LIMESTONE WINDOW MULLION REPLACEMENT

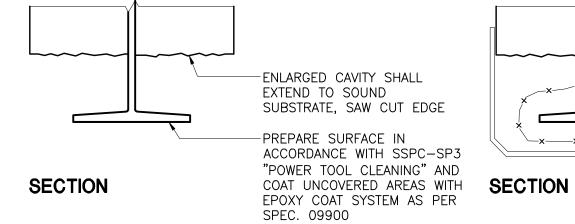
STEP 2: CUTTING AND REMOVAL OF CONCRETE

REMOVE DETERIORATED CONCRETE IN ACCORDANCE WITH

CREATE AN ENLARGED CAVITY BY PROVIDING A SAW CUT EDGE

ENLARGED CAVITY TO BE RECTILINEAR, WITH EDGES PARALLEL

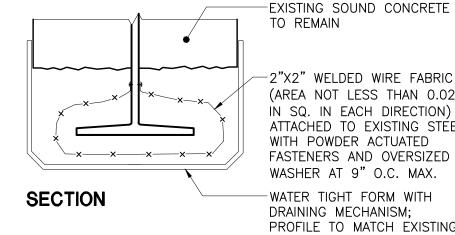
-2"X2" WELDED WIRE FABRIC (AREA NOT LESS THAN 0.025 IN SQ. IN EACH DIRECTION) ATTACHED TO EXISTING STEEL WITH POWDER ACTUATED FASTENERS AND OVERSIZED WASHER AT 9" O.C. MAX. WATER TIGHT FORM WITH DRAINING MECHANISM;

PROFILE TO MATCH EXISTING

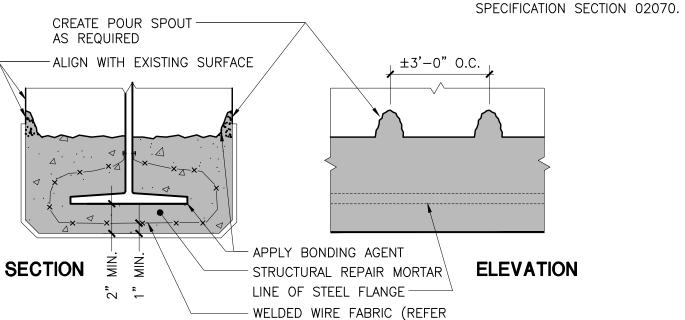
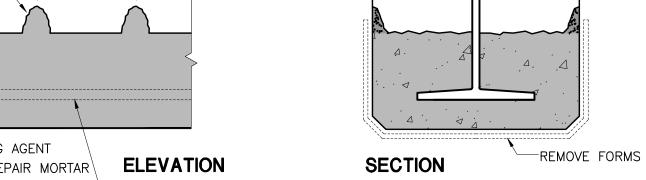
CONCRETE BEAM ENCASEMENT REPAIR

INSTALL WATER TIGHT FORM.

ACTUATED FASTENERS.

TO PREVIOUS STEP)

STEP 4: STRUCTURAL REPAIR MORTAR INSTALLATION

PUMP OR POUR FULL DEPTH STRUCTURAL REPAIR MORTAR THROUGH POUR SPOUTS. LEAVE FORMS IN PLACE FOR 48 HOURS AFTER THE REPAIR MORTAR IS POURED.

REMOVE FORMS AND PATCH HOLES AT FORM ANCHOR POINTS WITH STRUCTURAL REPAIR MORTAR. PROFILE AND TEXTURE OF FINISHED SURFACE TO MATCH EXISTING.

CONCRETE COLUMN ENCASEMENT REPAIR

EXISTING STEEL BEAM ENCASED IN CONCRETE DETERIORATED AND/OR CRACKED CONCRETE

STEP 1: IDENTIFICATION OF DETERIORATED CONCRETE

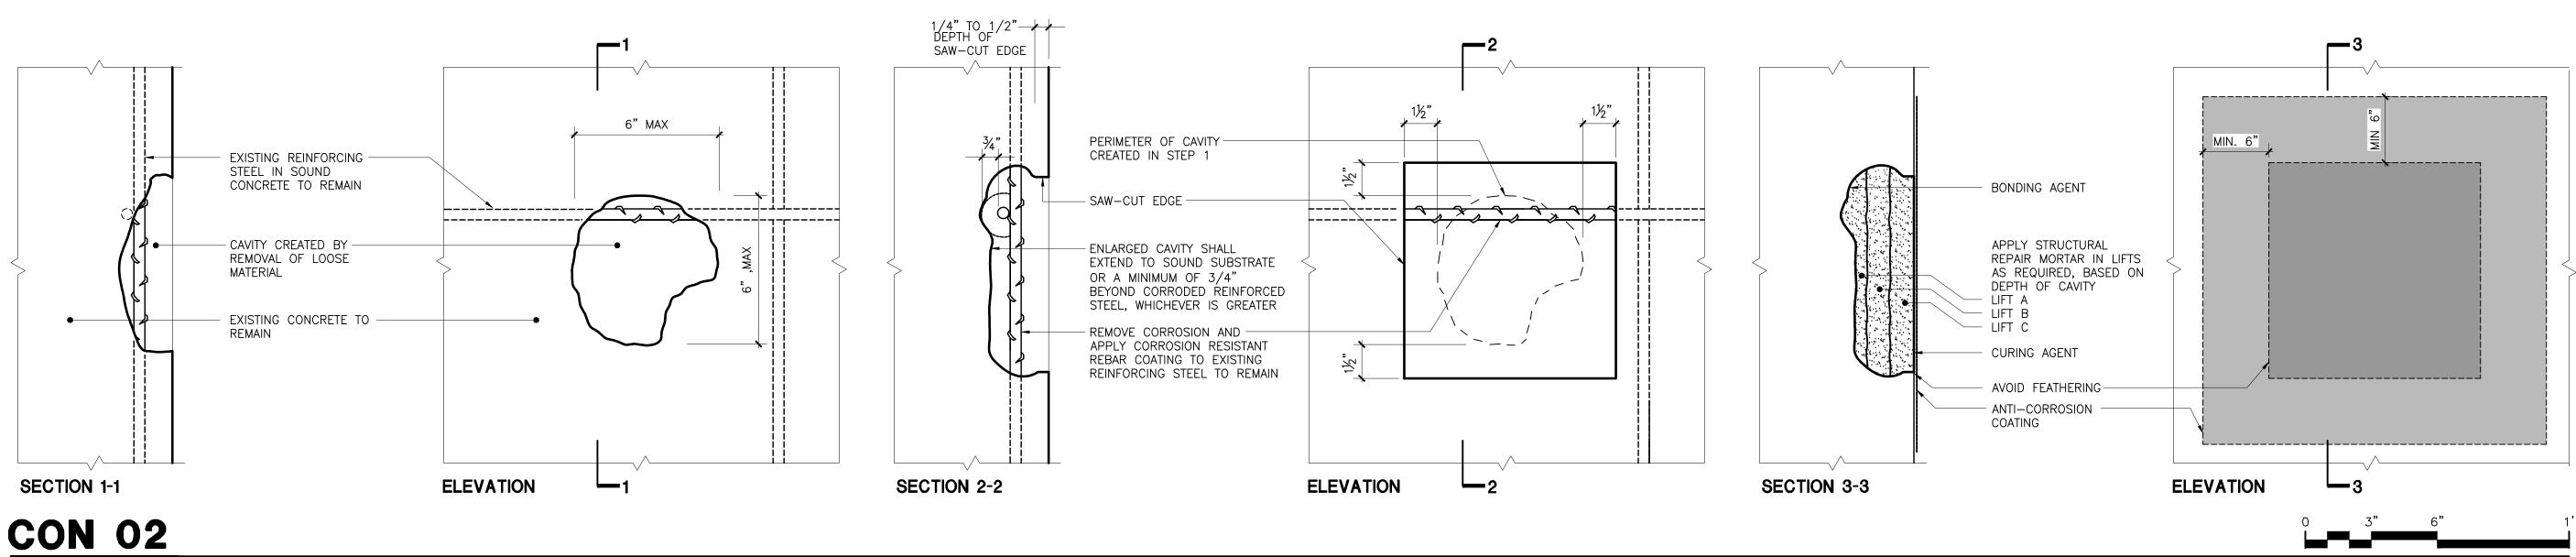
REMOVE ALL LOOSE MATERIAL.

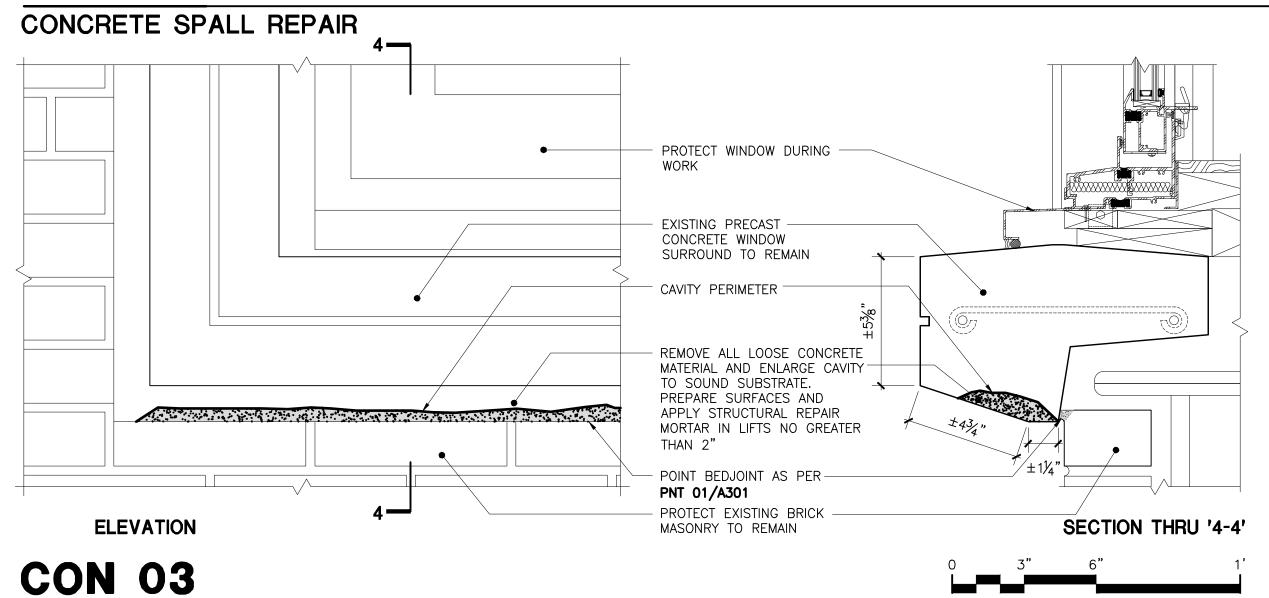
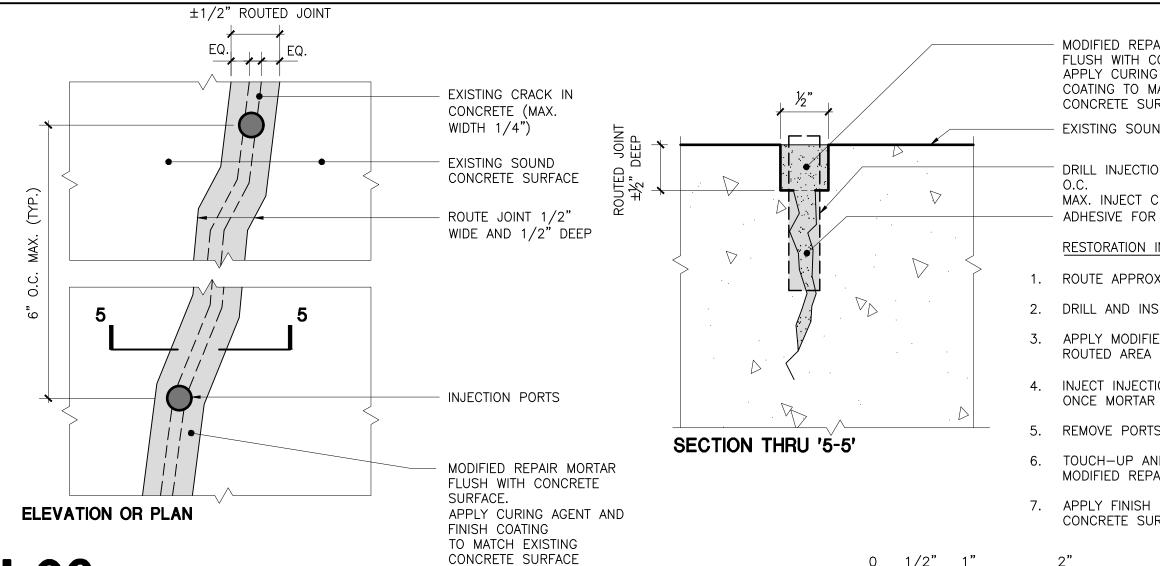
CONCRETE CRACK REPAIR

MODIFIED REPAIR MORTAR FLUSH WITH CONCRETE SURFACE. APPLY CURING AGENT AND FINISH COATING TO MATCH EXISTING CONCRETE SURFACE EXISTING SOUND CONCRETE SURFACE

DRILL INJECTION PORTS INTO CRACK AT 6" MAX. INJECT CRACK WITH INJECTION EPOXY ADHESIVE FOR CRACKS 1/8" - 1/4"

2. DRILL AND INSERT PORTS APPLY MODIFIED REPAIR MORTAR IN THE

6. TOUCH-UP AND COMPLETE SURFACE WITH MODIFIED REPAIR MORTAR
