TERRA COTTA CRACK REPAIR

Drawing Title:
TERRA COTTA REPAIR DETAILS —

MASONRY REPLACEMENT AND STONE REPAIR DETAILS

CONCRETE REPAIR DETAILS

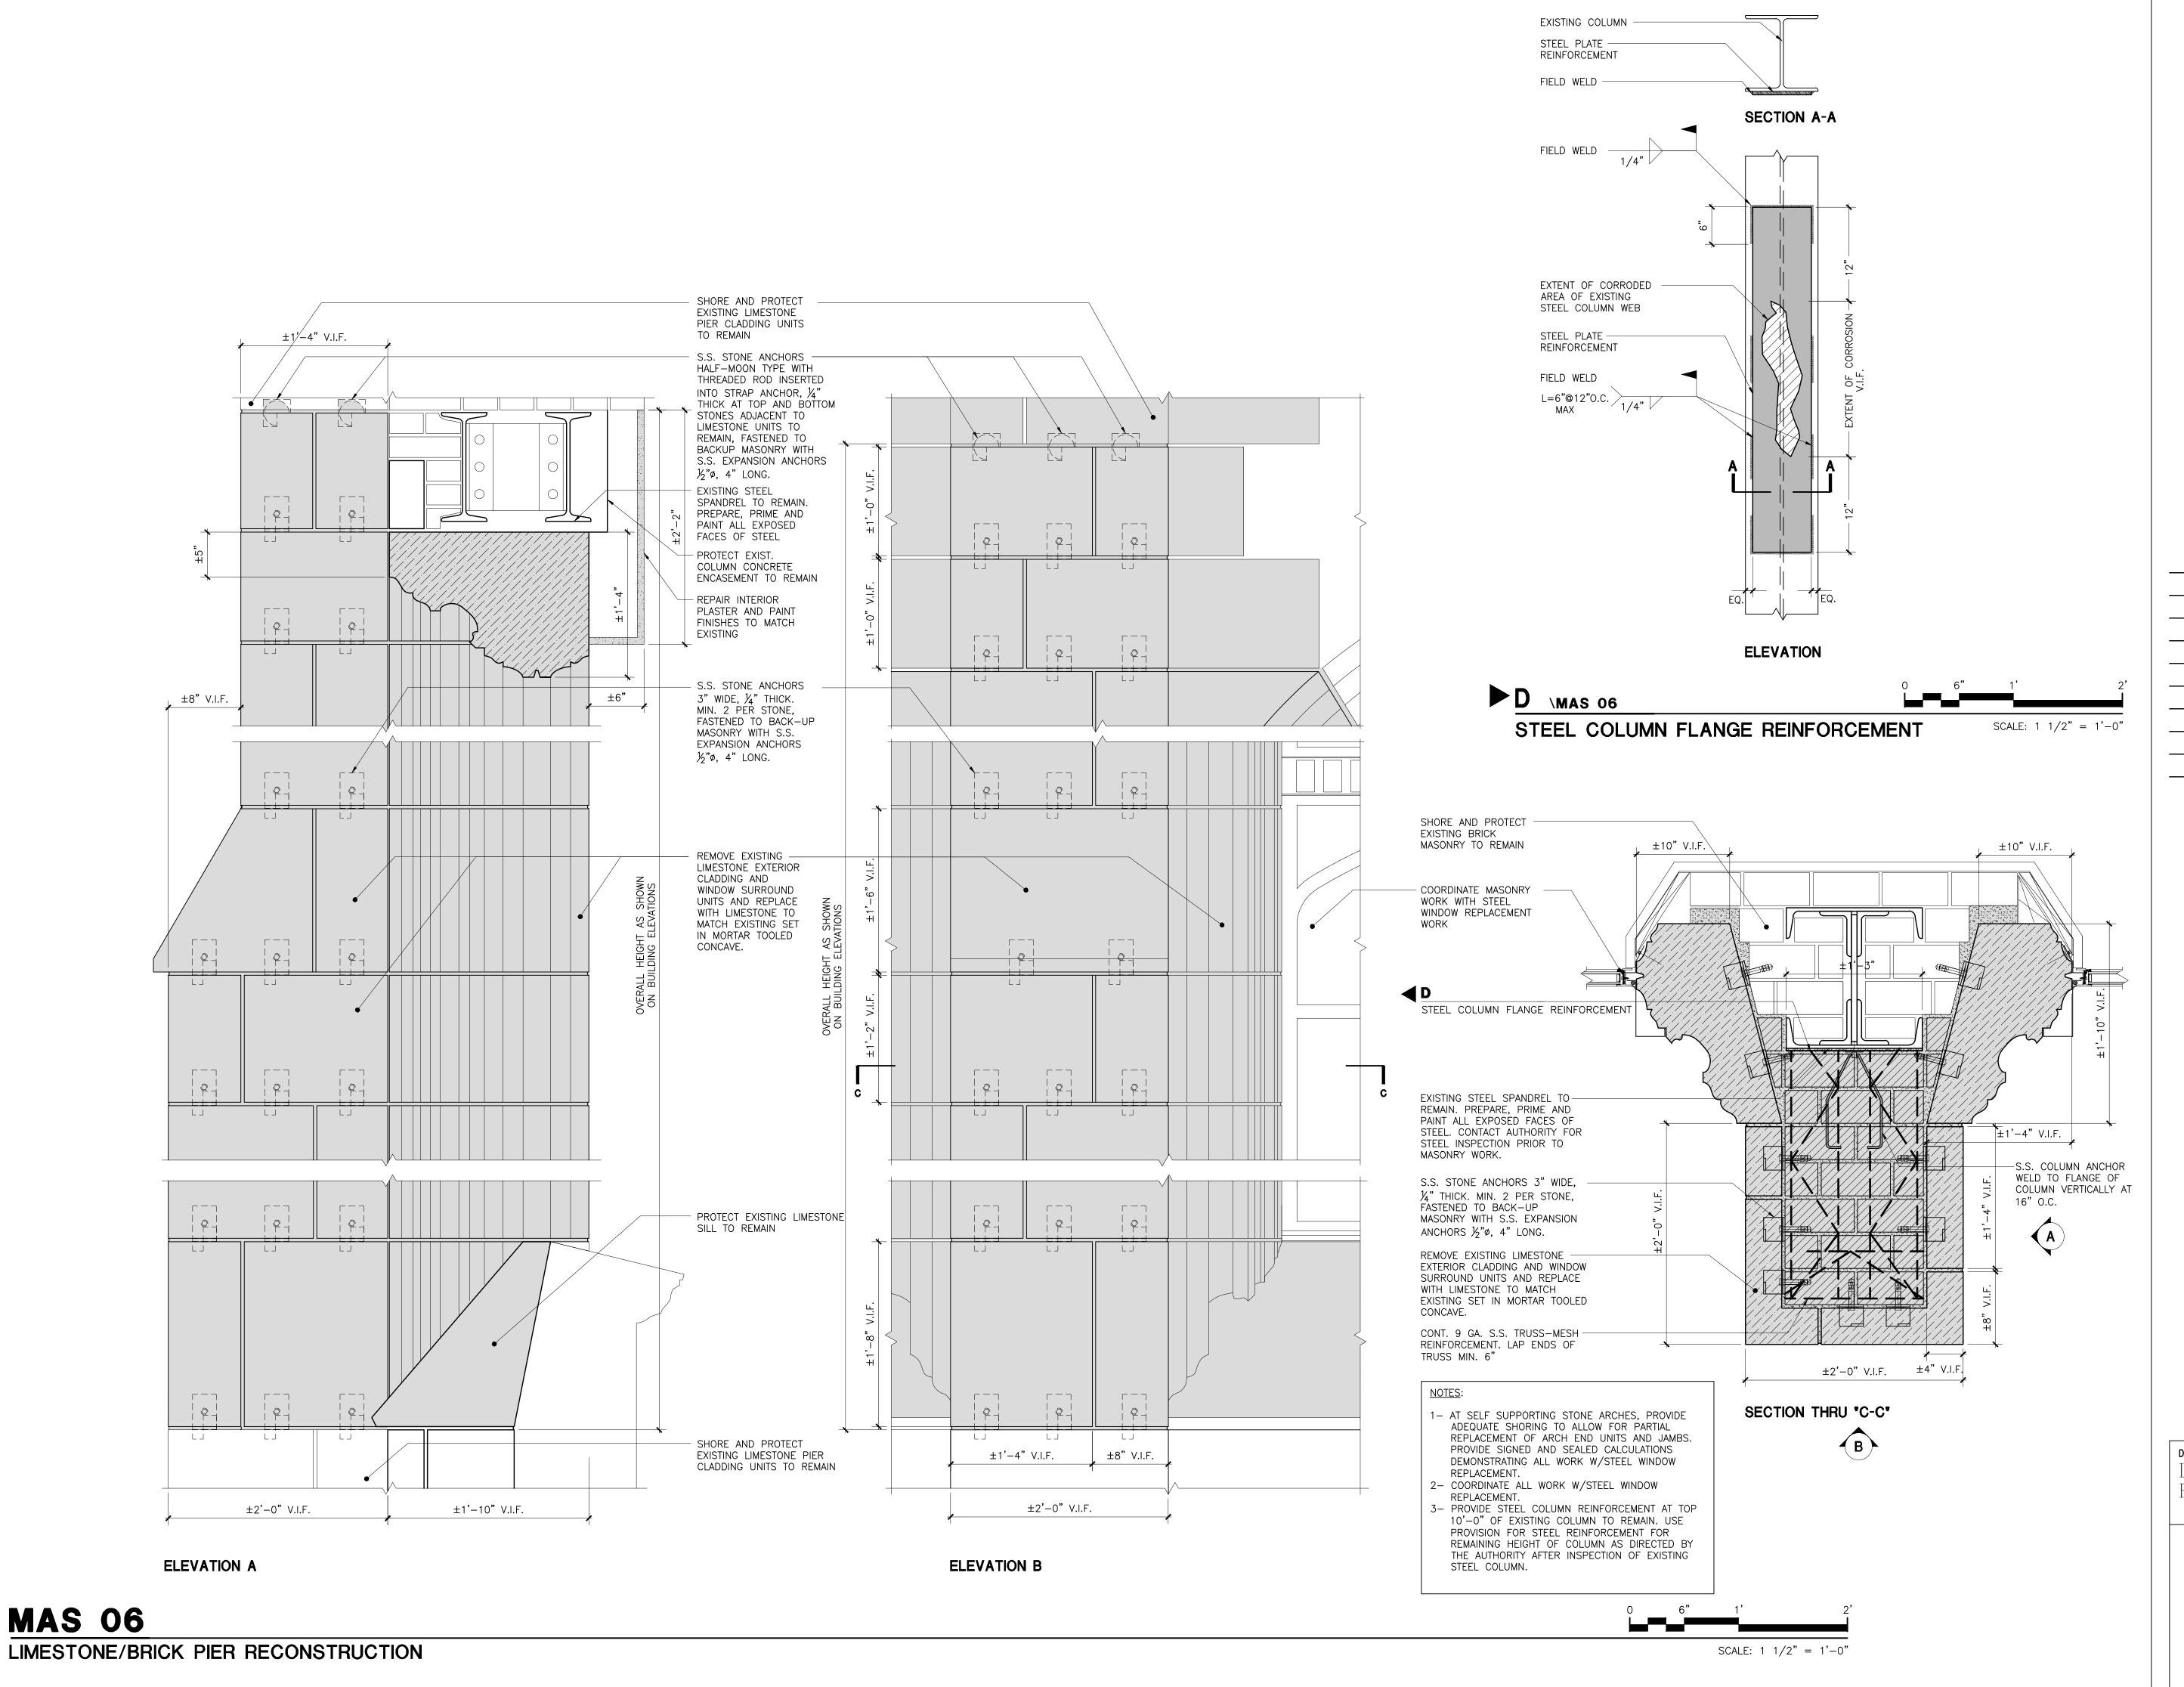
LIMESTONE/BRICK PIER RECONSTRÚCTION DETAILS

MAS 06
