The New York Landmarks Conservancy Lucy G. Moses Preservation Awards Nomination

George Westinghouse Career and Technical Education High School 105 Tech Place Brooklyn, New York

**Exterior Restoration**

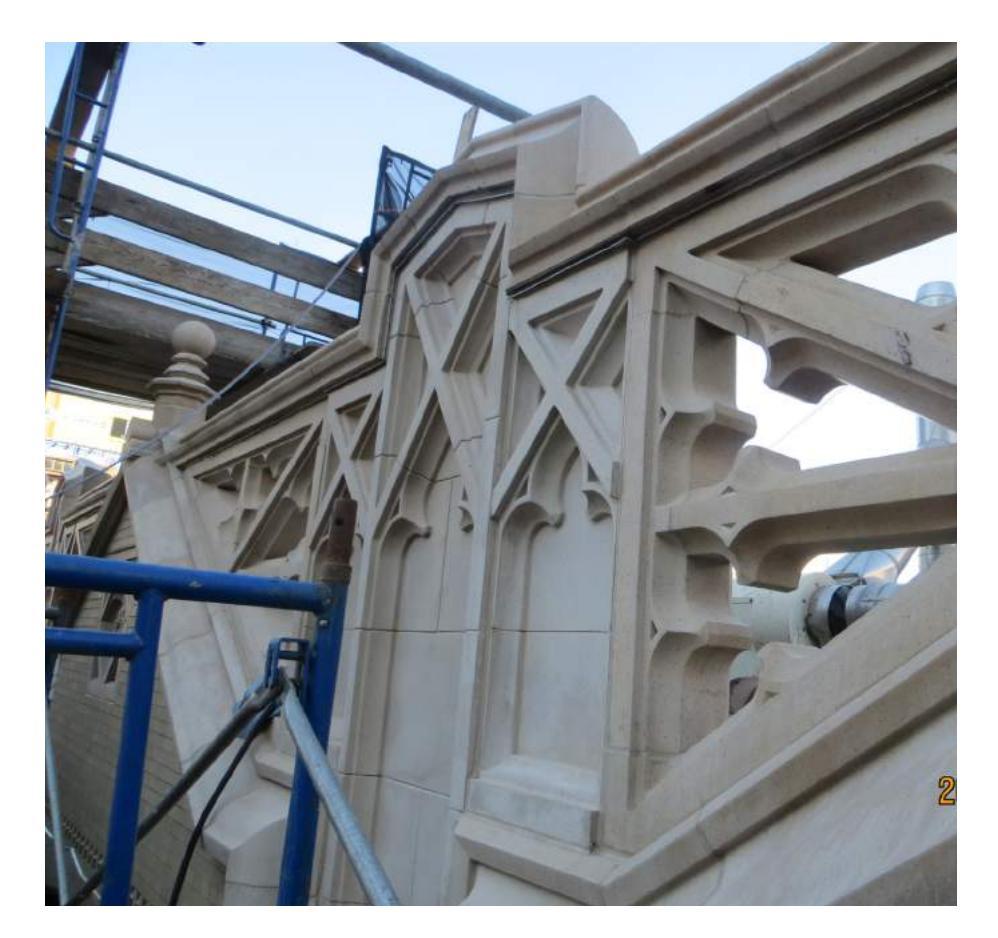
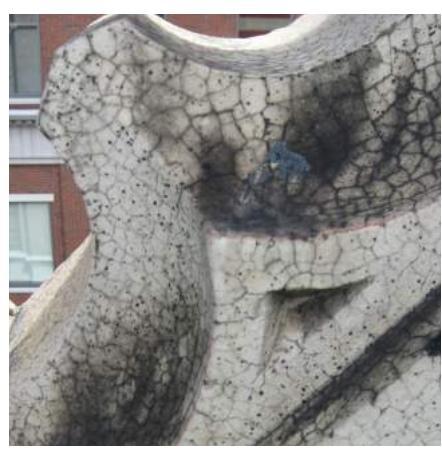
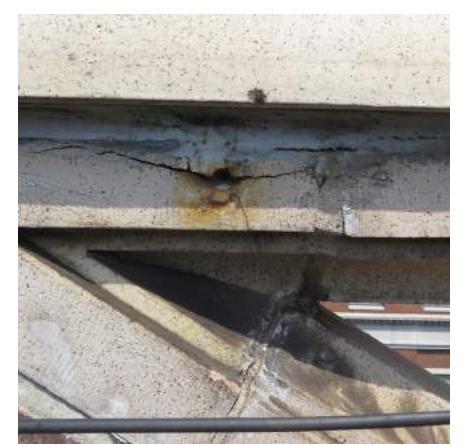
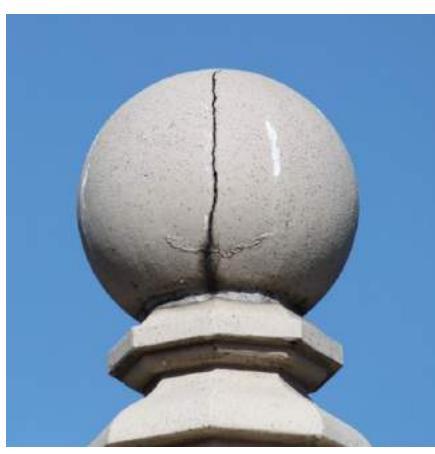
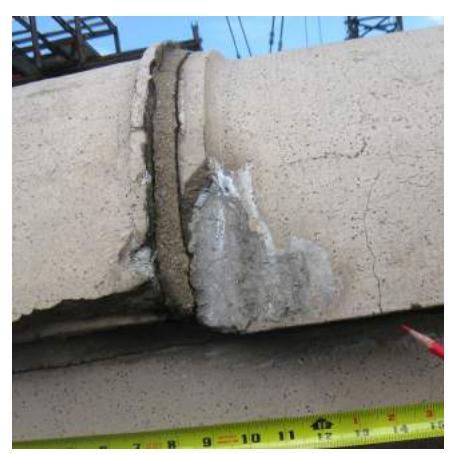
The entire street facing parapet was replaced in kind, to address extensive masonry deterioration - cracked, spalled and displaced terra cotta and bulging brick masonry as a result of corroding steel within the masonry walls. The off-street parapet was also replaced to address the deteriorated brick masonry, which was the cause of water infiltration into the interior of the building. Existing elements were carefully documented. All replacement masonry was selected to match existing materials in shape, color and texture. Architectural pre-cast concrete and glass-fiber-reinforced concrete were used in reconstructing the ornate parapet. SUPERSTRUCTURES wrote its specifications so that those two products would perform harmoniously and

Top left, bottom left, center and right: Parapet components before restoration. Top right: portion of restored parapet.

were made by the same manufacturer to ensure their visual compatibility. This work included removal of brick masonry and terra cotta at parapet level, down to the 4th-floor window lintel level arch. Careful parapet design and detailing was required to accomodate support for masonry, flashing and moisture control, and allow for expansion and contraction, while exactly replicating masonry in scale, color, shape and detail. Exposed structural steel elements were cleaned and coated and reinforced where deterioration had occurred. New vertical expansion joints and through-wall flashings were installed. Interior finishes damaged by water infiltration were repaired. SUPERSTRUCTURES worked closely with manufacturers, MIA and the contractor to ensure project success.

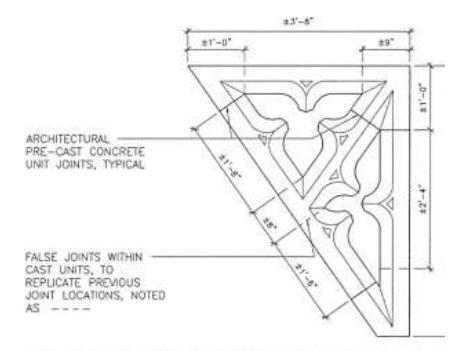
ARCHITECTURAL PRE-CAST CONCRETE UNITS - TRACERY TYPE E4

Above: Detail drawing of pre-cast concrete unit for parapet. Top left, and bottom left, center and right: during demolition and construction of parapet. Top right: Portion of restored parapet and coping.

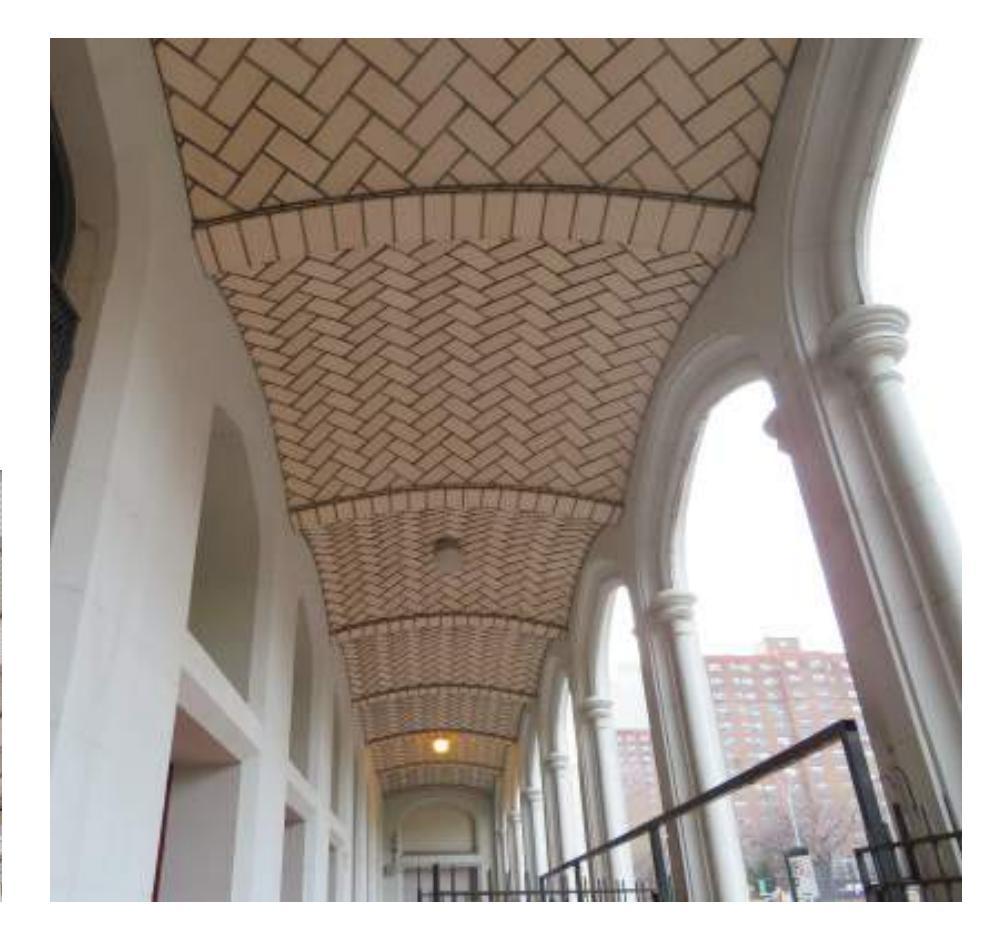
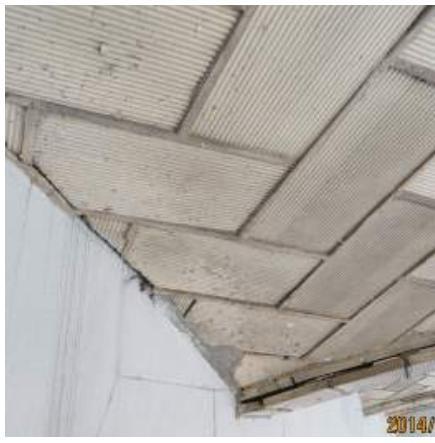
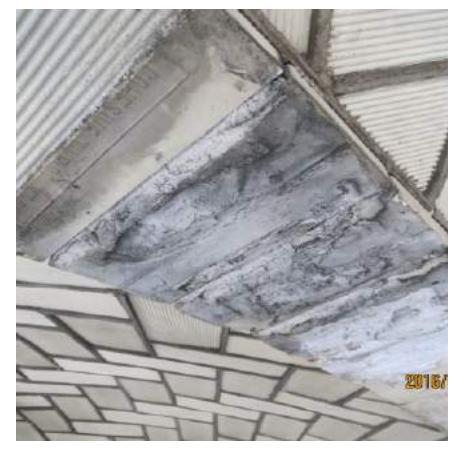
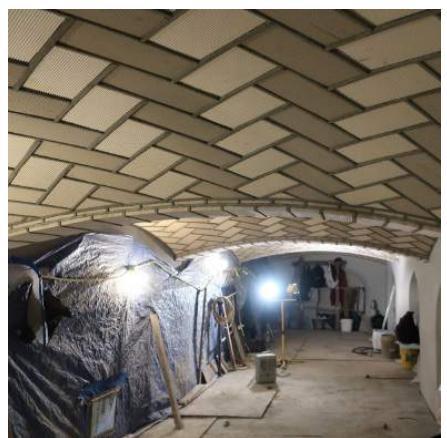
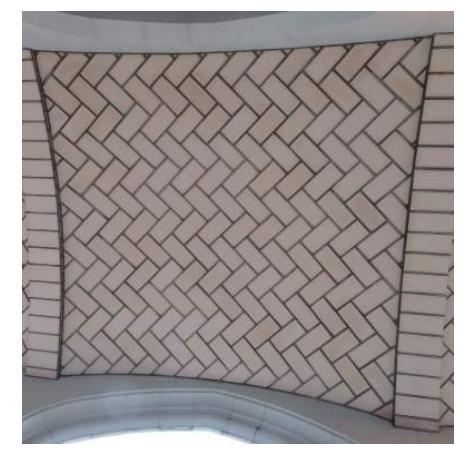
The arched Guastavino-tiled ceiling in the Tillary Street loggia, which had been damaged by water infiltration from above was fully restored. The entire first layer of tile was replaced. SUPERSTRUCTURES prepared custom specification for the work. The contractor hired a speciality subcontractor to carry out this portion of the restoration. The roof above the tiled ceiling was also replaced to prevent further water infiltration.

Top left: tiled ceiling before restoration. Bottom left and center: ceiling during construction. Top right and bottom right: restored Guastavino tile ceiling.

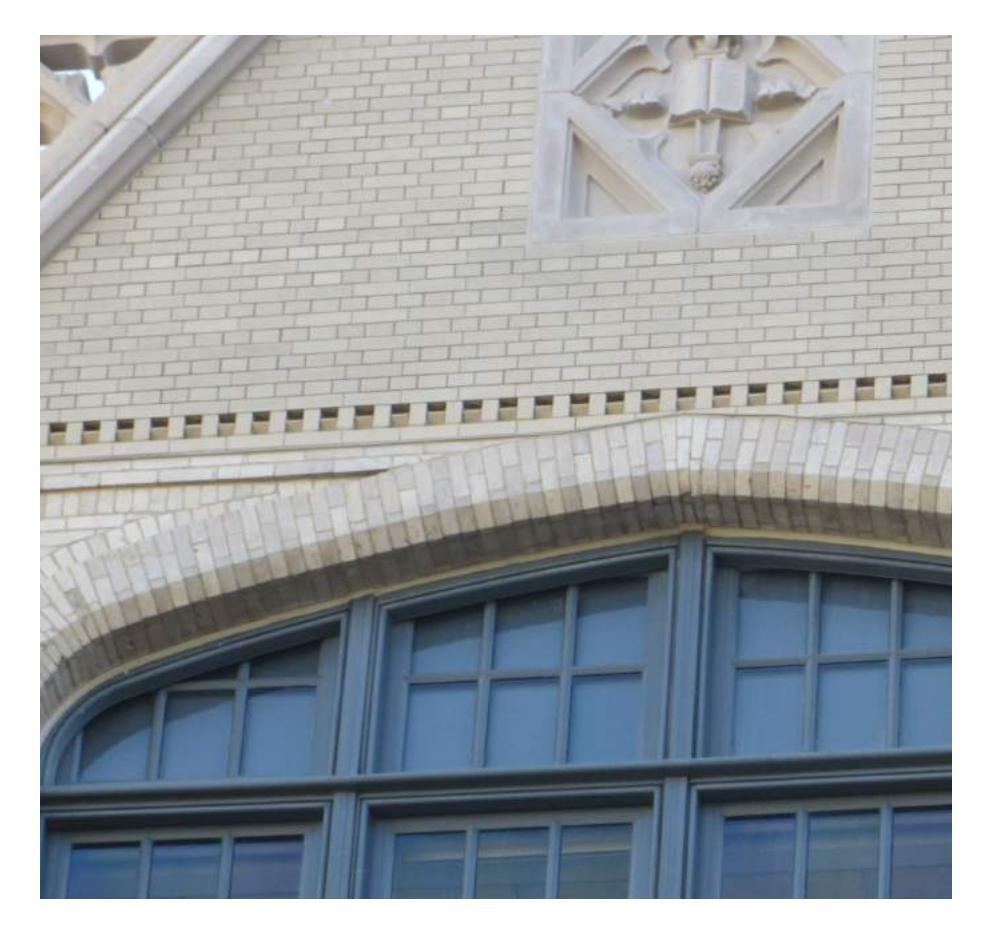
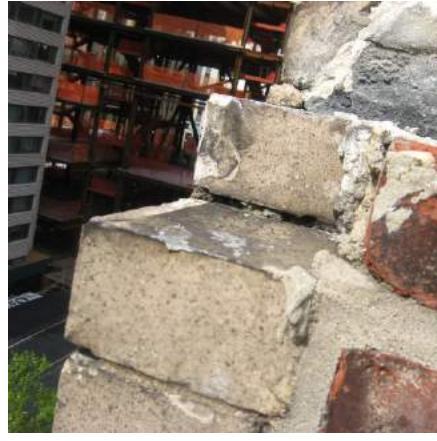
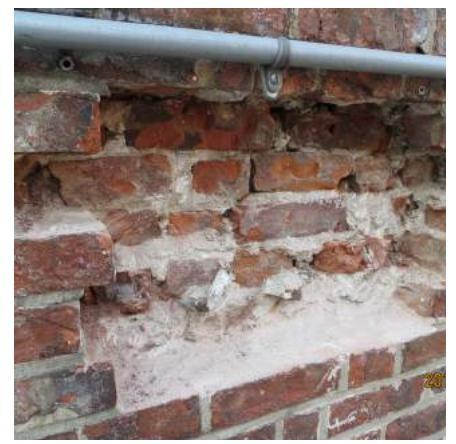
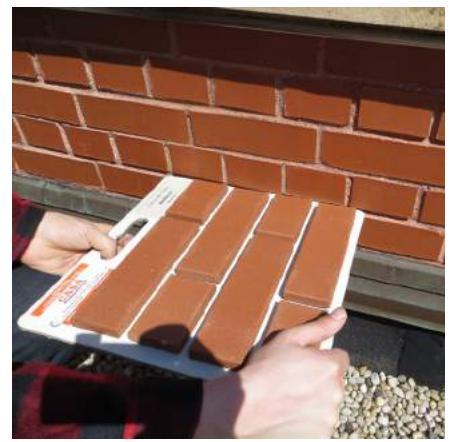
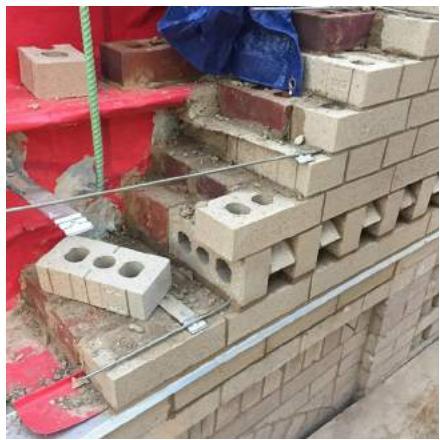
- Miscellaneous cracked/deteriorated face brick replacement. New brick and mortar matched existing in shape, color and texture,
- Machine tool cleaning, priming and painting of various lintels at various facade locations,
- Corner reconstruction of cracked brick masonry at addition building,
- · Miscellaneous sealant replacement, where deteriorated, and
- Concrete patching at areaway curbs.

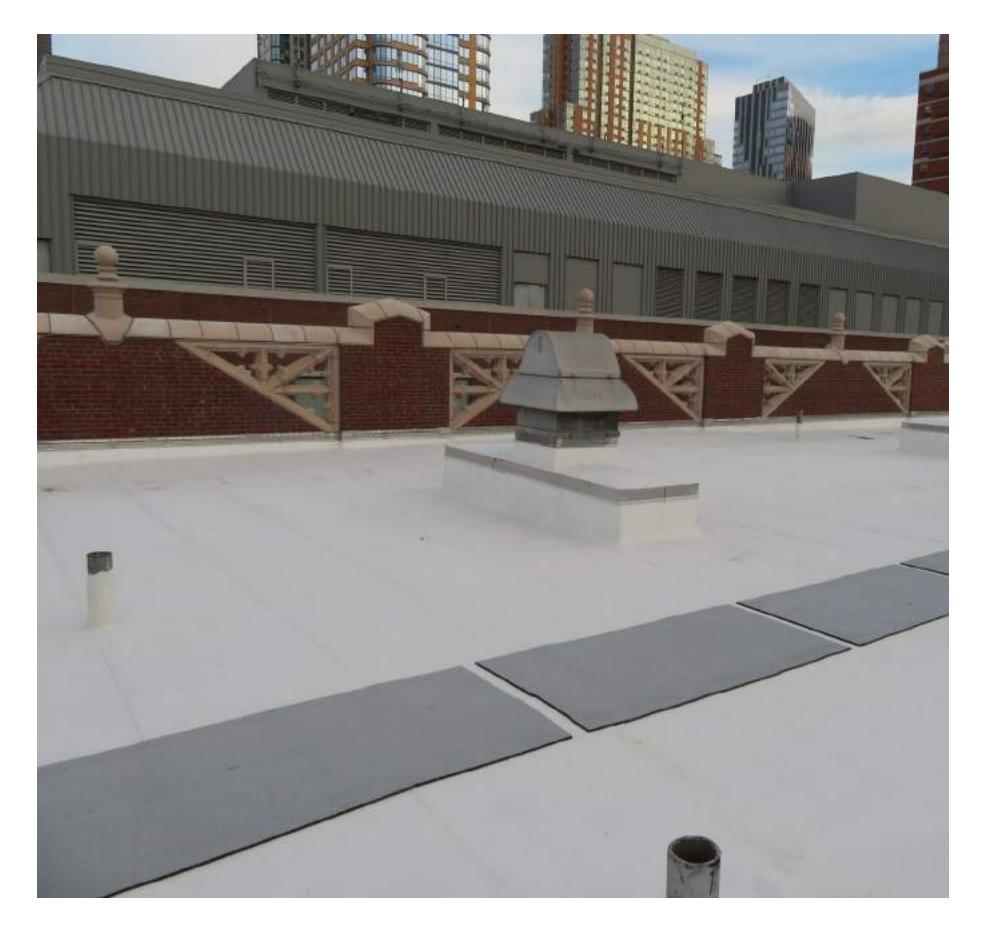
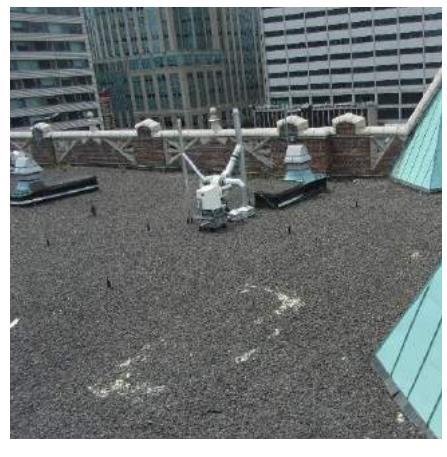
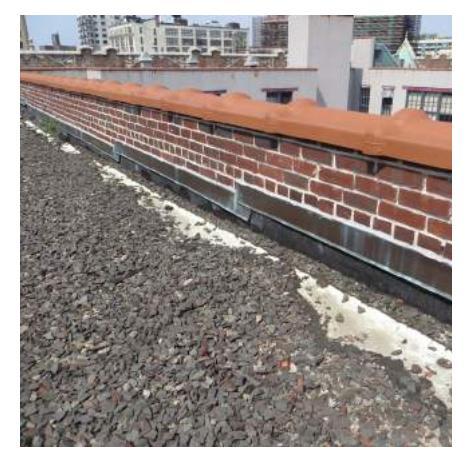
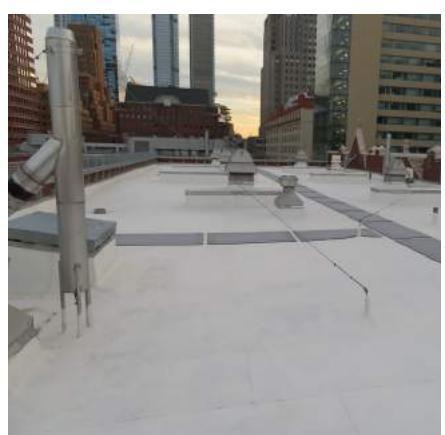
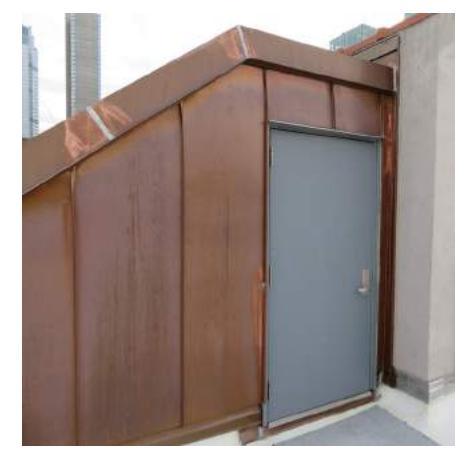
Existing flat, IRMA roofs and pitched standing seam copper roofs throughout the original building were replaced. The work included:

- Removal of existing deteriorated/leaking roofing systems,
- Installation of new steel bracing and new built-up roof systems,
- Replacement of roof drains,
- New copper standing-seam cladding and flat-seam roof at bulkhead.
