Non-Destructive Testing & Evaluation Methods

SUPERSTRUCTURES provides, in conformance with applicable listed standards, in-situ non-destructive testing and evaluation (NDT&E) of existing building components and materials, including:

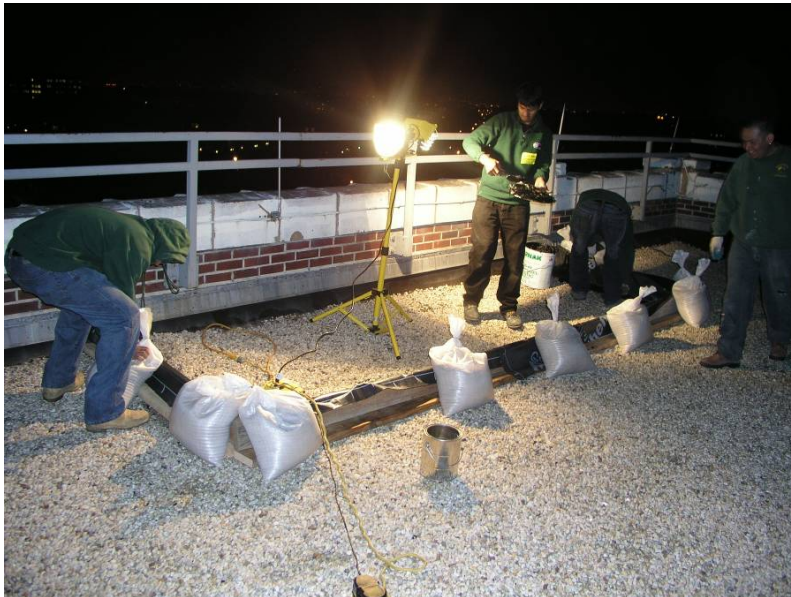
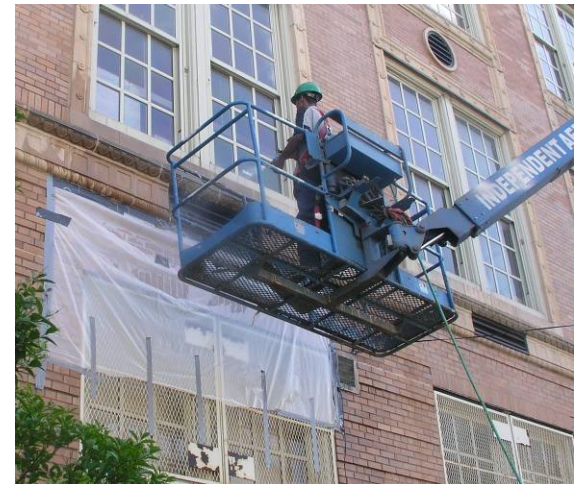
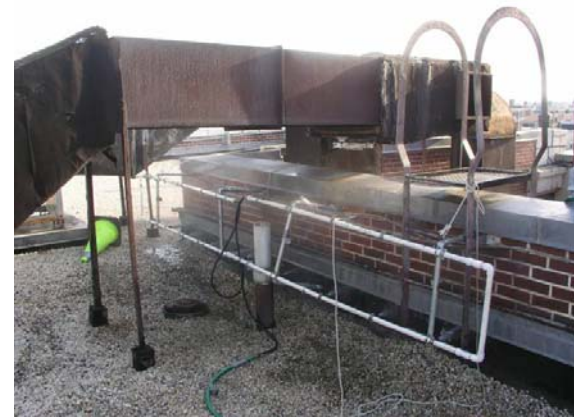
Leak Investigation

Water Testing of exterior surfaces to determine primary and secondary sources of leaks:

- Spray Bar: Water Penetration Resistance of masonry using an exterior pressure-regulated spray rack and interior moisture detection (modified ASTM E1105).
- Flood Test: Waterproofing Failure Detection of roofing using a containment assembly and interior moisture detection (following ASTM D5957).
- Leakage Mapping: Water Penetration Resistance of fenestration using an exterior pressure-regulated hose and interior moisture detection (AAMA 511-08).

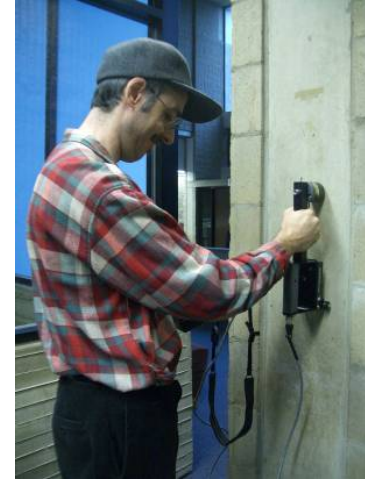
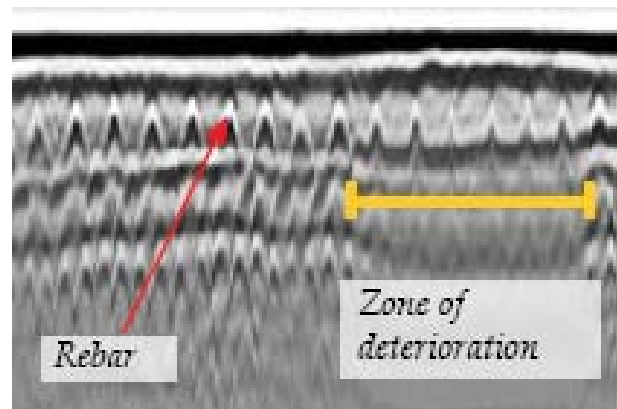
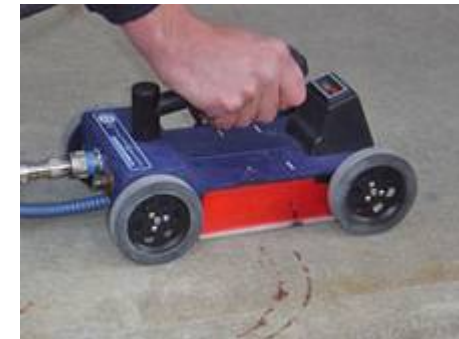
Reinforced Concrete Construction

Load-Carrying Capacity Parameters of concrete slab with reinforcing bar:

- Depth/Thickness of slab using impact-echo (ASTM C1383).
- Compressive Strength of concrete using rebound hammer (ASTM C805).
- Reinforcing Bar Size/Spacing/Location & Depth of Cover using covermeter (BS 1881-204).
- Reinforcing Bar Spacing/Location using ground penetrating radar (ASTM D6432).
- Delamination/Void Detection in concrete using rotary percussion (ASTM D4580) for near-surface voids or impact-echo (ASTM C1383) for deep voids.

Core Clearance prior to drilling/coring/boring in concrete:

- Rebar/Conduit Detection using ground penetrating radar (ASTM D6432).

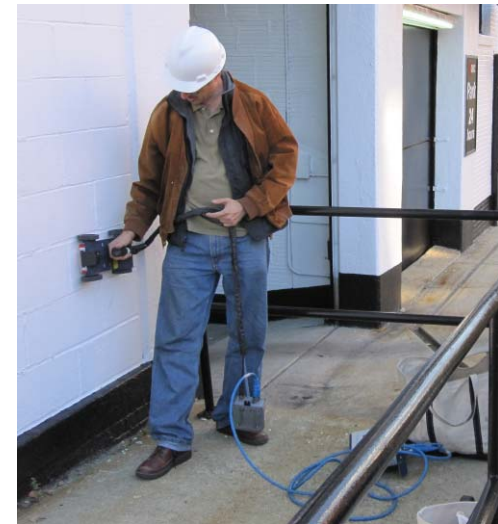
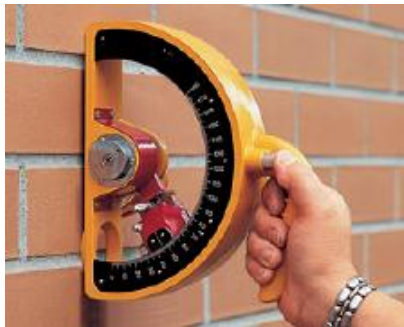
Masonry, Stone, and/or Terra Cotta Construction

Deficiency Detection in building facades:

- Infrared Thermography to detect patterns of differential heating, indicating potential voids or water retention (ASTM C1060).
- Detection of Corroded Ferrous Anchors/Wall Ties using the mass magnetic probe technique (non-destructive).
- Missing Grout Detection in CMU using ground penetrating radar (ASTM D6432).
- Delamination/Void Detection in masonry and/or stone using impact-echo (ASTM C1383).
- Visual Inspection of Internal Concealed Conditions using a fiber optic borescope and high intensity light source.

Characterization of building facades:

- Detection of Concealed Ferrous Anchors/Wall Ties using a pachometer (following ASTM D7046).
- Depth/Thickness of masonry and/or stone using impact-echo (ASTM C1383).
- Hardness Characterization of mortar using rebound hammer (RILEM MS-D.7).
- Surface Water Absorption using a "RILEM Tube" (RILEM II.4).

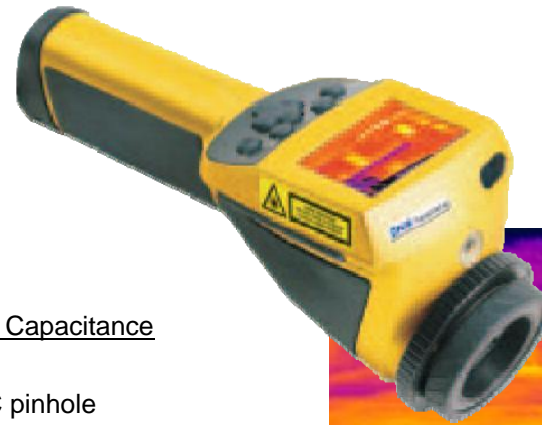
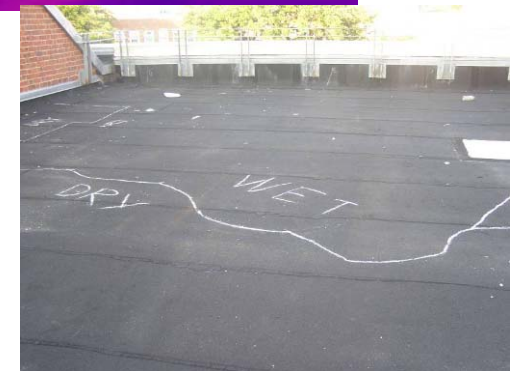
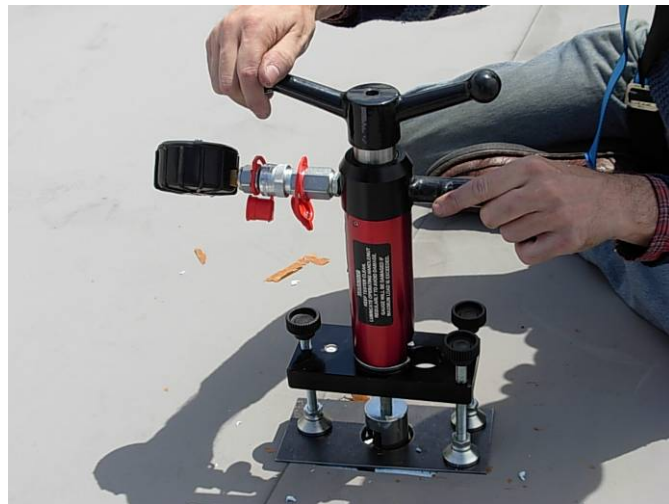
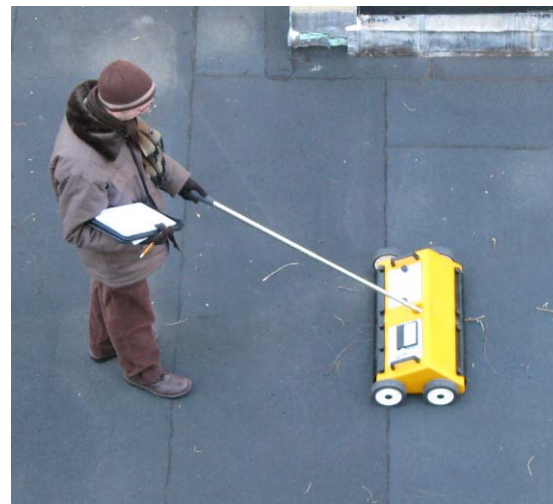
Roofs, Waterproofing Membranes and Assemblies

- Roof Moisture Survey using Infrared Thermography and Electrical Capacitance scanning (incorporating elements of ASTM C1153).
- Roof Membrane Integrity Mapping and Leak Detection using a DC pinhole detector.
- Deck Contour Mapping to determine "pitch to drain" using a laser level system.
- Withdrawal Resistance Verification of roof fasteners (ANSI/SPRI FX-1).

(Roof cuts and gravimetric testing required for full ASTM C1153 compliance. Contour mapping requires roof cuts to reach deck. Roof repair may be required after withdrawal resistance verification testing.)

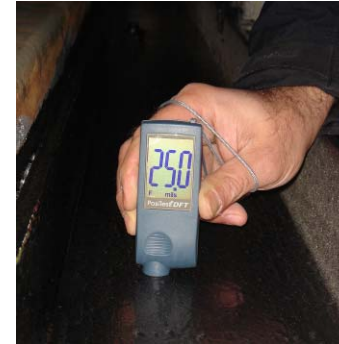
Coatings

Construction Administration testing:

- Pull-Off Strength Measurement using a portable adhesion tester (ASTM D4541).
- Coating Thickness Measurement of coatings on ferrous and non-ferrous metals using a non-destructive gage (ASTM E376).

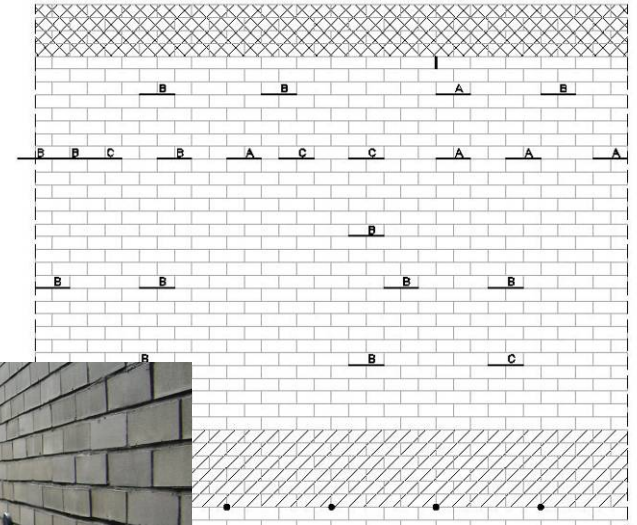
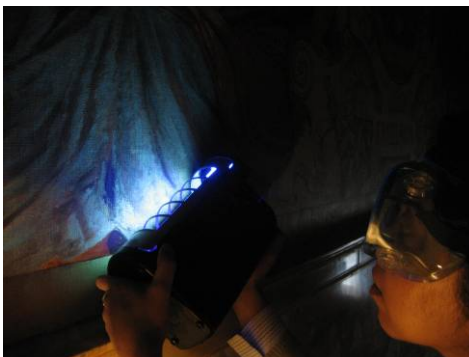
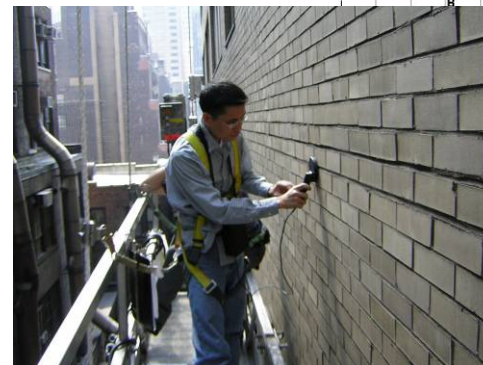
Stucco and/or Plaster

Deficiency Detection and Characterization of construction:

- Infrared Thermography to detect patterns of differential heating, indicating potential voids or water retention (ASTM C1060).
- Visual Inspection of Internal Concealed Conditions using a fiber optic borescope and high intensity light source.
- Patch Detection using an ultraviolet lamp to create fluorescent patterns.
- Detection of Concealed Ferrous Anchors/Wall Ties using a pachometer (following ASTM D7046).
